LIMITED OCCURRENCE INVESTIGATION REPORT – FINAL

Reference Number	CA18/3/2/1427						
Classification	Serious Incident	Date	15 August 2023		Time	0945Z	
Type of Operation	Private (Part 94)						
Location							
Place of Departure	Wonderboom Aerodrome (FAWB), Gauteng province		Place of Intended Landing		Wonderboom Aerodrome (FAWB), Gauteng province Pretoria		
Place of Occurrence	On gravel road at Rooiberg area at GPS co-ordinates determined to be 24°46'26" South 027°45'18"						
GPS Co-ordinates	Latitude	24° 46' 26" S	Longitude	027° 45' 18" E	Elevation	3800ft	
Aircraft Information							
Registration	ZU-ADM						
Make; Model; S/N	Aermacchi; Bosbok AM-3C (Serial Number: 2012)						
Damage to Aircraft	Minor			Total Aircraft Hours	3 341.5		
Pilot-in-command							
Licence Type	Airline Transport Pilot Licence (ATPL)		Gender	Male		Age	54
Licence Valid	Yes	Total Hours	11 600		Total Hours on Type	400	
Total Hours 30 Days	5		Total Flying on Type Past 90 Days	5

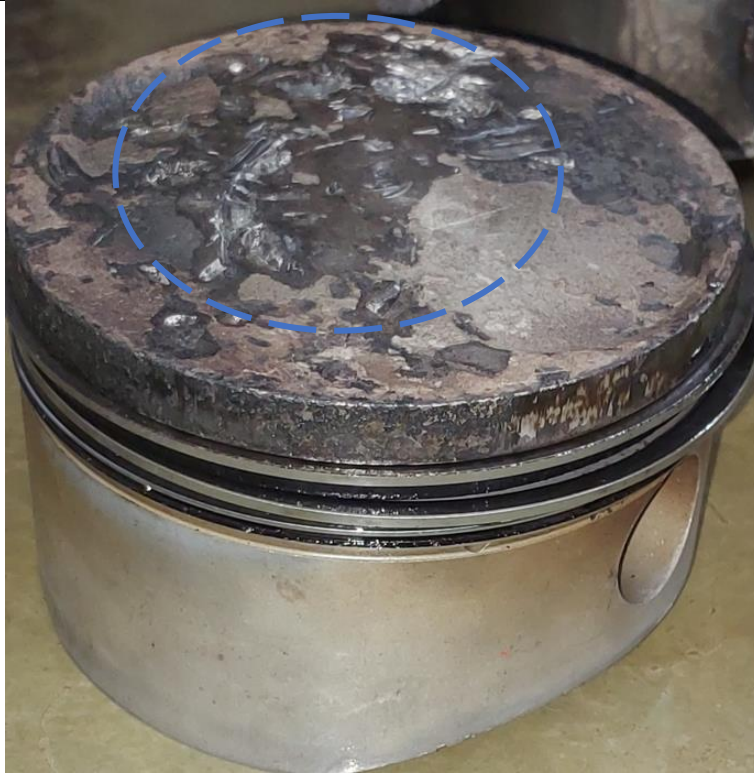
Figure 2: The blue circle indicates damage caused by the valve head on the number 2 piston crown.

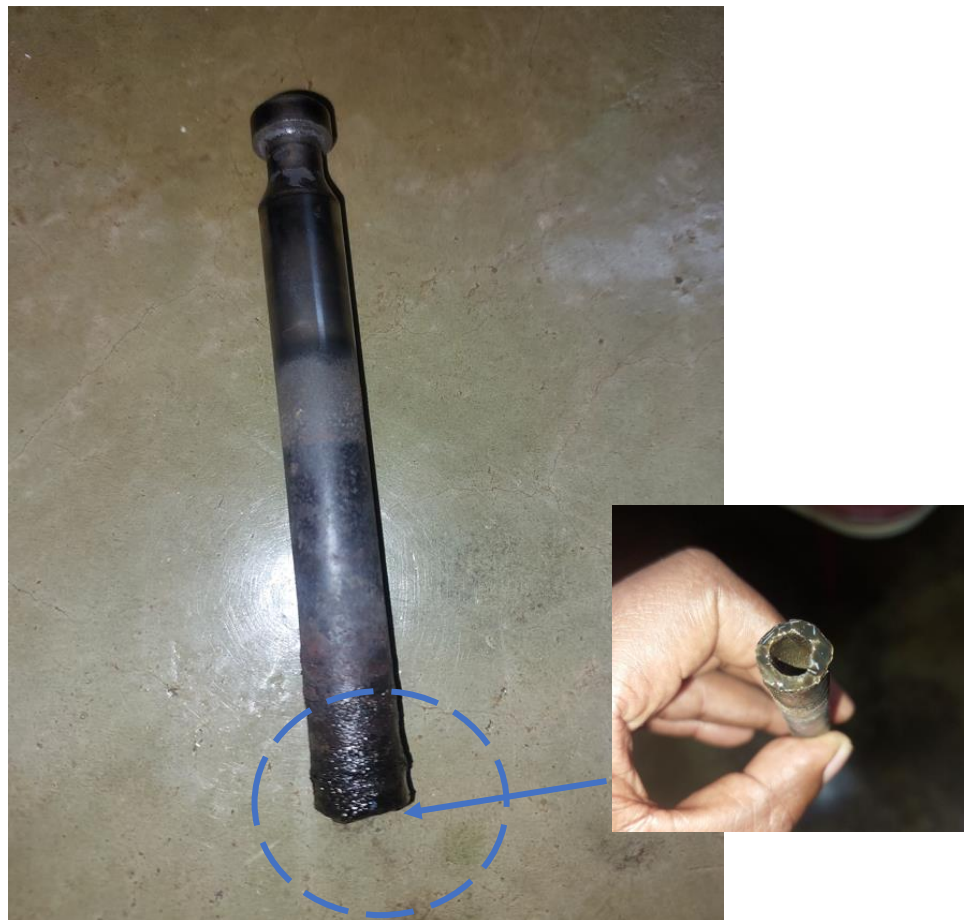
Figure 3: Cylinder number 2 exhaust valve stem with the head missing. It fractured during operation.

Probable Cause(s)
The pilot performed a successful forced landing on the road after the aircraft experienced an in-flight engine power loss as a result of the fractured exhaust valve stem in cylinder number 2.
Contributing Factor(s)
None.
Safety Action(s)
As a safety precaution, the aircraft maintenance organisation (AMO) sent the engine to the workshop for a complete overhaul.
Safety Message and/or Safety Recommendation/s
None.
About this Report
<p><i>The decision to conduct a limited investigation is based on factors including whether the cause is known and the evidence supporting the cause is clear, the level of safety benefit likely to be obtained from an investigation and that will determine the scope of an investigation. For this occurrence, a limited investigation has been conducted, and the Accident and Incident Investigations Division (AIID) has relied on the information submitted by the affected person/s and organisation/s to compile this limited report. The report has been compiled using information supplied in the initial notification, as well as from follow-up desk top enquiries to bring awareness of potential safety issues to the industry in respect of this occurrence, as well as possible safety action/s that the industry might want to consider in preventing a recurrence of a similar occurrence.</i></p> <p><i>All times given in this report are Co-ordinated Universal Time (UTC) and will be denoted by (Z). South African Standard Time is UTC plus 2 hours.</i></p>
