LIMITED OCCURRENCE INVESTIGATION REPORT – FINAL

Reference Number	CA18/3/2/1428						
Classification	Serious Incident	Date	21 August 2023		Time	1115Z	
Type of Operation	Private (Part 141)						
Location							
Place of Departure	Lanseria International Airport (FALA), Gauteng Province		Place of Intended Landing		Wonderboom Airport (FAWB), Gauteng Province		
Place of Occurrence	Lanseria International Airport (FALA), Gauteng Province						
GPS Co-ordinates	Latitude	25°55'38" S	Longitude	027°56'14" E	Elevation	4 500 ft	
Aircraft Information							
Registration	ZS-STP						
Make; Model; S/N	Cessna C172 (Serial Number: 17266715)						
Damage to Aircraft	None		Total Aircraft Hours	8608.4			
Pilot-in-command							
Licence Type	Commercial Pilot Licence (CPL)		Gender	Male		Age	35
Licence Valid	Yes		Total Hours	1380		Total Hours on Type	1380
Total Hours 30 Days	31		Total Flying on Type Past 90 Days	39			
People On-board	2+0		Injuries	0		Fatalities	0
						Other (on ground)	0

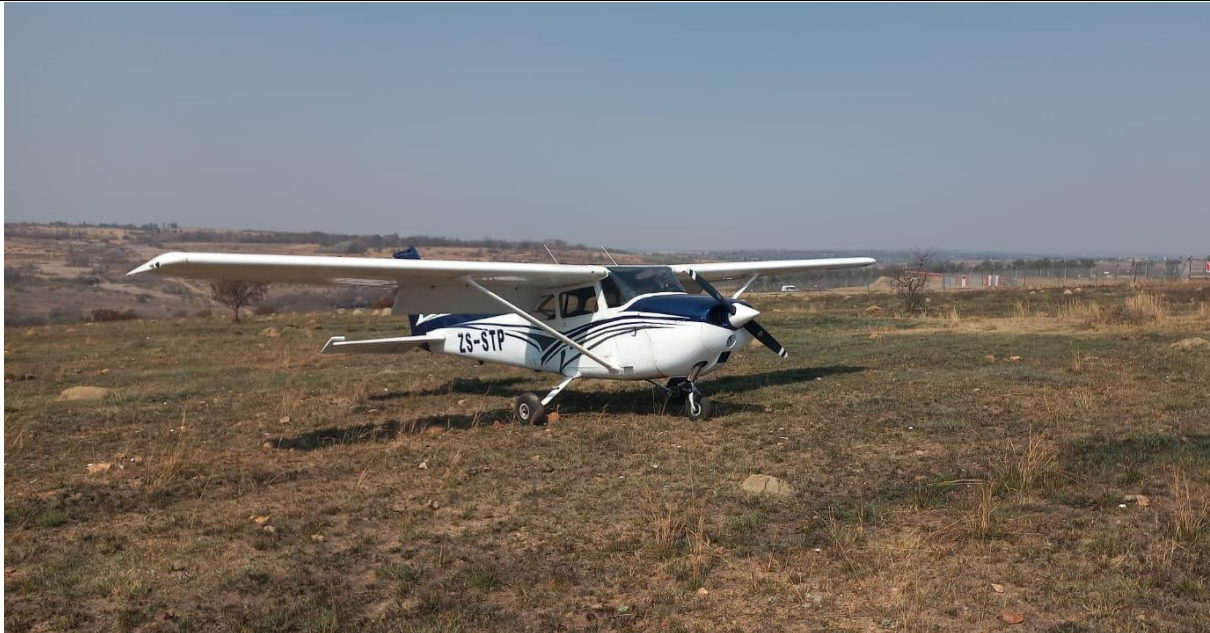
Fire Fighting (ARFF) personnel responded to the scene. Both crew members were not injured. The aircraft was also not damaged.

Following this incident, the aircraft was found to have used up all available fuel on-board, and this is the reason the engine surged and stopped.

Figure 1: The ZS-STP after the successful landing. (Source: Operator)

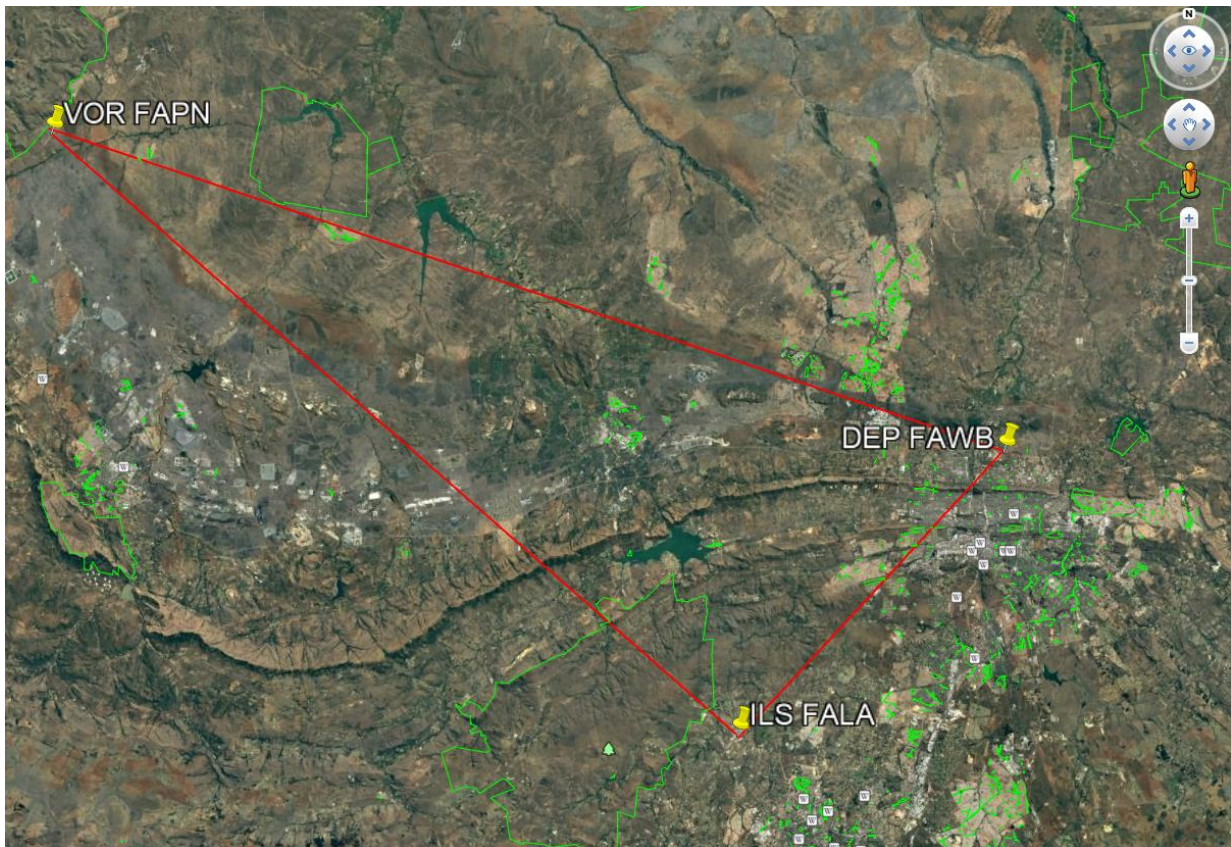
Figure 2: Routing and aerial work. (Source: Google Earth)
