LIMITED OCCURRENCE INVESTIGATION REPORT – FINAL

| Reference Number | CA18/3/2/1429 | | | | | | |
| Registration | ZS-AVA | | | | | | |
| Make; Model; S/N | Air Tractor Inc; AT502A (Serial Number: 502A-3365) | | | | | | |

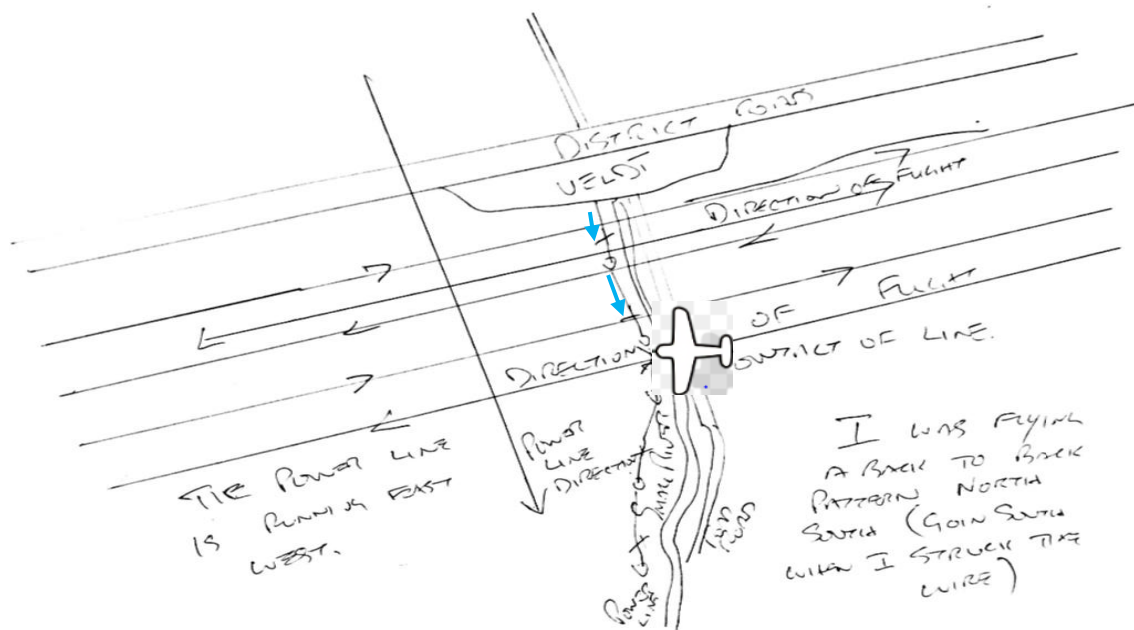
Sketch 1: An illustration of the aircraft's flight path and the approximate area of contact with the lines – the maize field sprayed is depicted on the right.
(Source: Pilot)

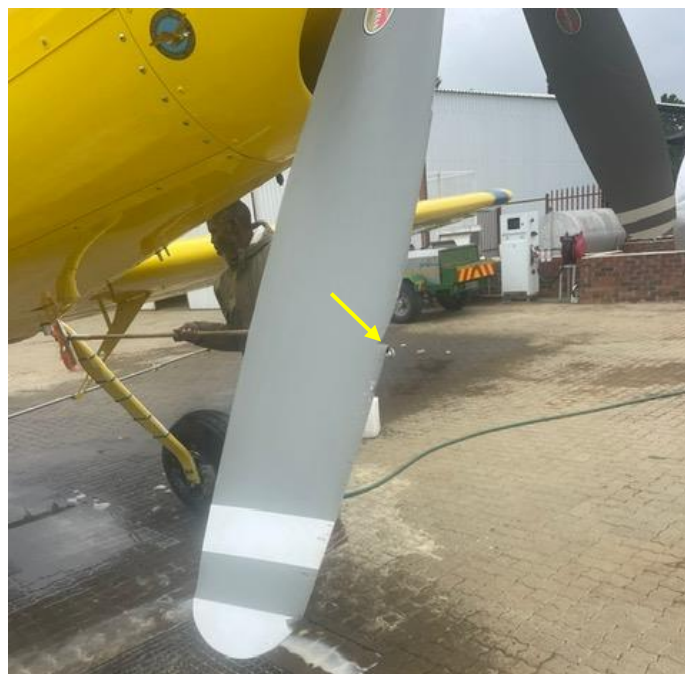
were subsequently severed by the propeller blades. The pilot maintained control of the aircraft and flew back to Vrede Private Airstrip, and landed safely. The aircraft sustained substantial damage to the propeller blades leading edge tips and the right-side elevator. The pilot disembarked from the aircraft unharmed.

Figure 1: Damage on one of the blades leading-edge tip. (Source: Operator)

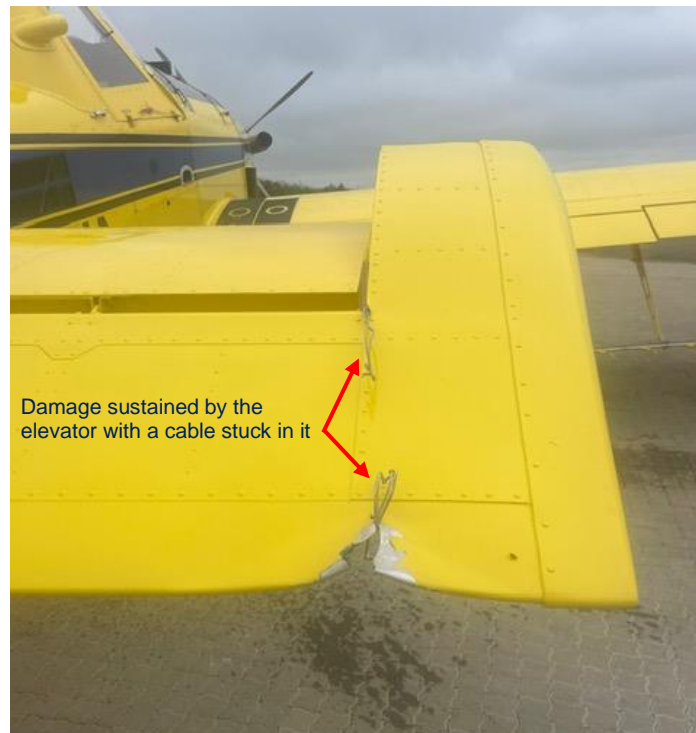
Figure 2: Damaged right-side elevator. (Source: Operator)
