LIMITED OCCURRENCE INVESTIGATION REPORT – FINAL

Reference Number	CA18/2/3/1431						
Classification	Serious Incident	Date	30 September 2023			Time	0710Z
Type of Operation	Training (Part 141)						
Location							
Place of Departure	Morningstar Aerodrome, Western Cape Province		Place of Intended Landing	Morningstar Aerodrome, Western Cape Province			
Place of Occurrence	Morningstar						
GPS Co-ordinates	Latitude	33°45'44.37" S	Longitude	018°32'54.69" E	Elevation	200 ft	
Aircraft Information							
Registration	ZU-AXT						
Make; Model; S/N	Bushbaby Explorer (Serial Number 023)						
Damage to Aircraft	Minor			Total Aircraft Hours	550		
Pilot-in-command							
Licence Type	Airline Transport Pilot Licence (ATPL)		Gender	Male		Age	68
Licence Valid	Yes	Total Hours	27601		Total Hours on Type	4.2	
Total Hours 30 Days	36.33		Total Flying on Type Past 90 Days	1.33			
People On-board	2+0	Injuries	0	Fatalities	0	Other (on ground)	0
What Happened							
<p>On Saturday morning, 30 September 2023, an instructor and a student pilot on-board a Bushbaby Explorer with registration ZU-AXT were engaged in circuit training at Morningstar Aerodrome, Western Cape province. Visual meteorological conditi

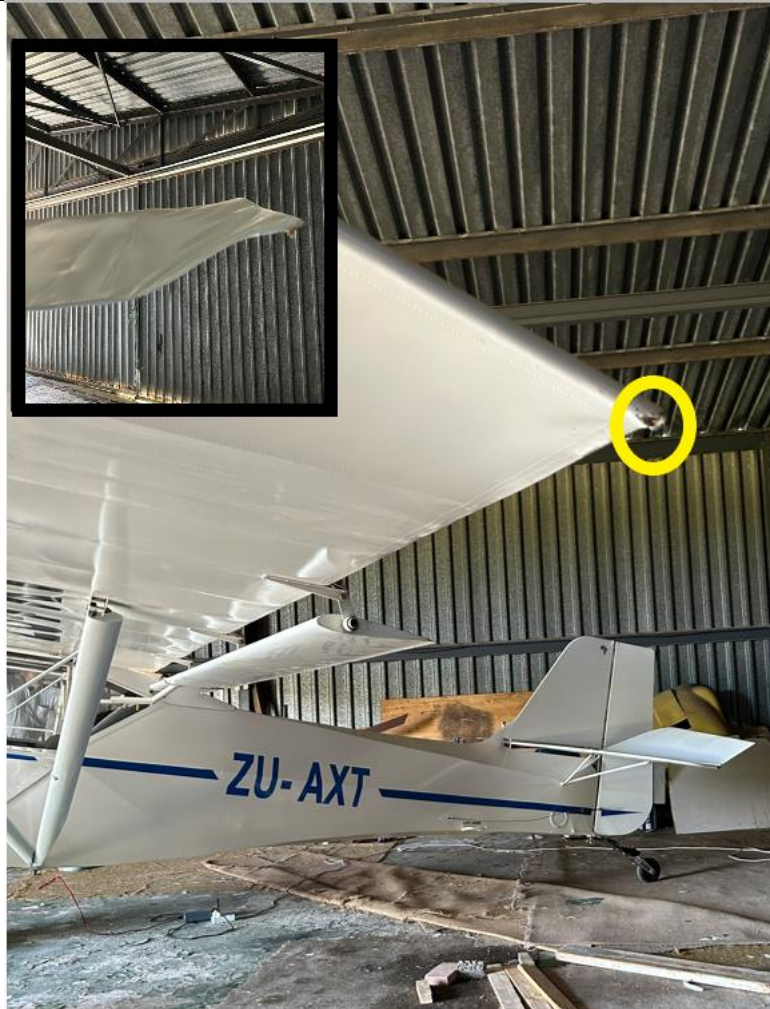
Figure 1: Damage on the left-wing tip. The inset shows the bent right wing tip in an upward direction. (Source: Operator)

10. The student pilot inadvertently allowed the aircraft to drift to the left by not compensating for the torque effect, which resulted in the left wing scraping the runway. The instructor took control of the aircraft and, in an attempt to correct the anomaly, he over corrected which led to the right wing also contacting the runway before he stabilised the aircraft. The aircraft landed safely on the remainder of the runway.

The student pilot failed to compensate for the torque effect, which resulted in the aircraft drifting to the left and the wing scraping the runway.

Pilots are advised to always be vigilant when operating within critical phases of flight such as take-offs and landings.
