AIRCRAFT SERIOUS INCIDENT REPORT AND EXECUTIVE SUMMARY

Reference:		CA18/3/2/1432	
Aircraft Registration	ZS-SPO&ZS-SLY	Date of Incident	8 November 2023		Time of Incident	1037Z	
Type of Aircraft	Cessna 172M (ZS-SPO)		Type of Operation		Training Flight (Part 141)		
Type of Aircraft	Cessna 172M (ZS-SLY)		Type of Operation		Private Flight (Part 91)		
Pilot-in-command Licence Type (ZS-SPO)		Student Pilot Licence (SPL)	Age	31	Licence Valid	Yes	
Pilot-in-command Licence Type (ZS-SLY)		Private Pilot Licence (PPL)	Age	23	Licence Valid	Yes	
Pilot-in-command Flying Experience (ZS-SPO)		Total Flying Hours	40		Hours on Type	22.9	
Pilot-in-command Flying Experience (ZS-SLY)		Total Flying Hours	123		Hours on Type	112.6	
Last Point of Departure (Both Aircraft)		Wonderboom Airport (FAWB), Gauteng Province					
Next Point of Intended Landing (ZS-SPO)		Wonderboom Airport (FAWB), Gauteng Province					
Next Point of Intended Landing (ZS-SLY)		Vereeniging Airport (FAVV), Gauteng Province

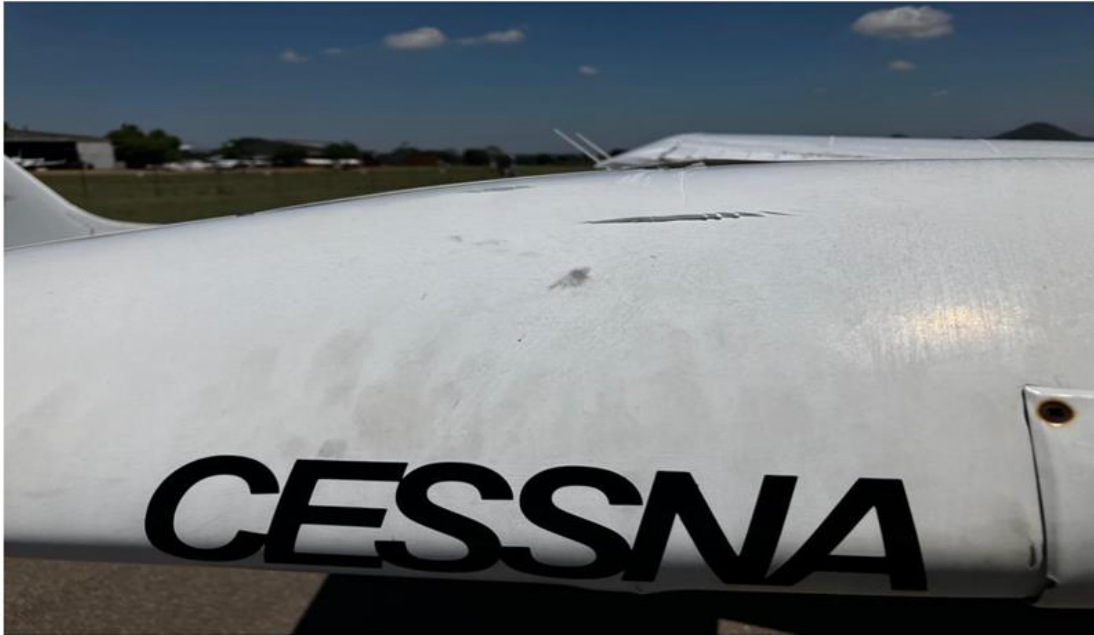
- 1.3.1 Both aircraft sustained minor damage. The ZS-SPO sustained scratches to the underside of the left-wing tip; the ZS-SLY sustained damage to the right-wing tip fairing (see Figure 2).

Figure 2: Minor damage to the right-wing tip fairing of ZS-SLY. (Source: ATO)

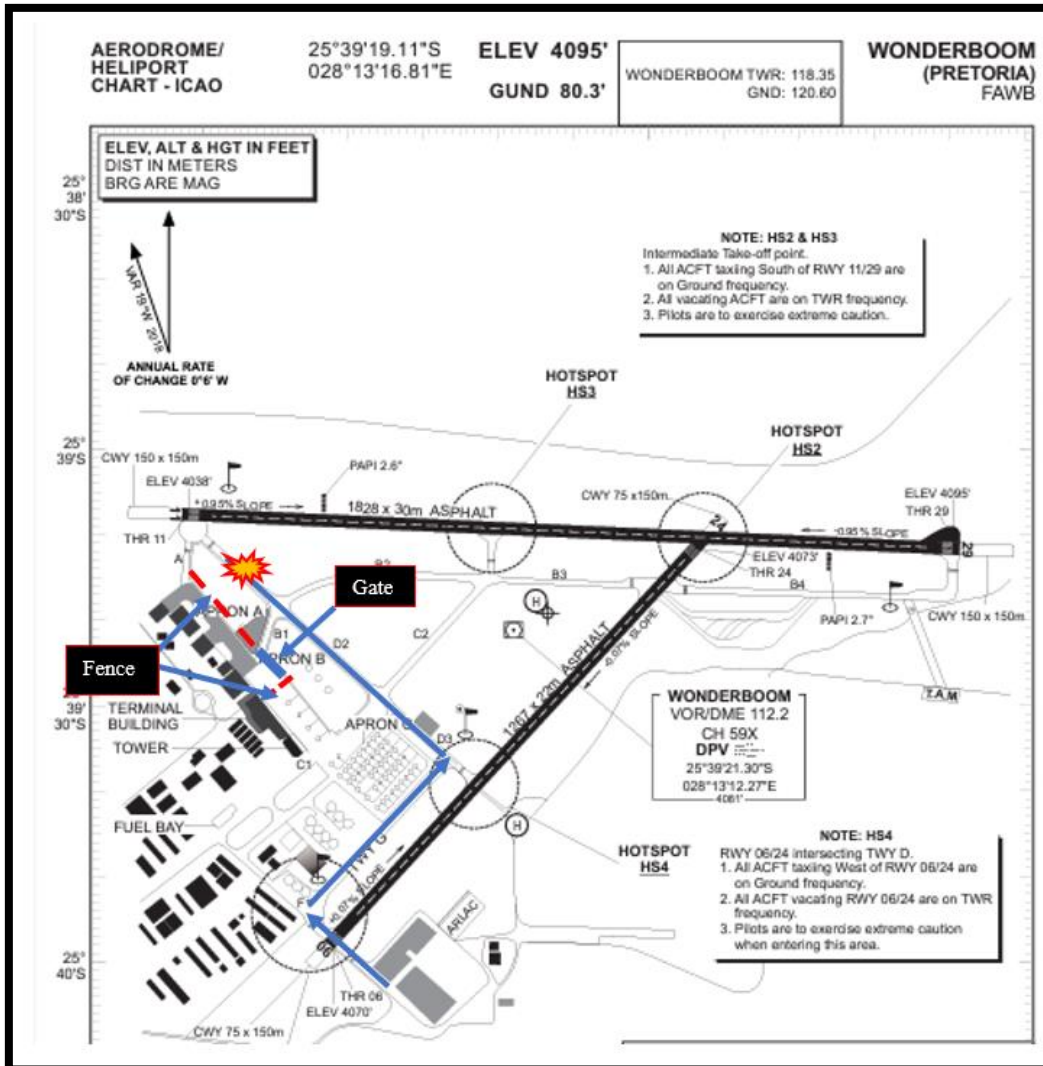
Figure 3: FAWB Chart; the blue lines indicating ZS-SPO taxi route.
 (Source: SACAA Aeronautical Information Publication [AIP])

- 2.2.3 There is a designated area for power checks near RWY 29 and RWY 24, and another run-up area near RWY 06. If RWY 11 is used, pilots utilise Taxiway D as a run-up area as there is no designated area available near RWY 11. The use of Taxiway D as a power check/run-up bay resulted in two SPs in separate occurrences impacting other aircraft which were conducting power checks on this taxiway. The AIID had issued the following recommendation: “*It is recommended to the FAWB management to consider erecting a designated engine run-up area before the holding point for Runway 11 to ensure sufficient aircraft separation and to reduce delay for departing traffic*”. The FAWB airport management is reviewing the recommendation.

4.2.1 It is recommended that the airport management create a run-up area near RWY 11 to prevent similar incidents from recurring. It is also recommended that the use of all taxiways as engine-run areas be prohibited to avoid such incidents.

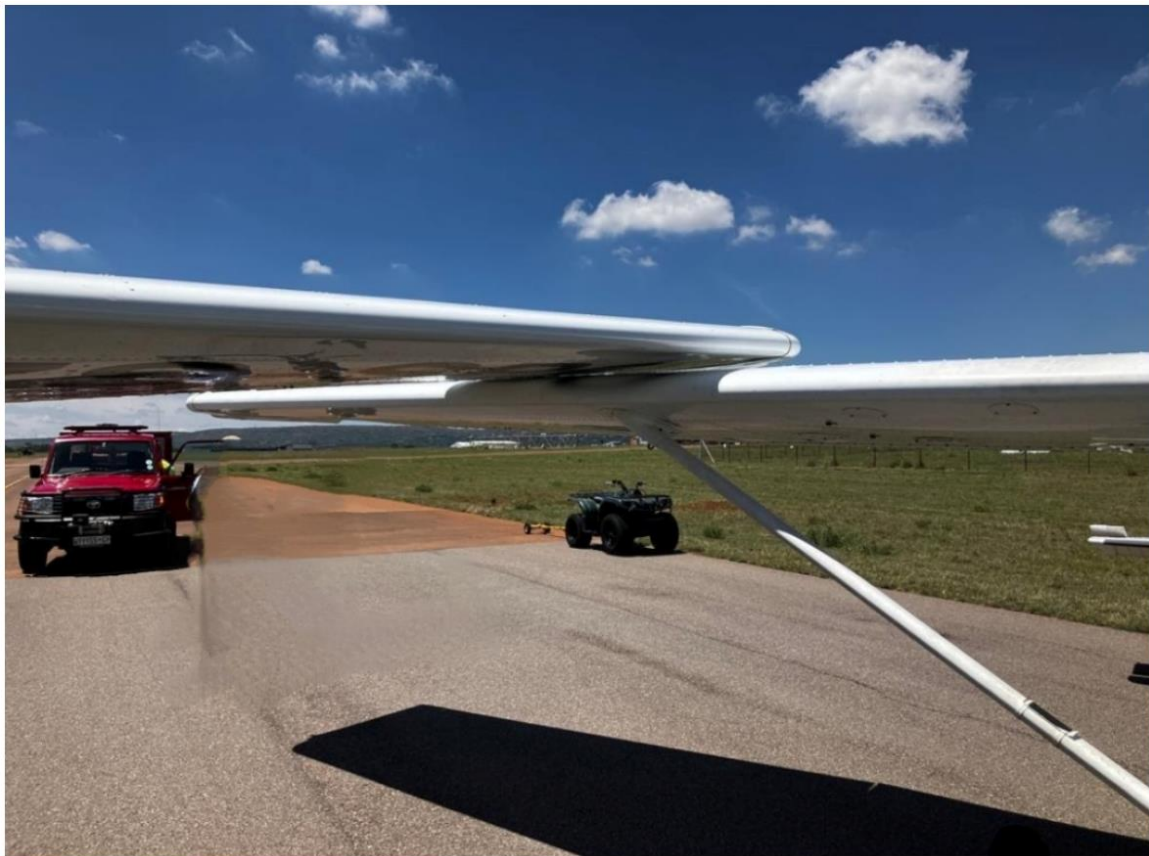
1.12.1 The left wing of ZS-SPO impacted the right wing of ZS-SLY at a low speed whilst ZS-SPO manoeuvred around the stationary ZS-SLY. This resulted in minor damage to the wing tips of both aircraft. Both pilots shut down the engines of their aircraft after the incident.

1.12.2 The ARFF found both aircraft on Taxiway D and with minor damage. The left-wing tip of ZS-SPO was found resting on the right-wing leading edge of ZS-SLY; ZS-SPO faced north-west whilst ZS-SLY faced north.

Figure 4: The ZS-SPO and ZS-SLY wings position after the incident site. (Source: ATO)
