**LIMITED OCCURRENCE INVESTIGATION REPORT – FINAL**

<b>Reference Number</b>	CA18/3/2/1433						
<b>Classification</b>	Serious Incident	<b>Date</b>	17 November 2023		<b>Time</b>	0520Z	
<b>Type of Operation</b>	Training (Part 141)						
<b>Location</b>							
Place of Departure	Ballito Microlight Airfield, KwaZulu-Natal Province		Place of Intended Landing	Ballito Microlight Airfield, KwaZulu-Natal Province			
Place of Occurrence	On a field, south of Tugela River and 3nm south of Isithebe						
GPS Co-ordinates	Latitude	29° 09' 06.23" S	Longitude	031° 23' 08.48" E	Elevation	134.5 ft	
<b>Aircraft Information</b>							
Registration	ZU-BGY						
Make; Model; S/N	Solowings, Windlass Aquilla (Serial Number: WA607)						
Damage to Aircraft	Minor			Total Aircraft Hours	599.2		
<b>Pilot-in-command</b>							
Licence Type	National Pilot Licence (NPL)		Gender	Male		Age	38
Licence Valid	Yes	Total Hours	1330		Total Hours on Type	701.9	
Total Hours 30 Days	43.2		Total Flying on Type Past 90 Days	33.5

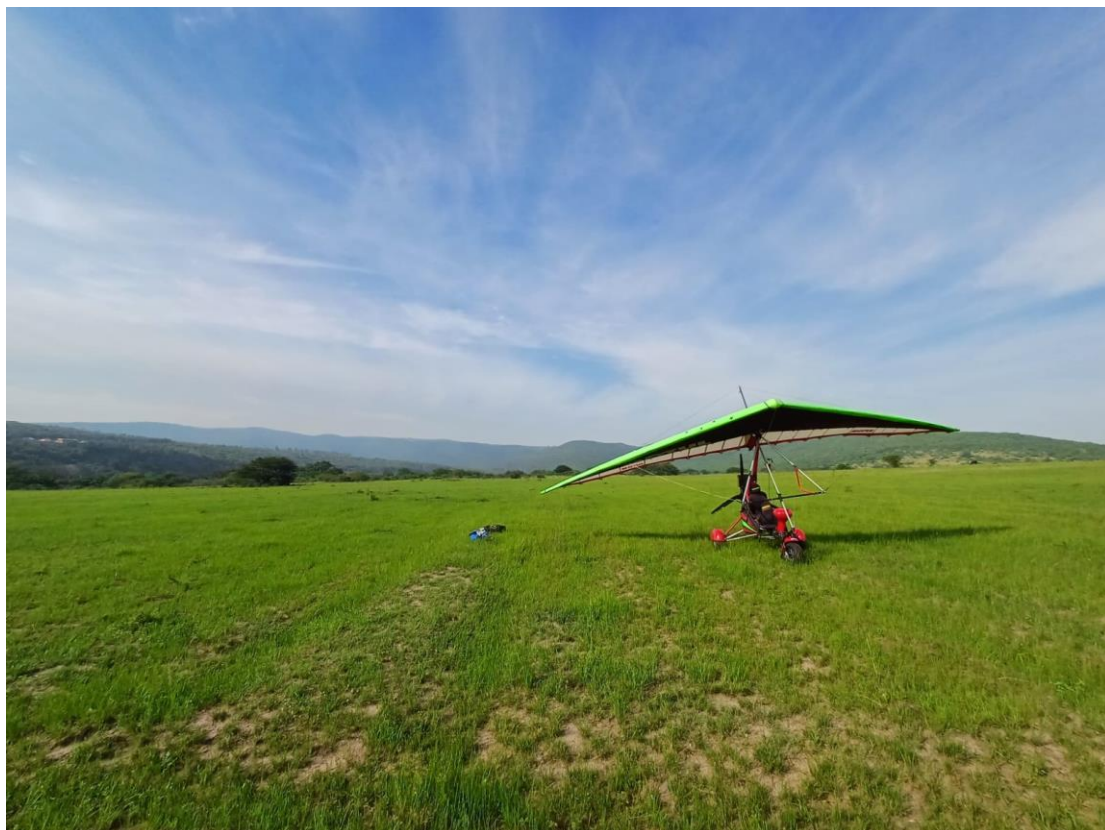
**Figure 2:** The microlight after the precautionary landing. (Source: Operator)
