LIMITED OCCURRENCE INVESTIGATION REPORT – FINAL

Reference Number	CA18/3/2/1434						
Classification	Serious Incident	Date	12 December 2023	Time	0956Z		
Type of Operation	Private (Part 94)						
Location							
Place of Departure	Wonderboom Airport (FAWB), Gauteng Province	Place of Intended Landing			Wonderboom Airport (FAWB), Gauteng Province		
Place of Occurrence	Runway 01 at Kitty Hawk Aerodrome, Gauteng Province						
GPS Co-ordinates	Latitude	25°51'32.52" S	Longitude	028°27'02.61" E	Elevation	4578 ft	
Aircraft Information							
Registration	ZU-FZA						
Make; Model; S/N	Van's RV7 (Serial Number: 74071)						
Damage to Aircraft	Minor			Total Aircraft Hours	312.6		
Pilot-in-command							
Licence Type	Airline Transport Pilot Licence (ATPL) Aeroplane		Gender	Male	Age	67	
Licence Valid	Yes	Total Hours	5474.5	Total Hours on Type	46.5		
Total Hours 30 Days	5.9		Total Flying on Type Past 90 Days			11.4	
People On-board	1+1	Injuries	0	Fatalities	0	Other (on ground)	0

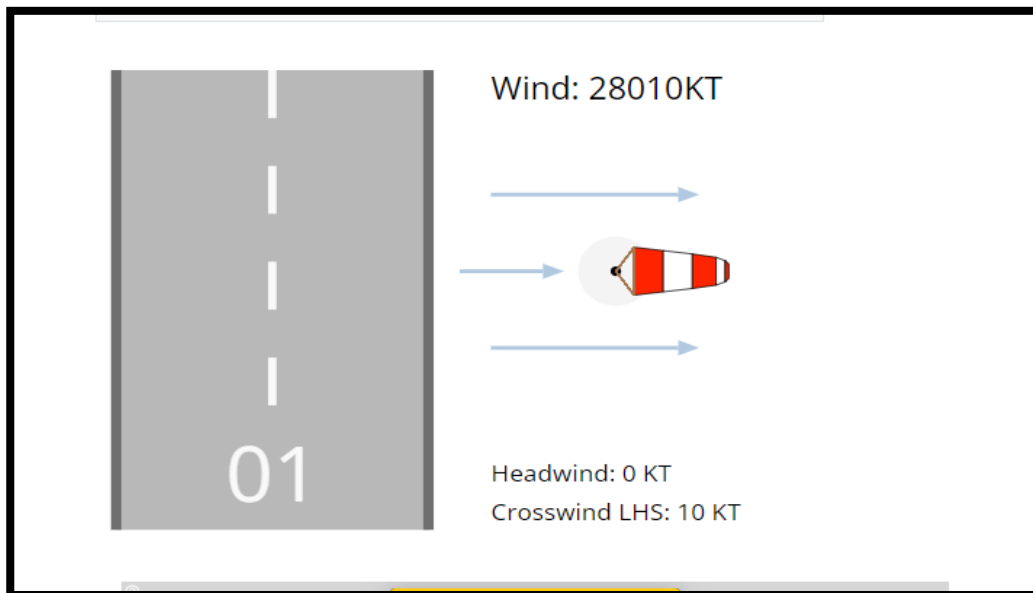
Figure 4: The crosswind was 90° from the left at 10 kts. (Source <https://aerotoolbox.com/crosswind>)

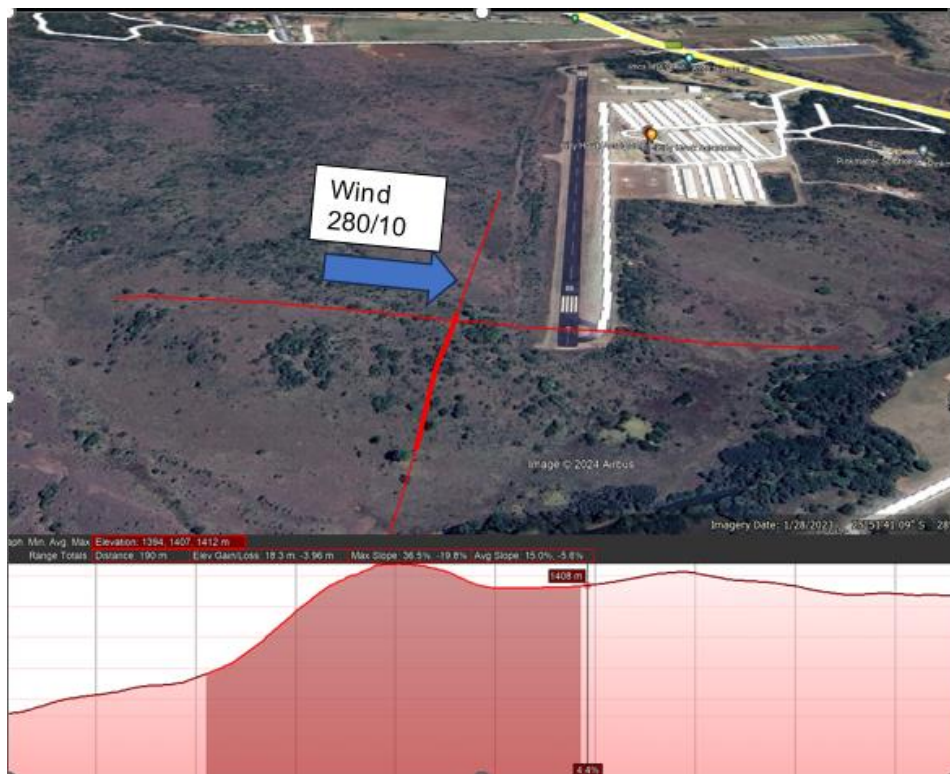
Figure 7: Image illustrates the rising terrain on the left of RWY 01. (Source Google Earth)

Probable Cause(s)
During a crosswind landing, the aircraft experienced windshear and lost lift, bounced and landed on its nose gear; as a result, the nose gear strut bent.
Contributing Factor(s)
Rising terrain on the left side of the runway.
Safety Action(s)
None.
Safety Message and/or Safety Recommendation/s
None.
About this Report
<p><i>The decision to conduct a limited investigation is based on factors including whether the cause is known and the evidence supporting the cause is clear, the level of safety benefit likely to be obtained from an investigation and that will determine the scope of an investigation. For this occurrence, a limited investigation has been conducted, and the Accident and Incident Investigations Division (AIID) has relied on the information submitted by the affected person/s and organisation/s to compile this limited report. The report has been compiled using information supplied in the initial notification, as well as from follow-up desktop enquiries to bring awareness of potential safety issues to the industry in respect of this occurrence, as well as possible safety action/s that the industry might want to consider in preventing a recurrence of a similar occurrence.</i></p> <p><i>All times given in this report are Co-ordinated Universal Time (UTC) and will be denoted by (Z). South African Standard Time is UTC plus 2 hours.</i></p>
