AIRCRAFT SERIOUS INCIDENT REPORT AND EXECUTIVE SUMMARY

Reference:		CA18/3/2/1435	
Aircraft Registration	ZS-TDJ/ZU-IJR	Date of Incident	16 December 2023		Time of Incident	0740Z	
Type of Aircraft	Piper PA-28-161			Type of Operation	Training (Part 141)		
Pilot-in-command Licence Type	Student Pilot Licence		Age	21	Licence Valid	Yes	
Pilot-in-command Flying Experience	Total Flying Hours		80	Hours on Type	80		
Last Point of Departure	George Airport (FAGG), Western Cape Province						
Next Point of Intended Landing	George Airport (FAGG), Western Cape Province						
Damage to Aircraft	None						
Location of the incident site with reference to easily defined geographical points (GPS readings if possible)							
At Plettenberg Bay Airport during approach for a touch-and-go landing on Runway 30							
Meteorological Information	Wind direction: 20°; Wind Speed: 7kt; Air Temperature: 20°C; Dew Point: 15°C; Visibility: 9999m						
Number of People On-board	1+0 ZS-TDJ	Number of People Injured	0	Number of People Killed	0	Other (On Ground)	0

Reference Number : CA18/3/2/1434
Occurrence Category : Category 1
Type of Operation : Training
Name of Operator : AIFA
Aircraft Registration : ZS-TDJ
Aircraf

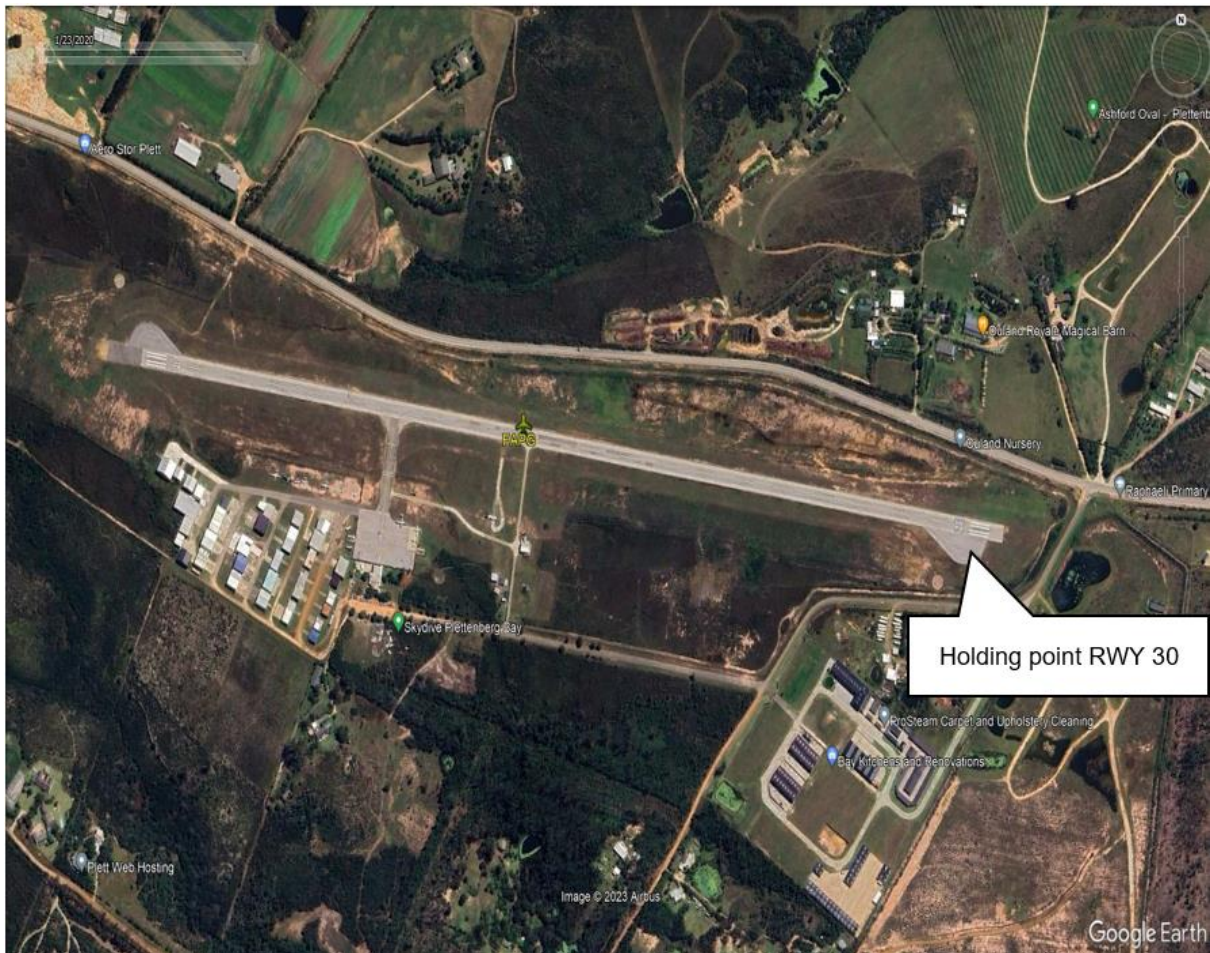
Figure 2: Aerial view of Plettenberg Bay Airfield. (Source: Google Earth)

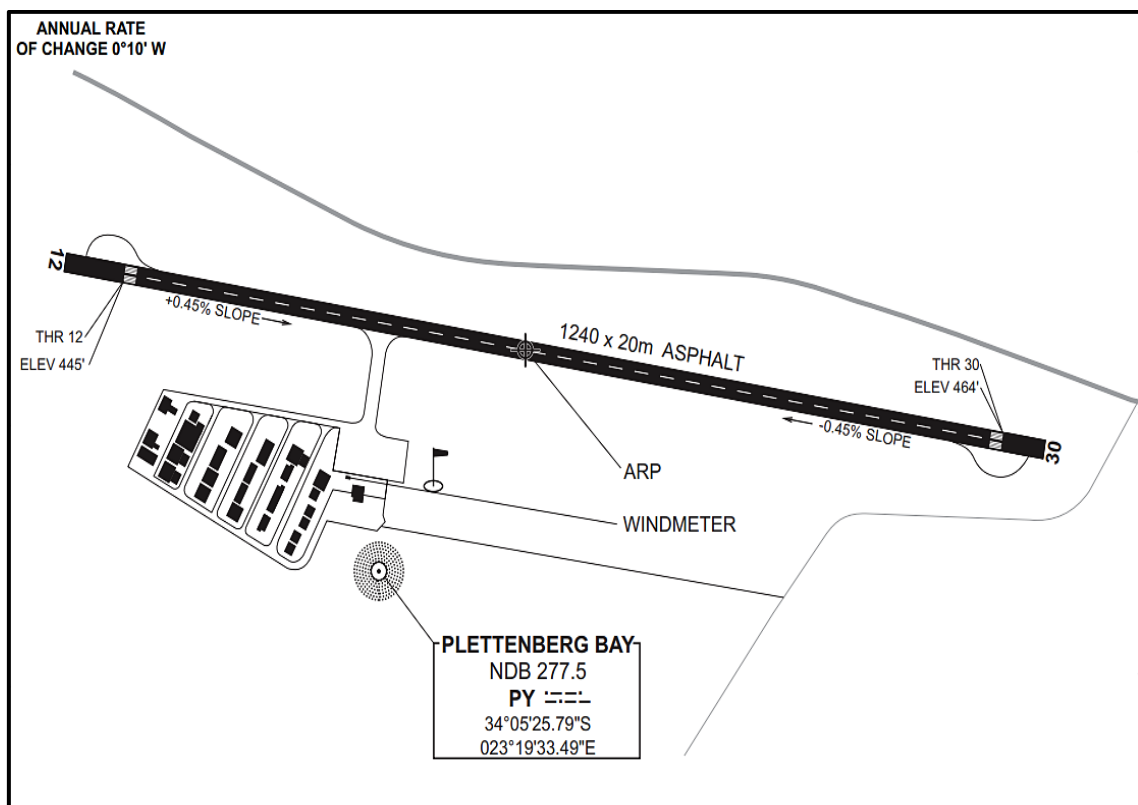
Figure 3: Schematic Diagram of FAPG. (Source: Regulator information for industry)

- 2.2.10 According to the schematic for FAPG, there is a single runway designated 12/30. There is no indication of a grass runway, but rather a grass-covered area on the right of the main runway in use. The ZU-IJR, during landing on a grass area, flew above an aircraft that was stationary at the holding point, awaiting departure.
