LIMITED OCCURRENCE INVESTIGATION REPORT – FINAL

Reference Number	CA18/3/2/1436						
Classification	Serious Incident	Date	11 January 2024	Time	1250Z		
Type of Operation	Training (Part 141)						
Location							
Place of Departure	Wonderboom Aerodrome (FAWB), Gauteng Province		Place of Intended Landing	Wonderboom Aerodrome (FAWB), Gauteng Province			
Place of Occurrence	General Flying Area 1, centre field sugar bean plantation, Wonderboom Aerodrome (FAWB)						
GPS Co-ordinates	Latitude	25° 26' 43" S	Longitude	028° 14' 47" E	Elevation	3 675 ft	
Aircraft Information							
Registration	ZS-EOZ						
Make; Model; S/N	Piper; PA-28-140 (Serial Number: 28-22041)						
Damage to Aircraft	Minor			Total Aircraft Hours	4196.6		
Pilot-in-command							
Licence Type	Commercial Pilot Licence (CPL)		Gender	Male		Age	25
Licence Valid	Yes	Total Hours	313.1		Total Hours on Type	132.9	
Total Hours 30 Days	20.3		Total Flying on Type Past 90 Days	58.2			
People On-board	2 + 0	Injuries	0	Fatalities	0	Other (on ground)	0

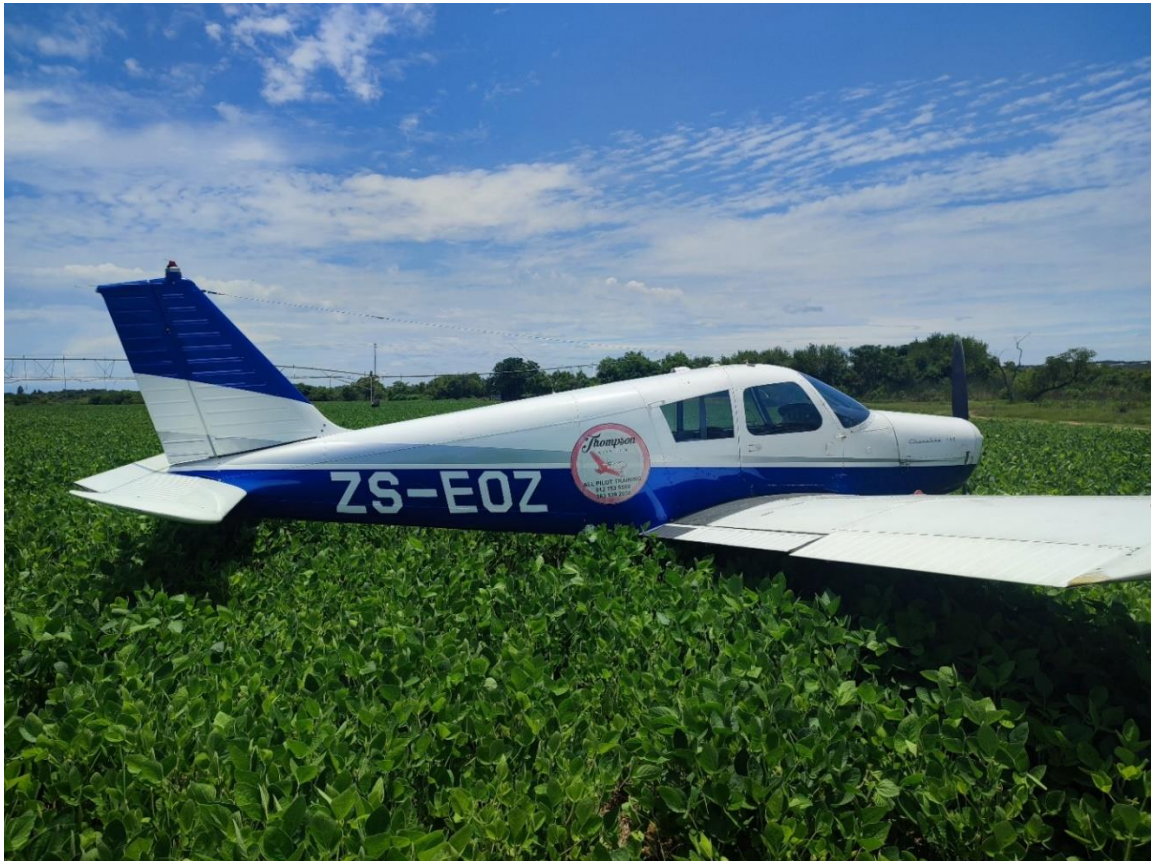
What Happened							
<p>On Thursday, 11 January 2024, a student pilot and an instructor on-board a Piper PA28-140 aircraft with registration ZS-EOZ took off from Wonderboom Aerodrome (FAWB) to conduct simulated engine failure exercises at the general flying area 1 (GFA 1) centre field and, thereafter, return to FAWB. Visual meteorological conditions (VMC) by day prevailed at the time of the flight which was conducted under the provisions of Part 141 of the Civil Aviation Regulations (CAR) 2011 as amended.</p> <p>According to the instructor, the take-off to the GFA 1 centre field was uneventful. The crew conducted two successful engine failure simulations, climbing to 1500 (ft) feet above ground level (AGL) each time. During the third simulation whilst on a go-around and the initial climb phase, the aircraft did not gain height. Also, there was no warning on the instrument panel when the engine lost power. The instructor took over the flight controls and executed a forced landing on a sugar bean plantation. During the landing roll, the vertical stabiliser's strobe light impacted an irrigation spray boom at the plantation before the aircraft came to a stop a few metres after touch down. There were no reported injuries during the incident; the aircraft sustained damage to the strobe light.</p>

Figure 2: The aircraft post-incident. (Source: AIID)

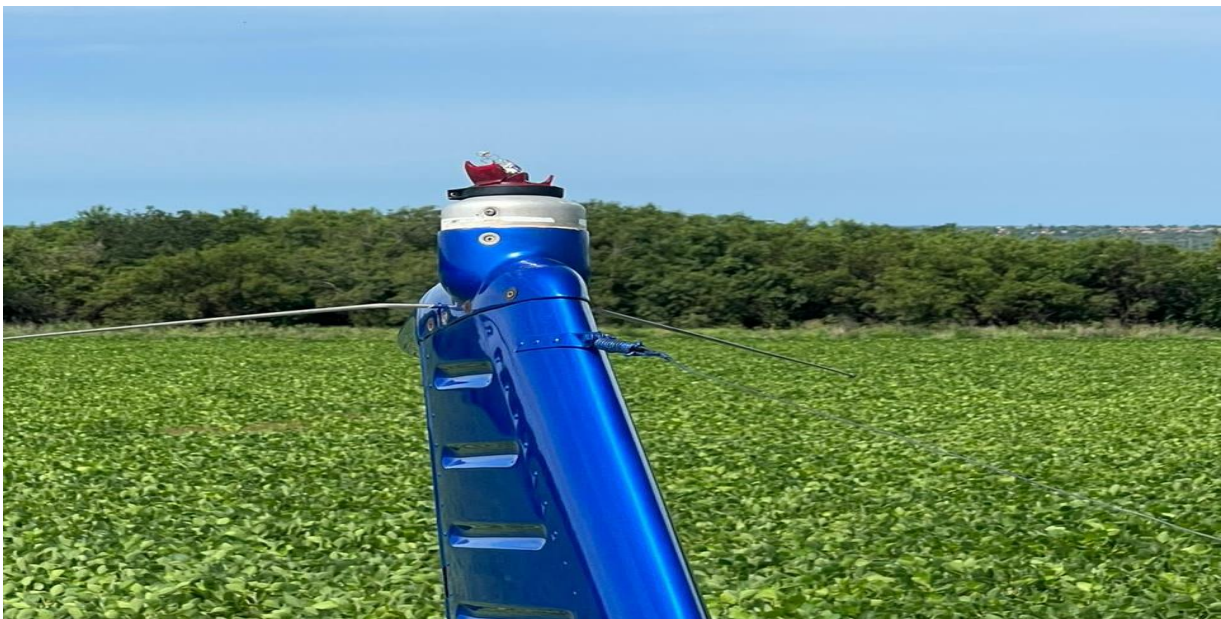
Figure 3: The damaged strobe light. (Source: Operator)

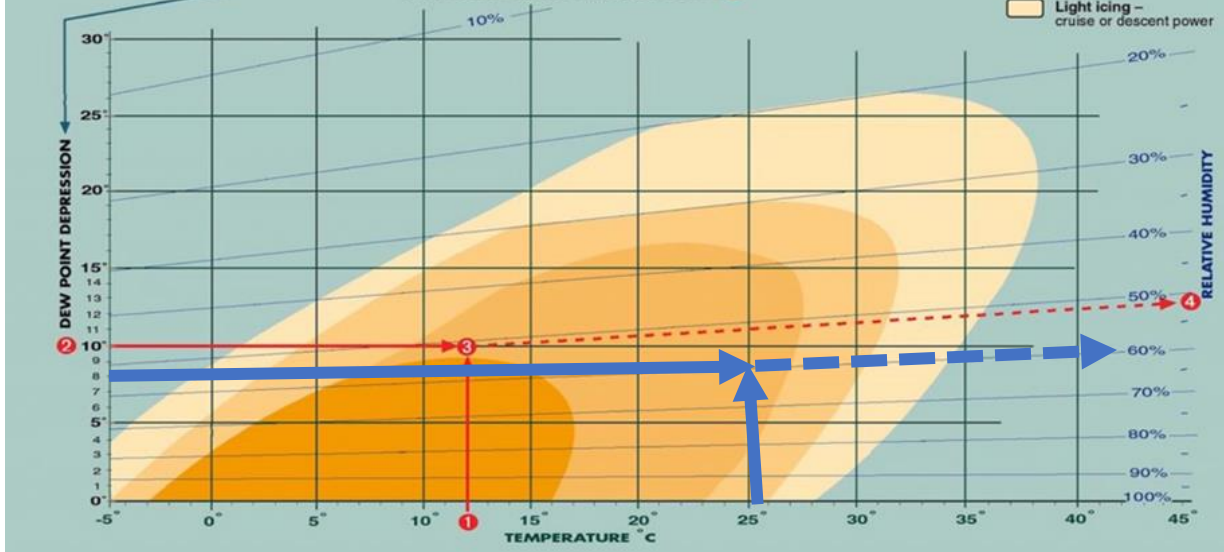
Figure 4: The carburettor icing-probability chart.

The carburettor icing probability chart for the day indicated that the dew point depression was 8°C with 25°C temperature, and a dew point of 17°C with relative humidity at 60%. This placed the engine carburettor at risk of serious icing probability when in a descent power setting. The aircraft was descending at a reduced power setting; when the power lever was advanced to climb, the engine did not produce power.

3.1 The weather conditions were a contributory factor to this incident as indicated by the carburettor probability chart.

4.1 The engine lost power probably due to carburettor icing during the third simulated engine failure exercise when the pilot advanced the power lever.

Loss of engine power was probably due to carburettor icing, which resulted in a forced landing.

Safety Action(s)
None.
Safety Message
To avoid injuries and damage to property, pilots are advised to conduct a proper flight planning by considering the effects of carburettor icing due to the closeness of the temperature and dew point.
About this Report
<i>The decision to conduct a limited investigation is based on factors including whether the cause is known and the evidence supporting the cause is clear, the level of safety benefit likely to be obtained from an investigation and that will determine the scope of an investigation. For this occurrence, a limited investigation has been conducted, and the Accident and Incident Investigations Division (AIID) has relied on the information submitted by the affected person/s and organisation/s to compile this limited report. The report has been compiled using information supplied in the initial notification, as well as from follow-up desk top enquiries to bring awareness of potential safety issues to the industry in respect of this occurrence, as well as possible safety action/s that the industry might want to consider in preventing a recurrence of a similar occurrence.</i>
