**LIMITED OCCURRENCE INVESTIGATION REPORT – FINAL**

<b>Reference Number</b>	CA18/3/2/1437					
<b>Classification</b>	Serious Incident	<b>Date</b>	15 January 2024	<b>Time</b>	0400Z	
<b>Type of Operation</b>	Aerial Works – Agricultural Spraying (Part 137)					
<b>Location</b>						
Place of Departure	Glenside Aerodrome, KwaZulu-Natal Province		Place of Intended Landing	Glenside Aerodrome, KwaZulu-Natal Province		
Place of Occurrence	Rooidraai Farm near Winterton in KwaZulu-Natal Province					
GPS Co-ordinates	Latitude	28°53'17.77" S	Longitude	029°33'55.89" E	Elevation	3 477ft
<b>Aircraft Information</b>						
Registration	ZS-ART					
Make; Model; S/N	Thrush Aircraft Inc; S2R-H80 (Serial number: H80-116)					
Damage to Aircraft	Minor		Total Airframe Hours	3 995.2		
<b>Pilot-in-command</b>						
Licence Type	Commercial Pilot Licence (CPL)		Gender	Male	Age	61
Licence Valid	Yes	Total Hours	11 945.7	Total Hours on Type	9 118.9	
Total Hours 90 Days	99.8		Total Flying Hours on Type Past 90 Days	99.8

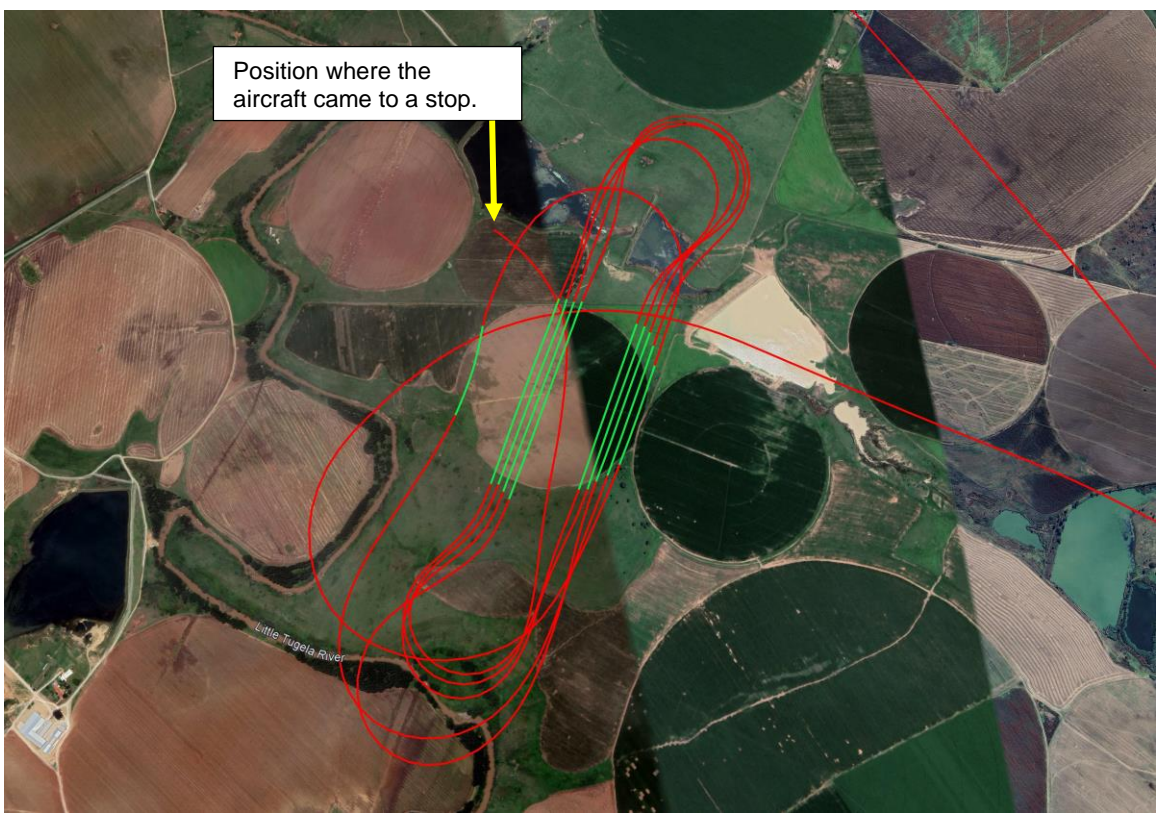
**Figure 1:** The spray pattern flown by the pilot, including the forced landing circuit. (Source: Pilot)

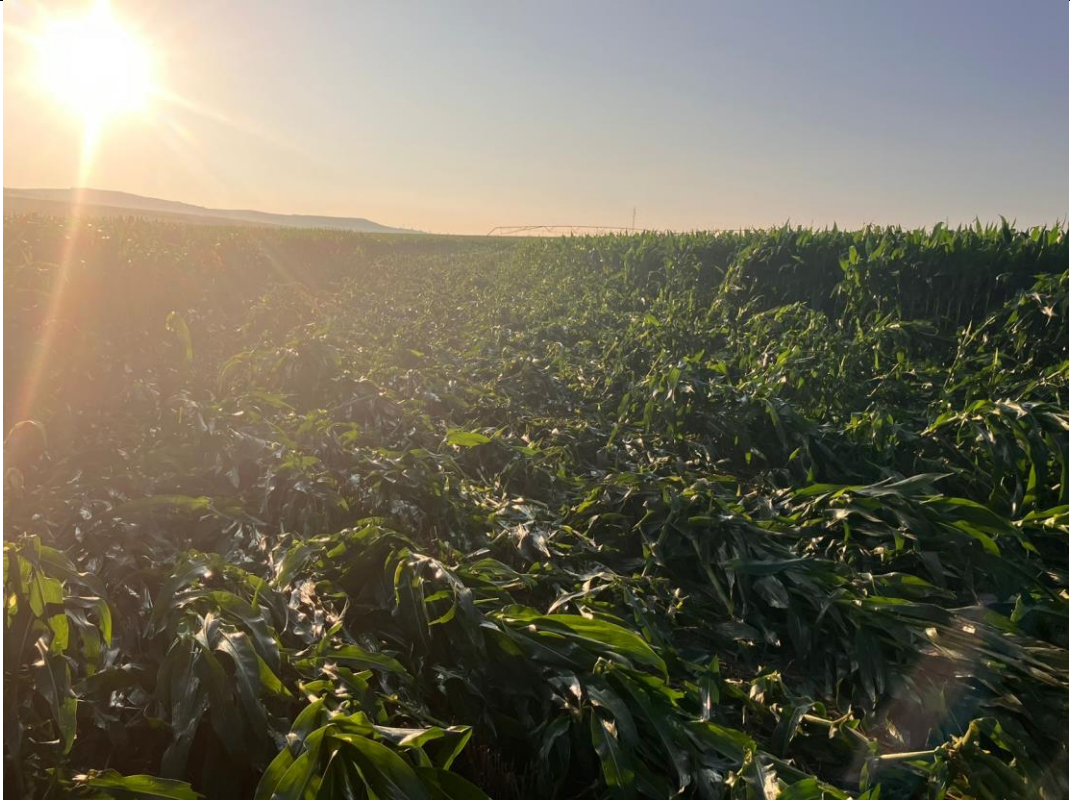
**Figure 2:** The flattened maize crops after the forced landing. (Source Pilot)

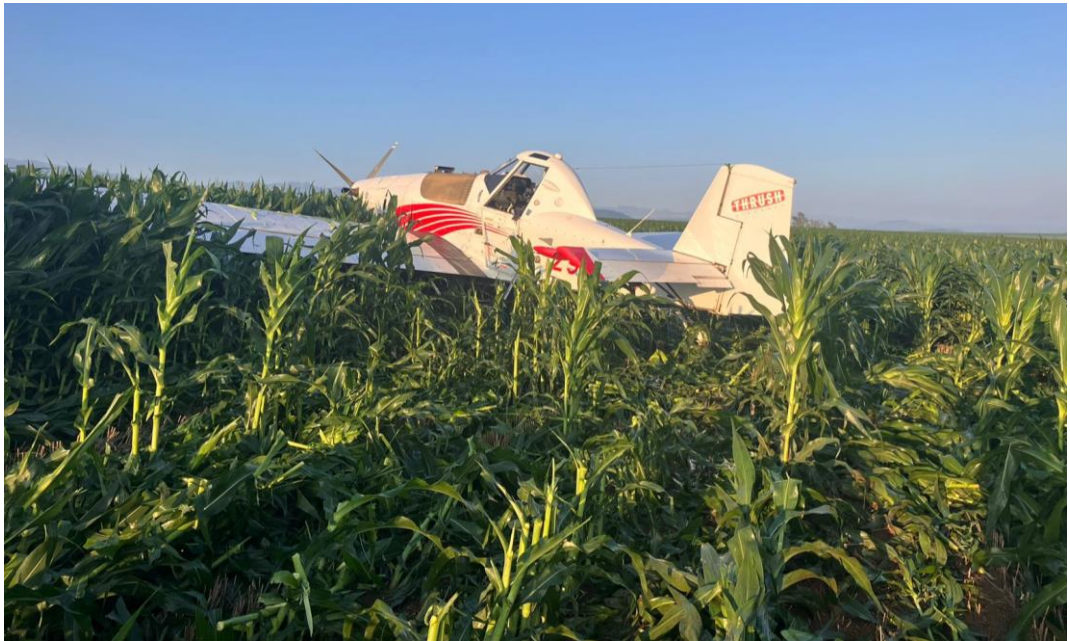
**Figure 3:** The aircraft where it came to a stop in the maize field. (Source: Pilot)

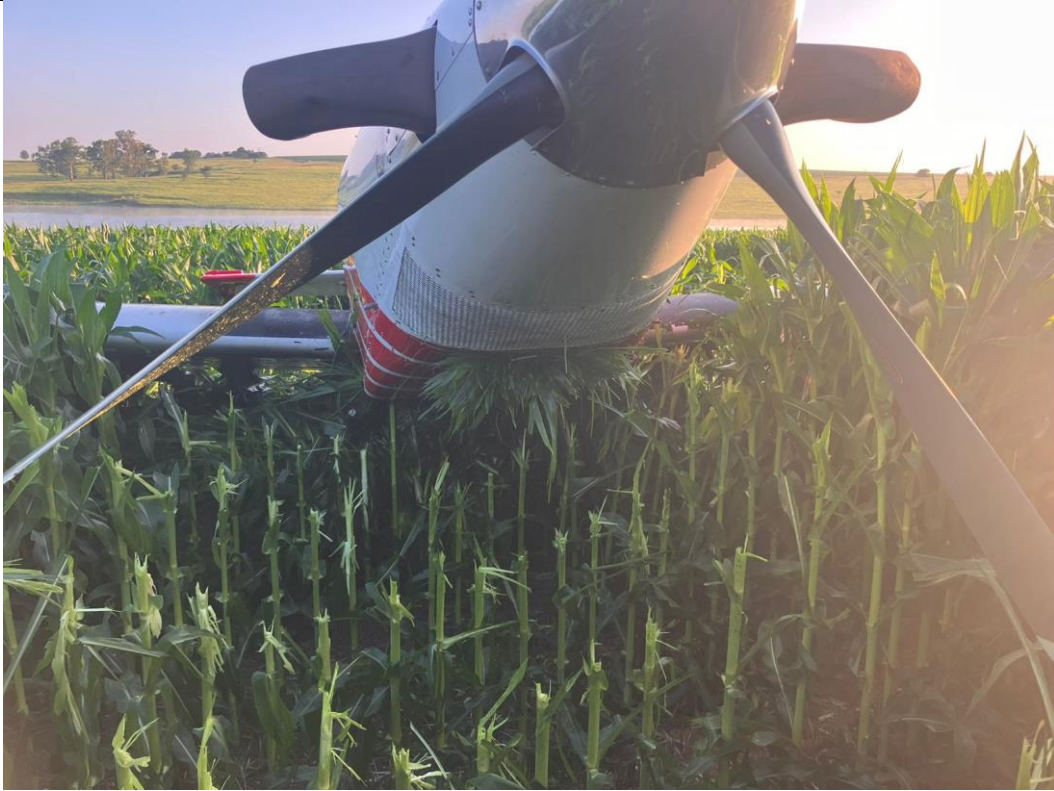
**Figure 4:** The front view of the aircraft in the maize field.

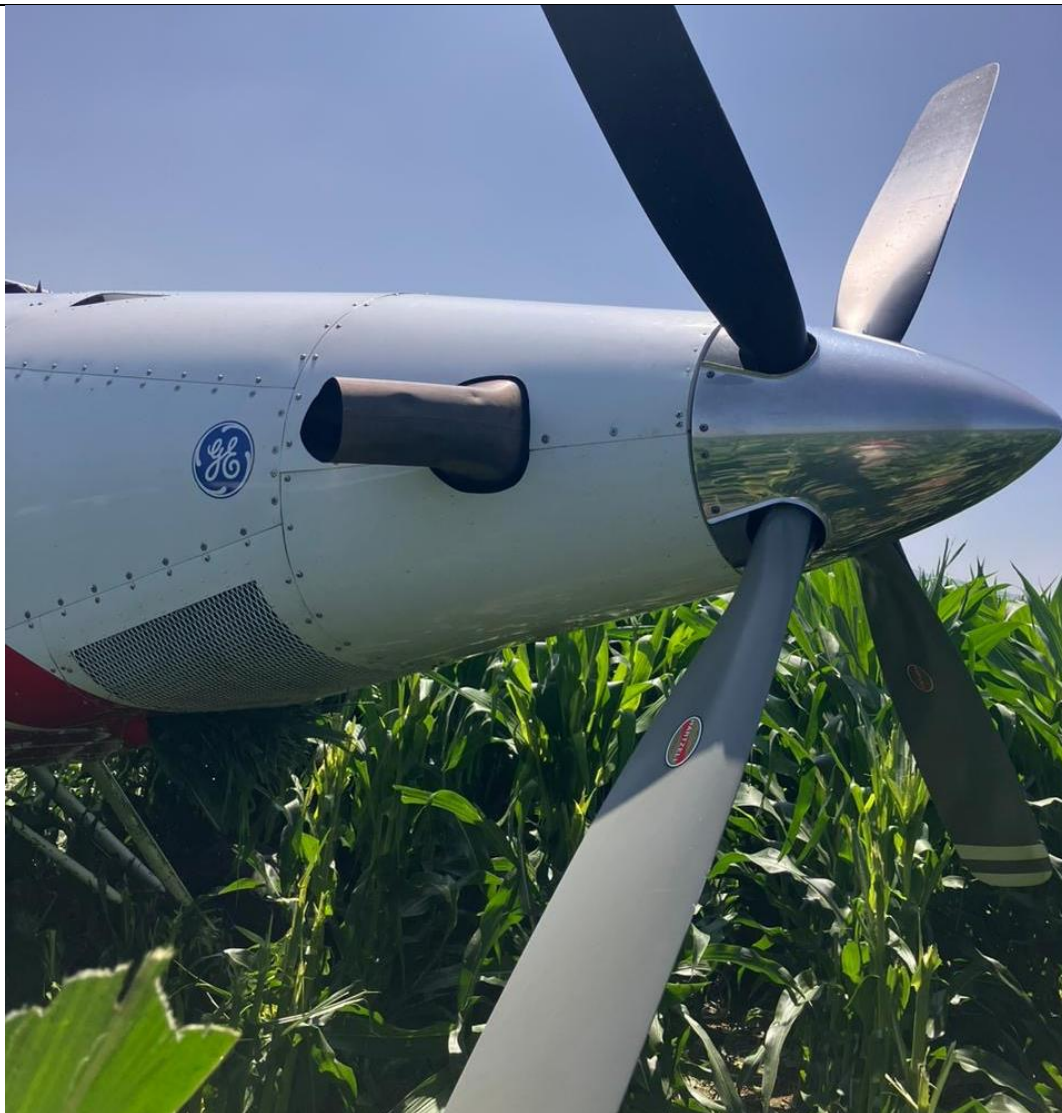
**Figure 5:** A view of the aircraft with the propeller in the feathered position. (Source: Pilot)

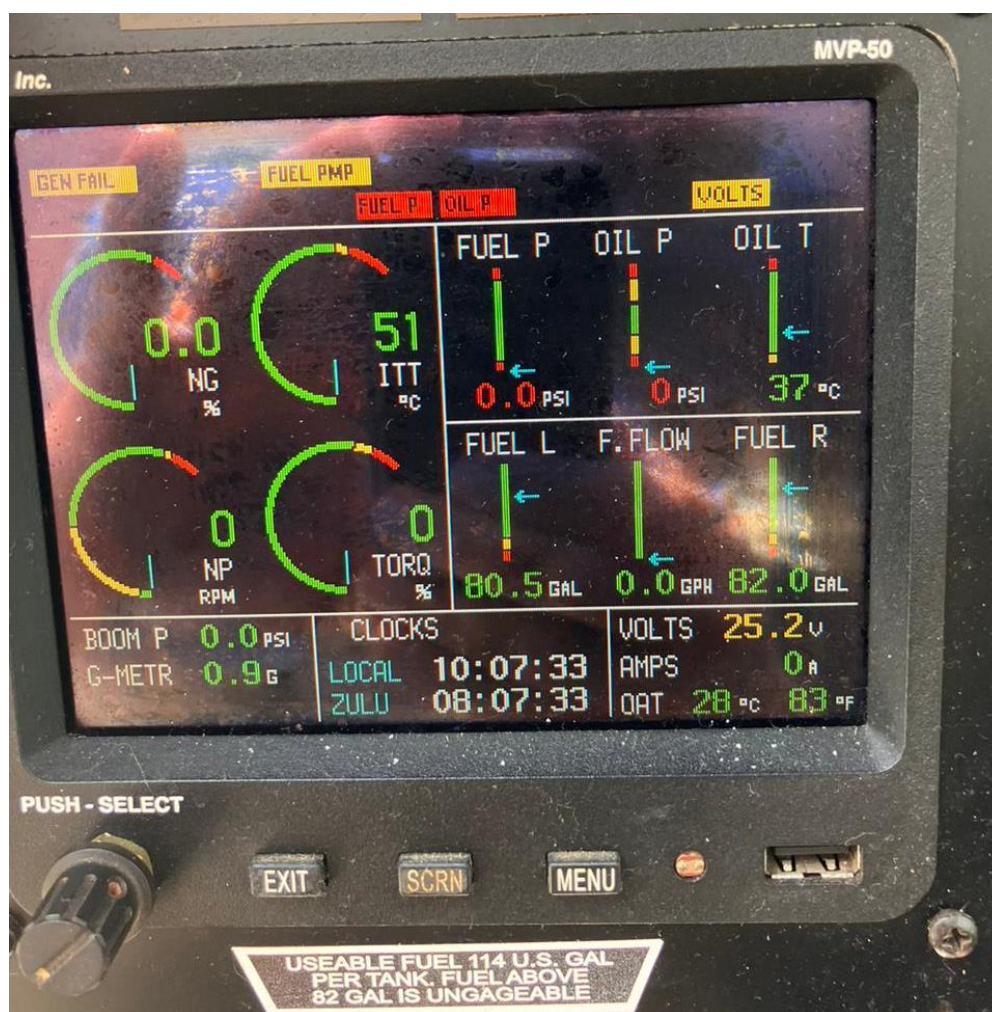
The aircraft was equipped with an MVP-50T, which is an engine monitoring system (see Figure 6) with a non-volatile memory. The unit was downloaded after the incident and the following data was retrieved:

*The total fuel remaining in the aircraft was 733 litres (193 US gallons).*

*There was no chip detector warning observed.*

*At 05:46:02, the Ng (Gas generator rotation speed indication) was 95%, the intermediate turbine temperature (ITT) was 625°C, and the Np (propeller speed) was 1 960 RPM with the torque at 68%.*

*At 05:47:33, the Ng had dropped to 61.1% with the ITT at 483°C, Np at 1 080 RPM and the torque at 8%.*

At 05:47:37, the Ng peaked at 84.9%, ITT 628°C, Np at 1 520 RPM, and the torque was 38%. This increase in engine parameters occurred after the pilot engaged the emergency circuit and advanced the emergency lever.

At 05:50:20, the aircraft came to a stop after the forced landing with the engine at ground idle Ng at 62.9%, ITT at 509°C, and torque at 18%. The pilot then switched off the engine.

Figure 6: The MVP-50T unit on-board the ZS-ART taken post-incident. (Source: Operator)

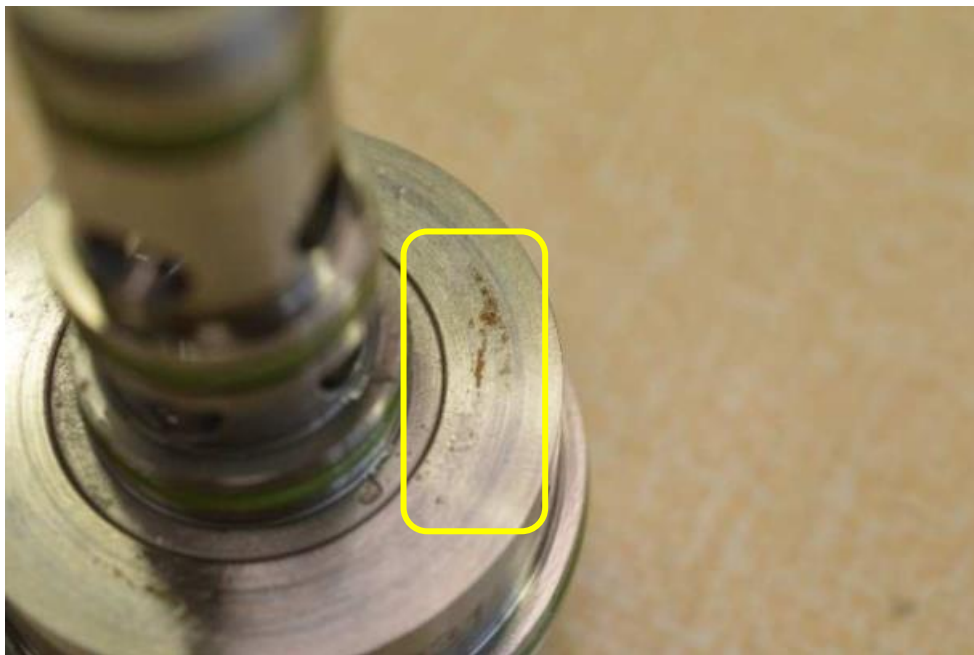
Disassembly was performed with the focus on the Main Metering Valve (MMV) which detects initial corrosion on the sleeve but on non-functional surfaces (Figure 7), therefore, it did not affect the FCU function although this indicated presence of water in the fuel. The Blade Relay Valve (BRV) was checked to ensure it functioned as expected. It was found to be operating optimally, and no increased clearances were identified. The BRV passed the functional test on sub-assembly level. No failure was found at FCU level.

**Figure 7:** Corrosion on the main metering valve.

2.7 The FCU was removed from the engine and was sent to the OEM for examination. The main metering valve displayed evidence of corrosion, but it did not have any effect on the functionality of the unit.

During a crop-spraying operation, there was a sudden reduction in engine power and the pilot opted to perform a forced landing on a maize field. The cause of the reduction in engine power could not be established with certainty. However, the presence of water in the fuel could not be excluded as a possibility as the main metering valve in the FCU displayed evidence of corrosion which is associated with water being present in the fuel system.
