LIMITED OCCURRENCE INVESTIGATION REPORT

Reference Number	CA18/2/3/1438						
Classification	Serious Incident		Date	5 July 2024		Time	1400Z
Type of Operation	Private (Part 94)						
Location							
Place of Departure	Sishen Airport (FASS), Northern Cape Province		Place of Intended Landing	Bruai, North West Province			
Place of Occurrence	Remote area near Bruai, North West Province						
GPS Co-ordinates	Latitude	25°59'04.2" S	Longitude	23°29'43.1" E	Elevation	3 840 ft	
Aircraft Information							
Registration	ZU-DLU						
Make; Model; S/N	Tecnam; P96 Golf (Serial Number: 043)						
Damage to Aircraft	Minor			Total Aircraft Hours	2 085.0		
Pilot-in-command							
Licence Type	Private Pilot Licence (PPL)		Gender	Male		Age	53
Licence Valid	Yes	Total Hours	605.2		Total Hours on Type	150.4	
Total Hours Past 30 Days	9		Total Flying Hours on Type Past 90 Days	18.0			
People On-board	1 + 0		Injuries	0		Fatalities	0
					Other (on ground)	0	
What Happened

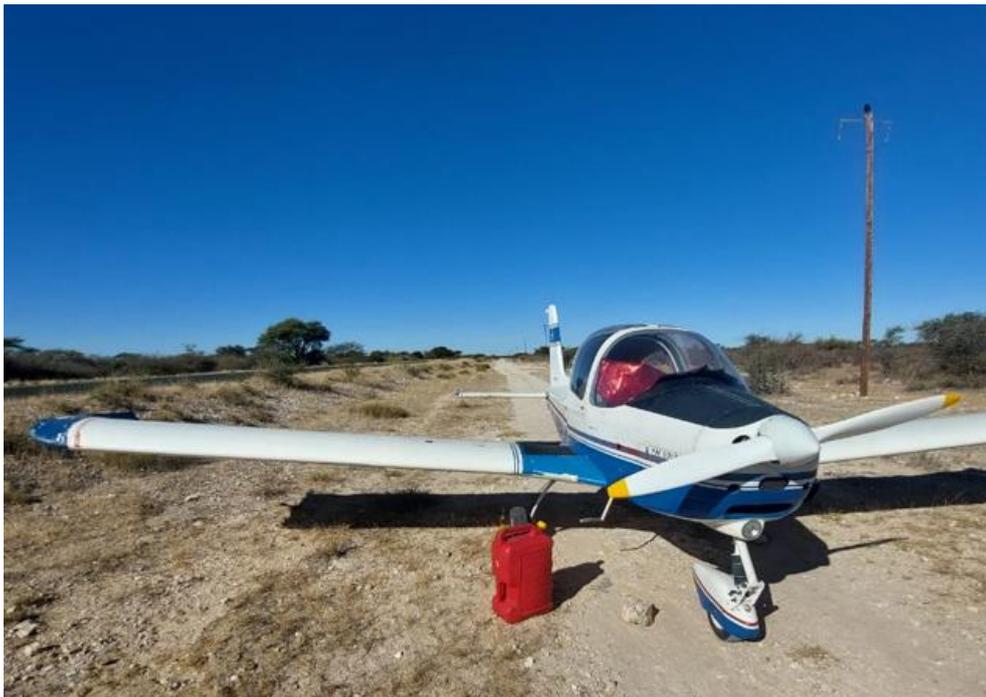
<p>On Friday, 5 July 2024, a pilot on-board a Tecnam aircraft with registration ZU-DLU took off on a private flight from Sishen Airport in Northern Cape province to Bruai in North West province. Visual meteorological conditions (VMC) by day prevailed at the time of the flight which was conducted under the provisions of Part 94 of the Civil Aviation Regulations (CAR) 2011 as amended.</p> <p>The pilot reported that approximately 10 minutes after take-off whilst cruising overhead a remote area near Bruai, the low fuel pressure warning indication illuminated and, subsequently, the engine lost power. The aircraft had 50 litres of fuel on-board prior to the incident, the total fuel capacity of the aircraft is 70 litres. The pilot surveyed the surrounding area and identified a gravel road on the left side of Reginal Road 379 (R379) and executed a forced landing. During the landing roll on an uneven surface dotted with shrubs, the left wing, left elevator and under fuselage skin were scratched which caused minor damage to the aircraft. The pilot was not injured during the serious incident. The aircraft was last flown on 29 June 2024 prior to this serious incident.</p> <p>The following weather report was provided by the pilot through the pilot questionnaire. Wind direction: southwest°; wind speed: 05 knots; air temperature: 18°C; visibility: CAVOK.</p> <p>There were no weather stations in the immediate vicinity of the site to obtain an accurate weather report.</p>

Figure 2: The aircraft as it came to rest after the serious incident. (Source: Pilot)

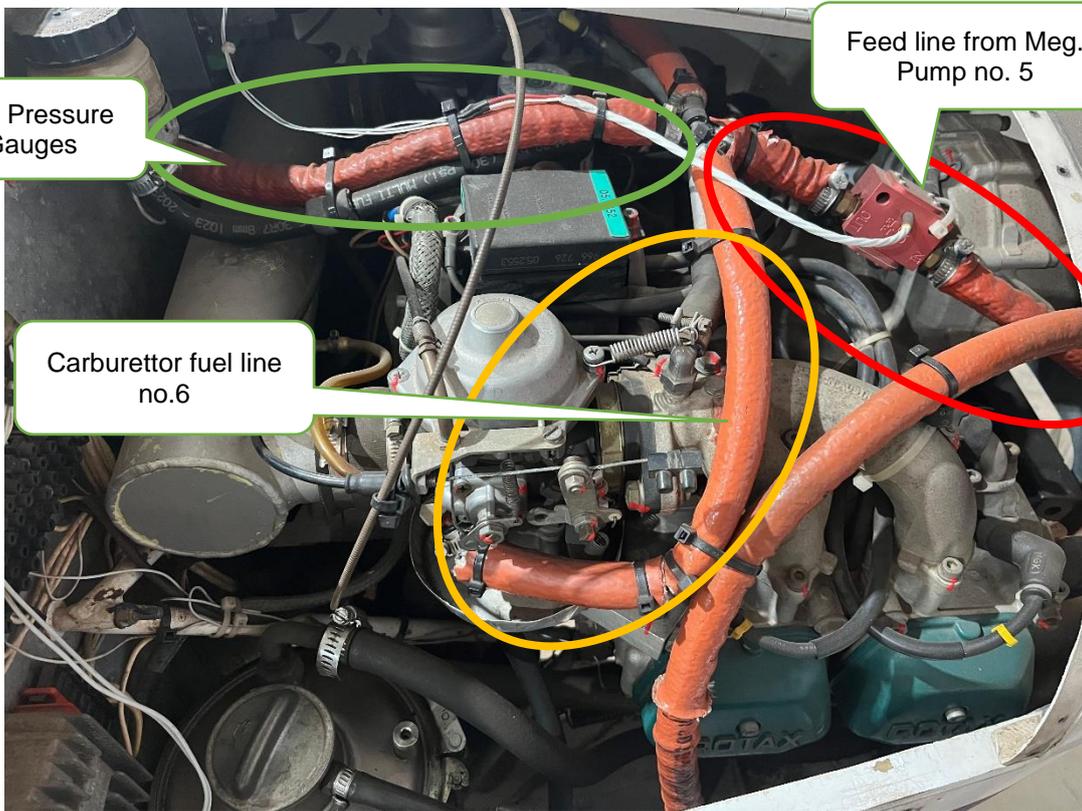
An assessment of the fuel system revealed that there was no overflow fuel return line fitted in the aircraft fuel system. This was likely to have contributed to an induced fuel vapor lock during flight due to the heat arising from the engine whilst the aircraft was being operated. The technical report revealed that the aircraft, built and designed in Europe, might have technical snags when operated in extreme heat conditions such as in South Africa (SA).

Figure 3 shows the flow of fuel from fuel tank (1) via a coarse filter (2), the fire cock (3), and fine filter (4) to the mechanical fuel pump (5). From the pump, fuel passes on via the fuel manifold (6) to the two carburettors. The return-line diverts fuel flows back to the fuel tank and suction side of the fuel system.

The aircraft was not fitted with the fuel line Number 9 shown in Figure 4. It is not standard for the Rotax engine to be fitted with the return fuel line.

Figure 3: Picture of the Rotax engine without the return line.

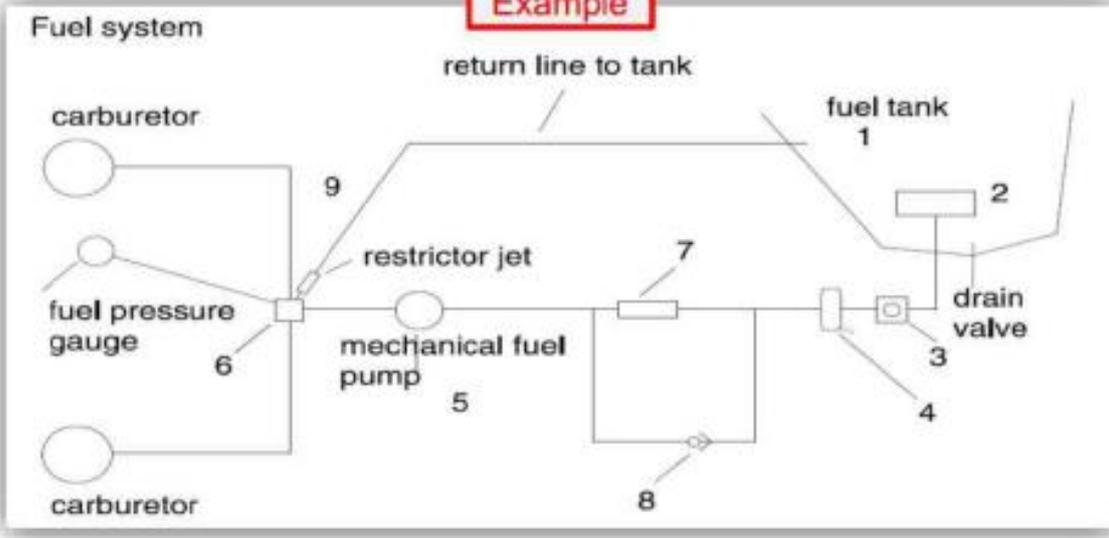
Return line Via the return line (5) surplus fuel flows back to the fuel tank and suction side of fuel system.
NOTE: The return line prevents malfunctions caused by the formation of vapor lock.

Diagram 1: Rotax 912 ULS fuel system schematic.
