LIMITED OCCURRENCE INVESTIGATION REPORT – FINAL

Reference Number	CA18/3/2/1439						
Classification	Serious Incident	Date	2 February 2024		Time	0620Z	
Type of Operation	Training (Part 141)						
Location							
Place of Departure	Stellenbosch Airfield (FASB), Western Cape Province		Place of Intended Landing		Stellenbosch Airfield (FASB), Western Cape Province		
Place of Occurrence	Runway 19 FASB						
GPS Co-ordinates	Latitude	33°58'50.41"S	Longitude	18°49'20.36"E	Elevation	355 feet	
Aircraft Information							
Registration	ZU-EJB						
Make; Model; S/N	Foxbat (Serial Number: 161)						
Damage to Aircraft	Minor			Total Aircraft Hours	2067.2		
Pilot-in-command							
Licence Type	Student Pilot Licence (SPL)		Gender	Male		Age	30
Licence Valid	Yes	Total Hours	28.8		Total Hours on Type	28.8	
Total Hours 30 Days	2.8		Total Flying on Type Past 90 Days		28.8		
People On-board	1+1	Injuries	0	Fatalities	0	Other (on ground)	0
What Happened							
<p>On Friday, 2 February 2024, a flight instructor and a student pilot on-board a Foxbat aircraft with registration ZU-EJB were engaged in a training flight at Stellenbosch Airfield (FASB) in the Western Cape province when the serious incident occu

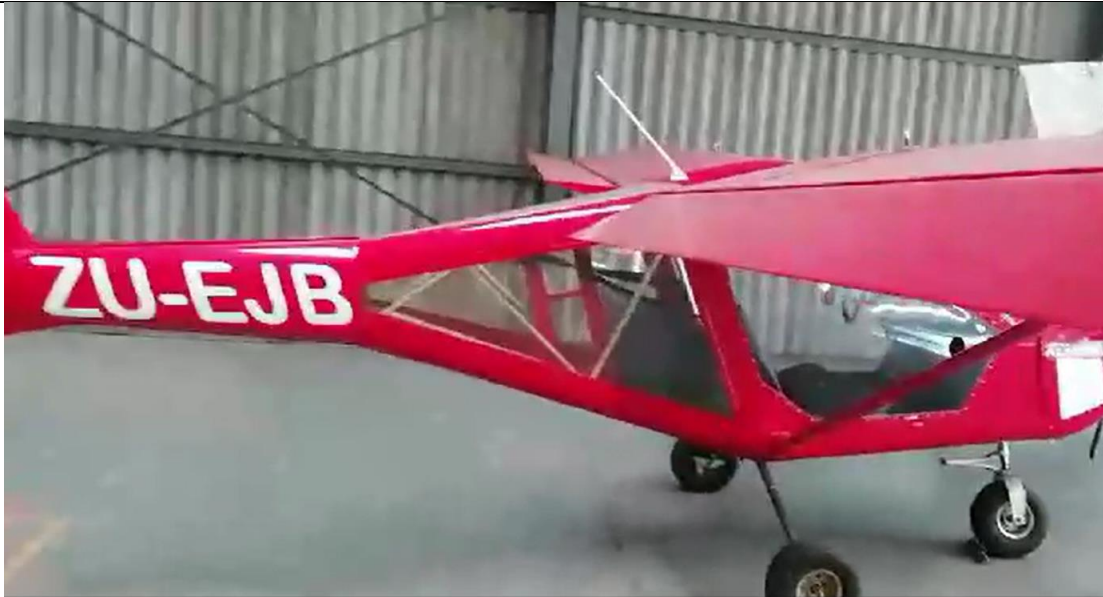
Figure 1: The damaged nose wheel strut. (Source: Operator)

6. According to the incident report from the training school, the aircraft was involved in an occurrence that led to a bounce, and which was neither reported to the training school nor recorded in the flight folio. During this occurrence, the nose wheel strut sustained a crack which continued to develop each time the aircraft was flown. This is until the day of the serious incident (this report) when the nose wheel strut gave in and bent to the right. This caused the aircraft to veer off to the left whilst rolling on RWY 19 at FASB.

The nose gear strut bent which rendered the aircraft uncontrollable; it veered off to the left of RWY 19 during the landing roll.

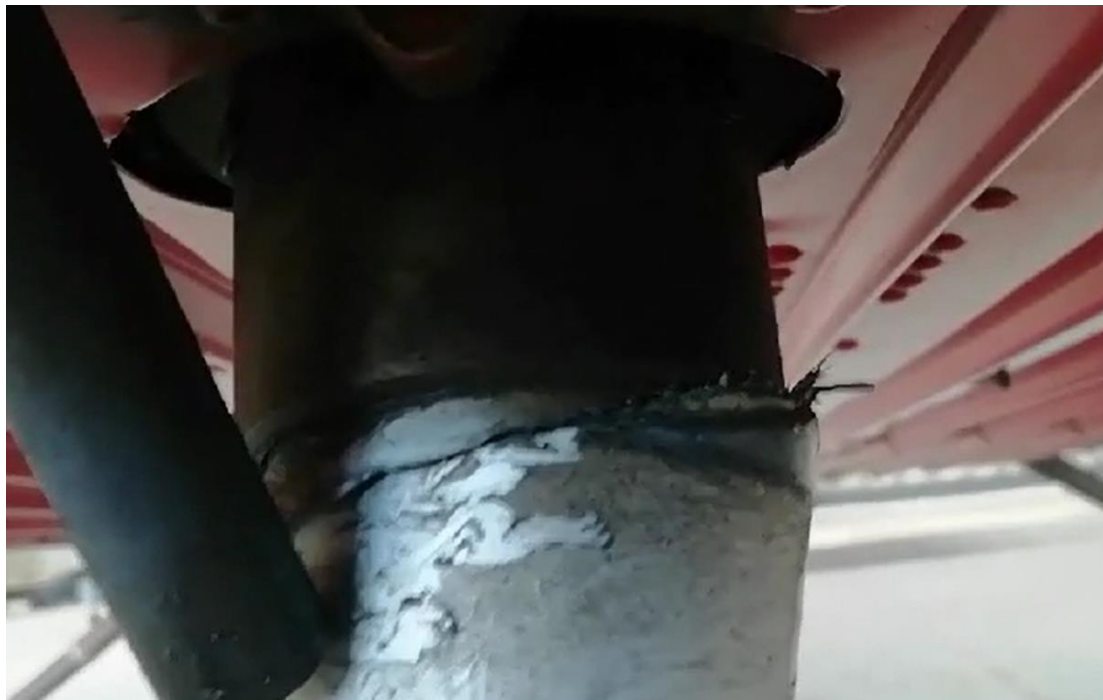
Figure 2: The close-up view of the damaged nose wheel strut. The black pipe is the fuel vent pipe. (Source: Operator)

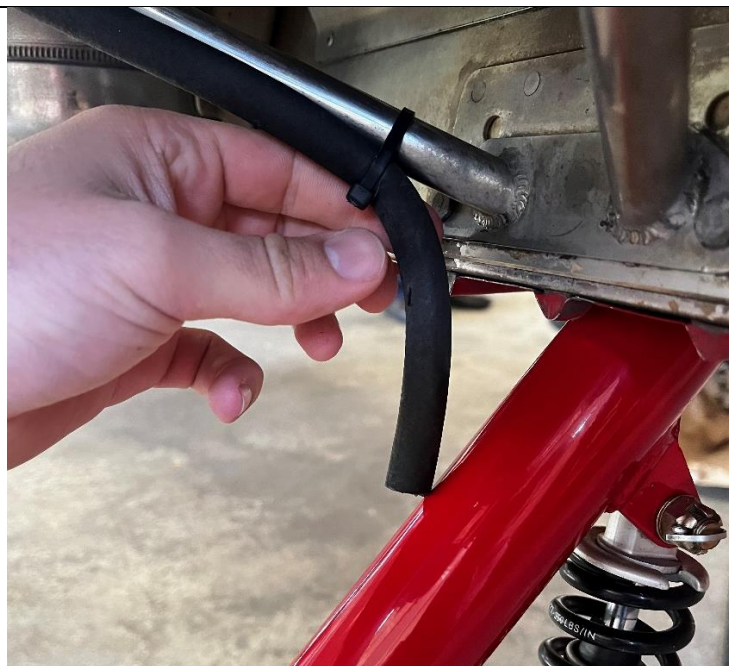
Figure 4: The fuel vent pipe. (Source: Operator)
