LIMITED OCCURRENCE INVESTIGATION REPORT – FINAL

Reference Number	CA18/3/2/1440						
Classification	Serious Incident	Date	17 February 2024	Time	1200Z		
Type of Operation	Training (Part 141)						
Location							
Place of Departure	Bram Fischer International Airport (FABL), Free State Province		Place of Intended Landing	Springs Aerodrome (FASI), Gauteng Province			
Place of Occurrence	Open field, approximately 20 nautical miles (nm) north-east of FABL						
GPS Co-ordinates	Latitude	28°57'86.9" S	Longitude	26°25'8.86" E	Elevation	5 337ft	
Aircraft Information							
Registration	ZS-PWR						
Make; Model; S/N	Construzioni Aeronautiche; Tecnam P-92 (Serial Number: 1651)						
Damage to Aircraft	None		Total Airframe Hours	613.6			
Pilot-in-command							
Licence Type	Commercial Pilot Licence (CPL)		Gender	Female		Age	24
Licence Valid	Yes	Total Hours	259.2		Total Hours on Type	6.6	
Total Hours 90 Days	8.9		Total Flying Hours on Type Past 30 Days	0.8			
People On-board	2 + 0	Injuries	0	Fatalities	0	Other (on ground)	0

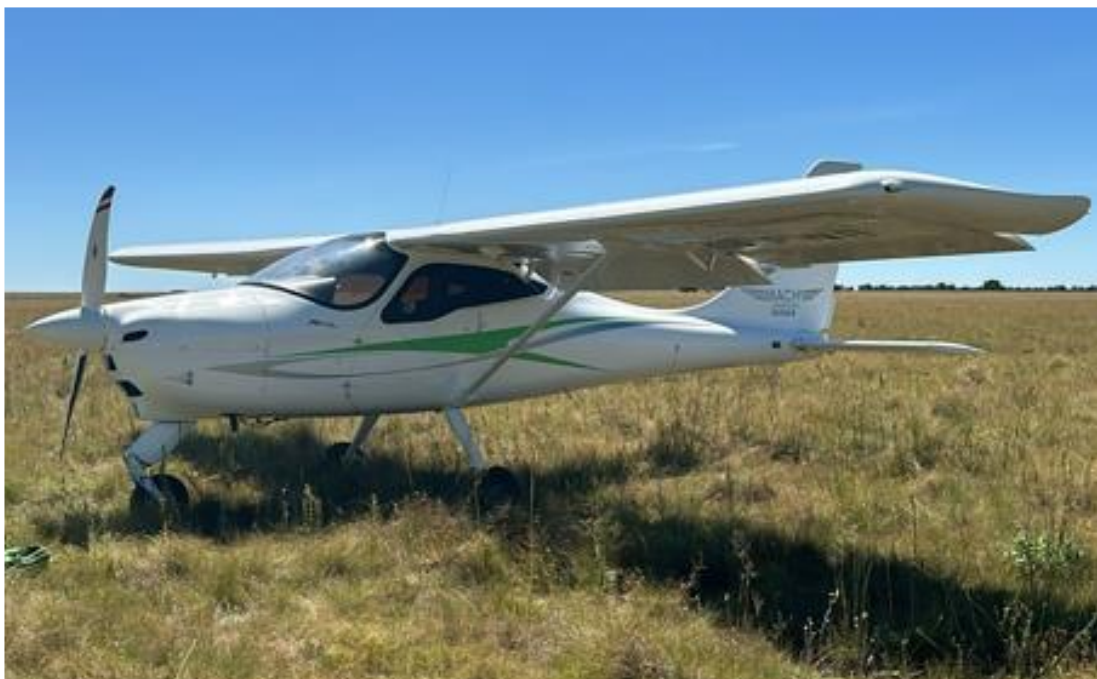
The serious incident occurred during daylight on an open field at Global Positioning System (GPS) co-ordinates determined to be 28°57'86.9" South 26°25'8.86" East, at an elevation of 5 337 feet (ft).

Figure 1: The aircraft after it had come to a stop on the field. (Source: Flight instructor)

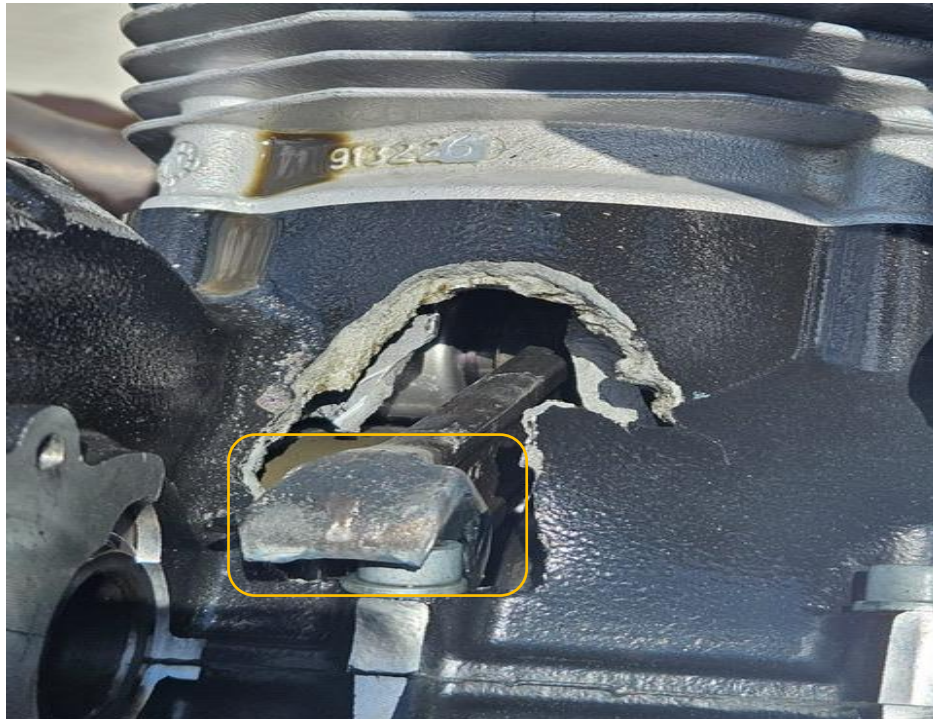
After disembarking from the aircraft, the flight instructor noticed engine oil residue on the aircraft's underbelly. He then opened the engine top cowling and noticed a hole (or damage) to the right of the crankcase which was caused by the Number 1 (right front) connecting rod that had failed.

Figure 2: The Number 1 connecting rod protrudes from the crankcase. (Source: Flight instructor)

11. The operator had an Operation Specifications Certificate that was issued by the Regulator on 14 April 2023 with an expiry date of 30 June 2024.
12. The oil pump failed which caused oil starvation to the rotating components of the engine and, thus, the failure of the Number 1 connecting rod.

Probable Cause
Engine cessation in-flight as a result of failure of the Number 1 connecting rod due to lack of lubrication that was caused by a defective oil pump; this resulted in the pilot executing a successful forced landing.
Contributing Factors
None.
Safety Action(s)
None.
Safety Message
None.
About this Report
<p><i>The decision to conduct a limited investigation is based on factors including whether the cause is known and the evidence supporting the cause is clear, the level of safety benefit likely to be obtained from an investigation, and that will determine the scope of an investigation. For this occurrence, a limited investigation has been conducted, and the Accident and Incident Investigations Division (AIID) has relied on the information submitted by the affected person/s and organisation/s to compile this limited report. The report has been compiled using information supplied in the initial notification, as well as from follow-up desktop inquiries to bring awareness of potential safety issues to the industry in respect of this occurrence, as well as possible safety action/s that the industry might want to consider in preventing a recurrence of a similar occurrence.</i></p> <p><i>All times given in this report are Co-ordinated Universal Time (UTC) and will be denoted by (Z). South African Standard Time is UTC plus 2 hours.</i></p>

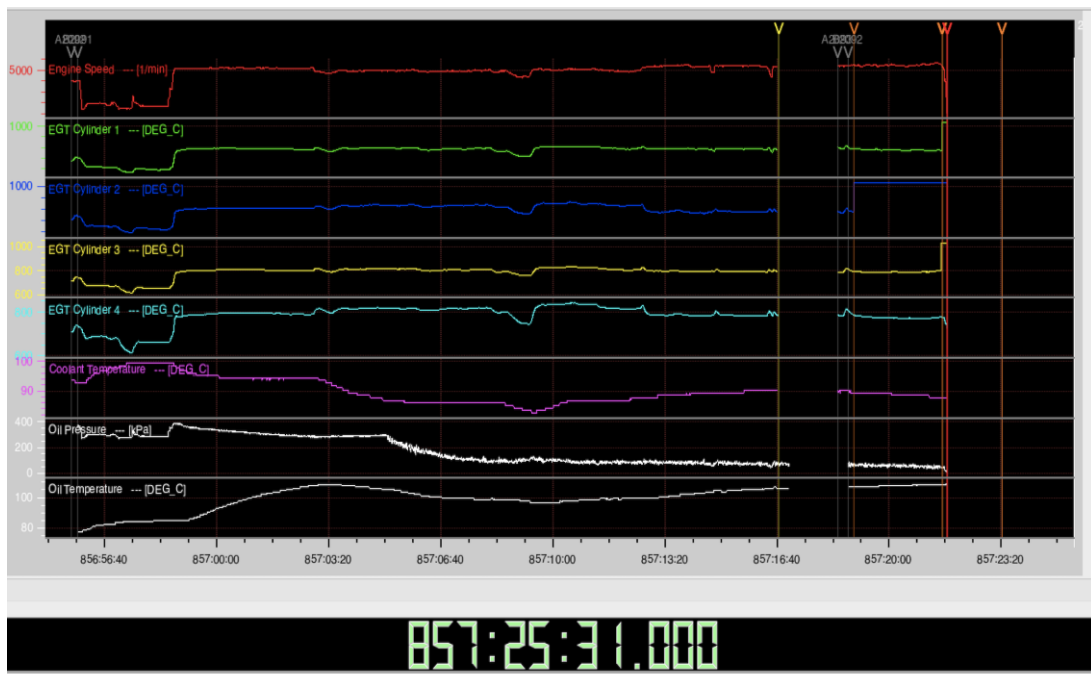
The aircraft was equipped with an engine control unit (ECU), model number ECU-204-102D, which is an engine monitoring system (Graph 1) with a non-volatile memory. The unit was downloaded after the serious incident and the following data was retrieved:

- The total fuel remaining in the tanks indicated 73 litres (l) / (19.2 United States [US] gallons).
- There was no chip detector warning observed.

Graph 1: The data downloaded from the ECU shows an increase in temperature, depicted by multiple sensors. It also depicts the decrease in oil pressure.

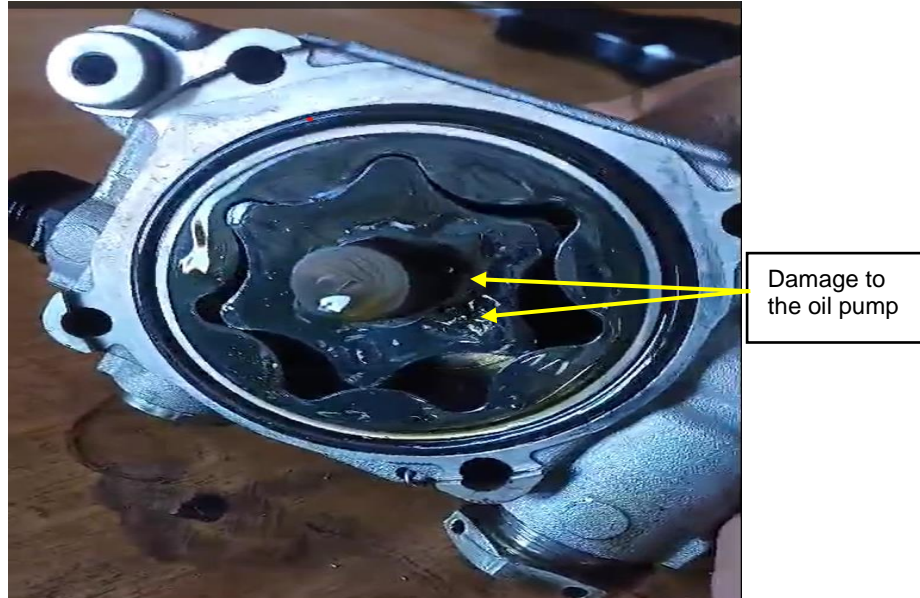
The oil pump was removed from the engine and stripped. It was found damaged, and metal particles were found inside the pump. It was concluded that the oil pump was defective. There was no oil pressure, and this caused the engine to overheat due to lack of lubrication (see Figure 2).

Figure 3: Disassembled oil pump with metal particles visible. (Source: Operator)

Without the oil pressure supplied by the pump, all bearings will eventually fail, some will start failing under load within a few seconds. The oil pressure fills the gap between moving components. When there is no oil wedge to keep components from contacting each other, there will be metal-on-metal contact which will create extreme heat levels and friction and might permanently destroy the components.
