LIMITED OCCURRENCE INVESTIGATION REPORT – FINAL

Reference Number	CA18/3/2/1441						
Classification	Serious Incident	Date	7 February 2024		Time	1400Z	
Type of Operation	Private (Part 94)						
Location							
Place of Departure	Buffeldoorn Farm in Klerksdorp, North West Province		Place of Intended Landing	Tedderfield Airfield (FATA), Gauteng Province			
Place of Occurrence	Buffeldoorn Farm in Klerksdorp, North West Province						
GPS Co-ordinates	Latitude	26°41'14.16" S	Longitude	026°46'54.50" E	Elevation	4593 ft	
Aircraft Information							
Registration	ZU-ADS						
Make; Model; S/N	Sling 4 (Serial Number: 056K)						
Damage to Aircraft	Minor		Total Aircraft Hours	1 436.6			
Pilot-in-command							
Licence Type	Private Pilot Licence (PPL)		Gender	Male		Age	46
Licence Valid	Yes	Total Hours	797.7		Total Hours on Type	728	
Total Hours Past 30 Days	5.8		Total Flying Hours on Type Past 90 Days	4.9			
People On-board	1 + 0	Injuries	0	Fatalities	0	Other (on ground)	0

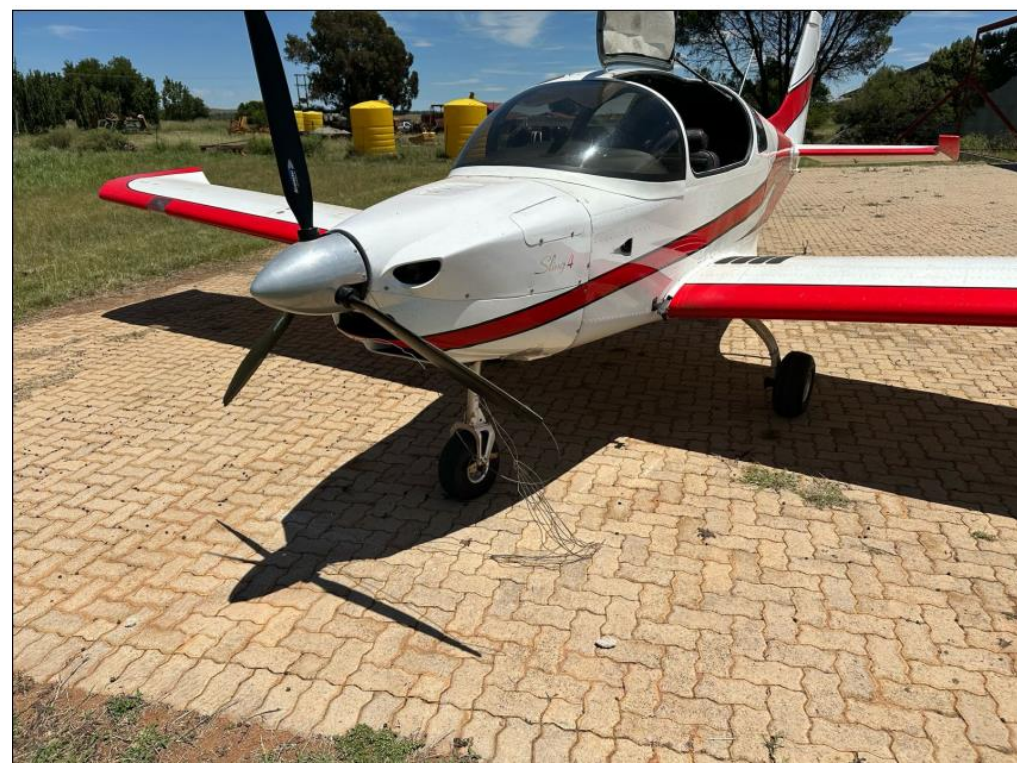
Figure 2: The aircraft after the serious incident. (Source: Pilot)

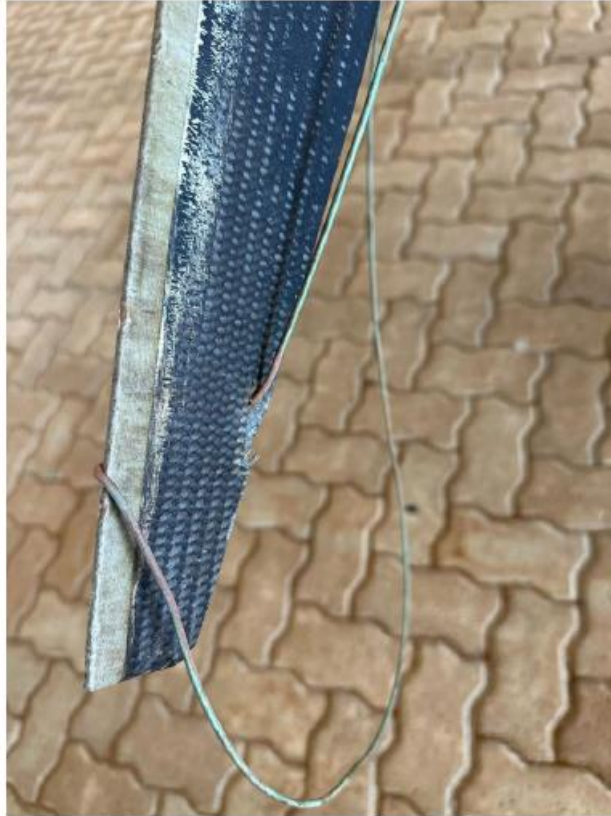
Figure 3: Damage to the propeller tip with the wire still entangled. (Source: Pilot)

<p>6. The wire was entangled to the aircraft's propeller. The wire lay hidden from the pilot's sight during runway inspection.</p> <p>7. Failure to inspect the taxiway.</p>
<p>Probable Cause</p>
<p>During taxi from the parking area to the take-off point of the runway, the cable that lay hidden on the grass entangled the aircraft's propeller.</p>
<p>Contributing Factor</p>
<p>Foreign object not cleared from taxiway.</p>
<p>Safety Action(s)</p>
<p>None.</p>
<p>Safety Message</p>
<p>In the interest of safety and to avoid injury or damage to property, pilots operating in unmanned and unmaintained airstrips are advised to ensure that the taxi and movement areas of the aircraft are free of hazardous objects.</p>
<p>About this Report</p>
<p><i>The decision to conduct a limited investigation is based on factors including whether the cause is known and the evidence supporting the cause is clear, the level of safety benefit likely to be obtained from an investigation and that will determine the scope of an investigation. For this occurrence, a limited investigation has been conducted, and the Accident and Incident Investigations Division (AIID) has relied on the information submitted by the affected person/s and organisation/s to compile this limited report. The report has been compiled using information supplied in the initial notification, as well as from follow-up desk top enquiries to bring awareness of potential safety issues to the industry in respect of this occurrence, as well as possible safety action/s that the industry might want to consider in preventing a recurrence of a similar occurrence.</i></p> <p><i>All times given in this report are Co-ordinated Universal Time (UTC) and will be denoted by (Z). South African Standard Time is UTC plus 2 hours.</i></p>
