**AIRCRAFT SERIOUS INCIDENT REPORT AND EXECUTIVE SUMMARY**

<b>Reference:</b>		CA18/3/2/1442			
<b>Aircraft Registration</b>	ZS-CMK	<b>Date of Incident</b>	26 March 2024	<b>Time of Incident</b>	0920Z		
<b>Type of Aircraft</b>	Bombardier CL-600-2B19	<b>Type of Operation</b>		Commercial (Part 121)			
<b>Pilot-in-command Licence Type</b>	Airline Transport Licence (ATPL)	<b>Age</b>	64	<b>Licence Valid</b>	Yes		
<b>Pilot-in-command Flying Experience</b>		<b>Total Flying Hours</b>	18 357	<b>Hours on Type</b>	624.1		
<b>Last Point of Departure</b>	O.R. Tambo International Airport (FAOR), Gauteng Province						
<b>Next Point of Intended Landing</b>	George Airport (FAGG), Western Cape Province						
<b>Damage to Aircraft</b>	Substantial						
<b>Location of the incident site with reference to easily defined geographical points (GPS readings if possible)</b>							
En route to George Airport (FAGG) at FL300							
<b>Meteorological Information</b>	Wind direction: 150°; Wind speed: 07kts; Temperature: 22°C; Dew Point: 15°C; Cloud Cover: Few 0300VC 045; Cloud Base: 4 500ft; Visibility: CAVOK; QNH: 1015hPa

**Reference Number** : CA18/3/2/1442  
**Occurrence Category** : Category 1  
**Type of

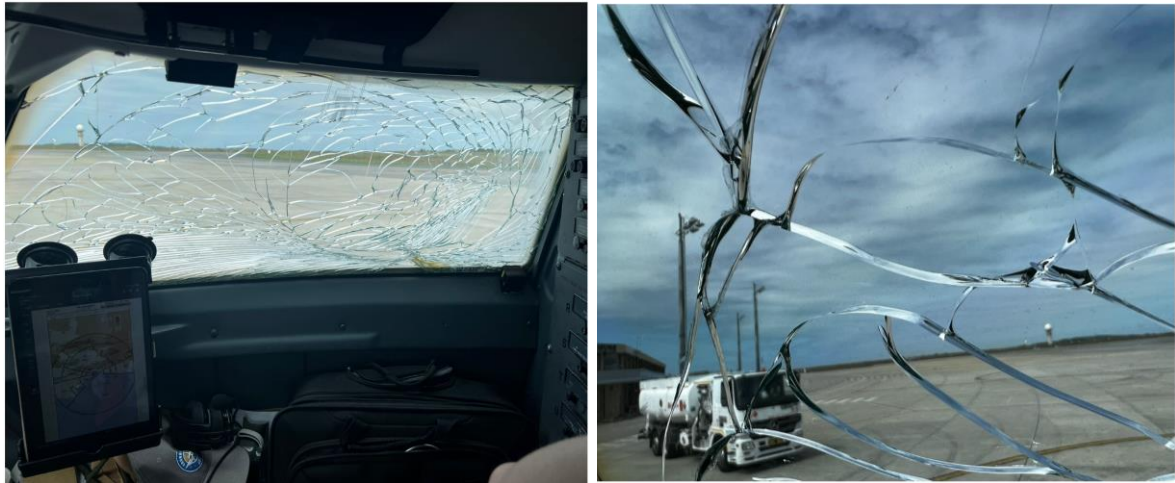
- 1.3.1. The starboard windshield cracked in-flight.

**Figures 1 and 2:** The cracked right-side windshield. (Source: Operator)

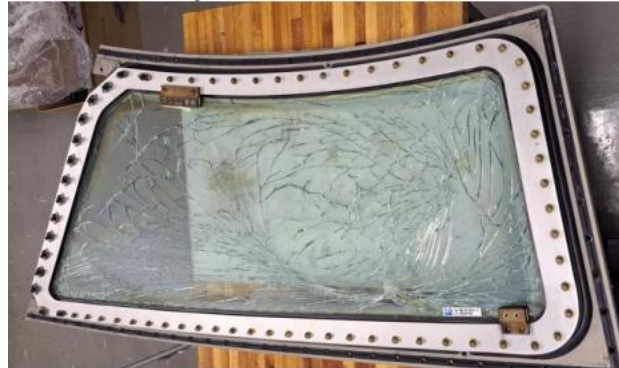
1.16.1. The cracked starboard (co-pilot) cockpit windshield (Photo 1), PPG Part No FAA PMA NP139322- 12, Serial No 08303H7346 from a Bombardier CRJ100-ER, aircraft registration

**Figure 6:** Cracked windshield.

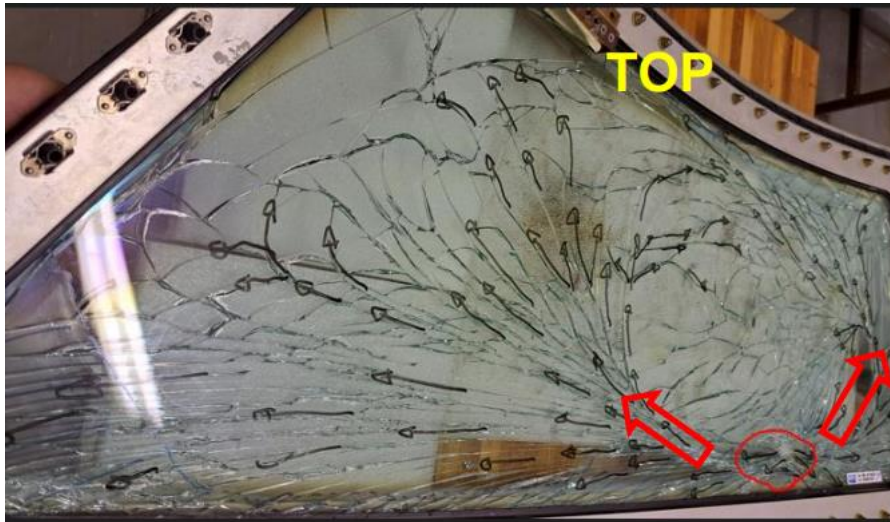
*The visual inspection revealed multiple fractures originating from the bottom right-side area (pilot's view) and extending in two directions (Photos 1 and 2, red circle, red arrows). Extensive delamination was noted between the outer glass layer (Diagram 1) and the interlayer at the anti-icing heating element interface (Photos 2 and 3, blue demarcation). This will be detrimental to the effectiveness of the heating element while in operation, resulting in a temperature gradient between the outer and the inner sections of the glass layer inducing (applied) stresses. Selected areas revealed indications of recent delamination (Photo 3, blue dashed lines) most probably induced following the initial failure of the outer glass layer. At the point of initiation, clear indications of discolouring of the polymer interlayer were noted suggesting electrical arcing involving the heating element (Photo 3, yellow circle). The initial fracture originated from the delaminated zone and at the point of arcing. The arcing would have further increased the temperature gradient within a small area resulting in increased stresses exceeding the designed limits (compression/tension region) of the Tempered Glass layer. Inspection of the windshield seals and outer frame revealed no clear indication/s of excessive wear and/or incorrect fitting (Photo 4).*

Photo 1: Inside view (digital).

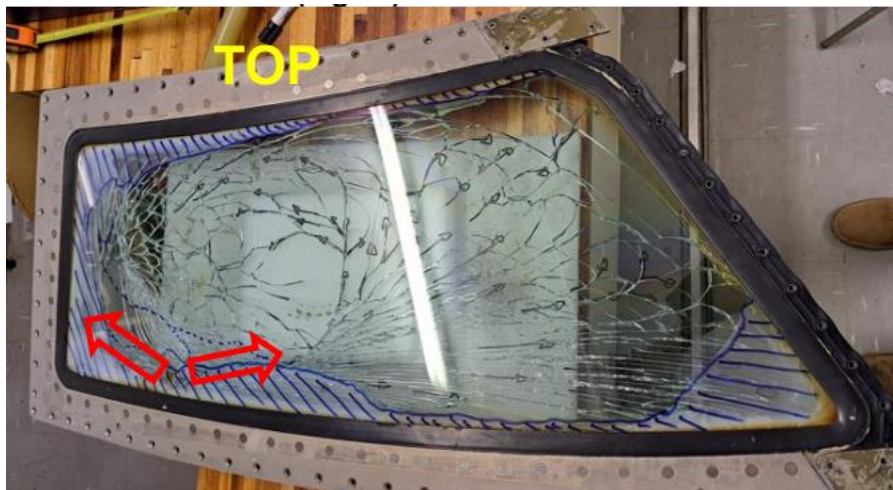
Photo 2: Outside view (digital).

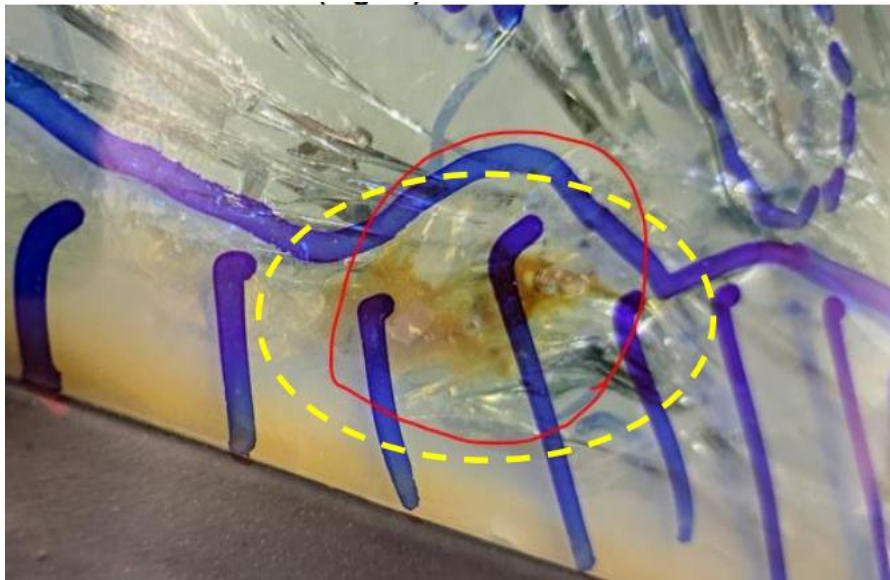
Photo 3: Arcing indications (digital).

- (a) *The inspection of the starboard windshield assembly revealed multiple (large shards) fractures within the outer, thermally tempered glass layer.*
- (b) *The windshield revealed extensive circumferential delamination between the outer and intermediate layers at the heating element interface. This contributed to a temperature gradient between the outer and inner zones of the glass layer, increasing the applied stresses during operation. Delamination proved to be the most common cause of failure of heated windshield assemblies.*
- (c) *The fracture initiated within the delaminated zone at a point where the heating element revealed signs of localised arcing. The increased localised stresses are most probably the primary causational factor towards the initiation of the final failure. The arcing can be*

*attributed to moisture ingestion between the outer glass and the intermediate polymer layer delaminated areas during operation.*

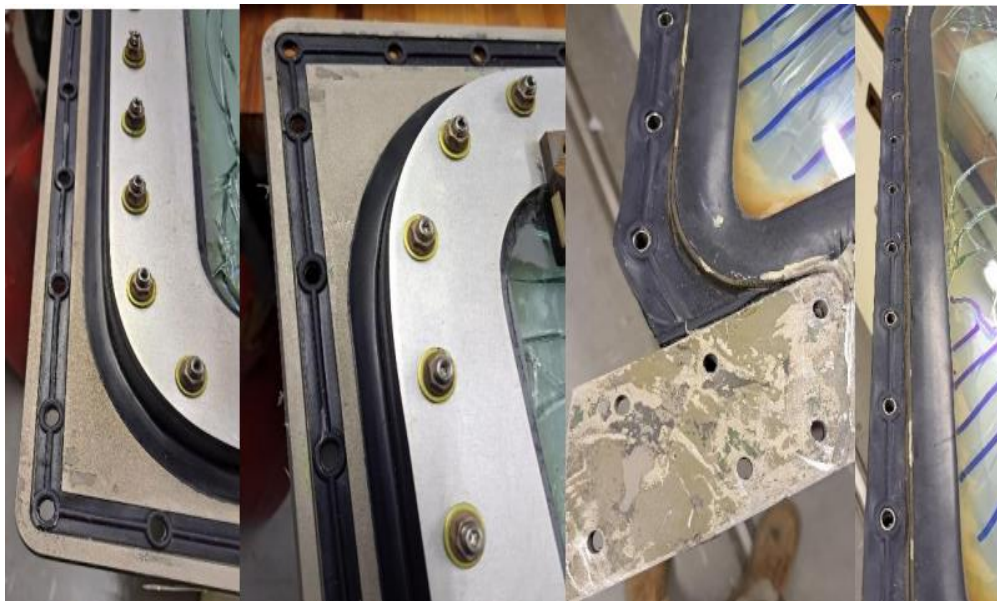
Photo 4: Windshield seal condition (digital).
