LIMITED OCCURRENCE INVESTIGATION REPORT – FINAL

Reference Number	CA18/3/2/1443						
Classification	Serious Incident	Date	25 March 2024	Time	1200Z		
Type of Operation	Training (Part 141)						
Location							
Place of Departure	Private Farm, East of Khowa (Elliot), Eastern Cape Province		Place of Intended Landing	Private Farm, East of Khowa (Elliot), Eastern Cape Province			
Place of Occurrence	Private farm approximately 11 nautical miles east of Khowa (Elliot), Eastern Cape Province						
GPS Co-ordinates	Latitude	31° 22'56.8" S	Longitude	028° 03'25" E	Elevation	5 065 feet	
Aircraft Information							
Registration	ZS-JDB						
Make; Model; S/N	Robinson; R44 Raven II (Serial Number: 11881)						
Damage to Aircraft	Minor		Total Aircraft Hours	3938.0			
Pilot-in-command							
Licence Type	Commercial Pilot Licence (CPL) Helicopter		Gender	Male		Age	23
Licence Valid	Yes	Total Hours	1 400		Total Hours on Type	700	
Total Hours 30 Days	65.4		Total Flying on Type Past 90 Days	150.3

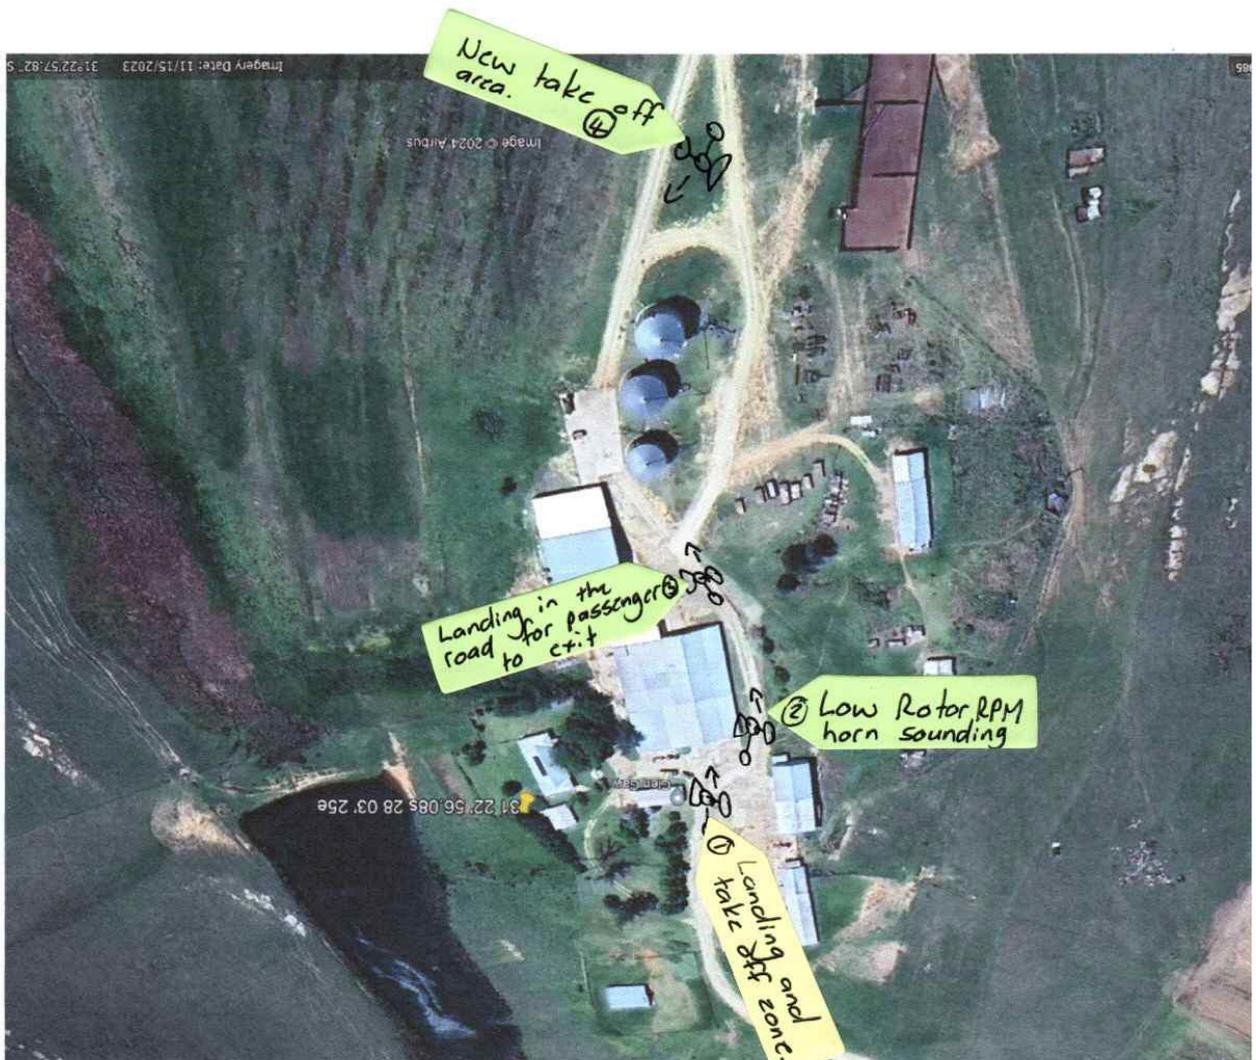
Figure 1: A view of the incident site. (Source: Pilot)

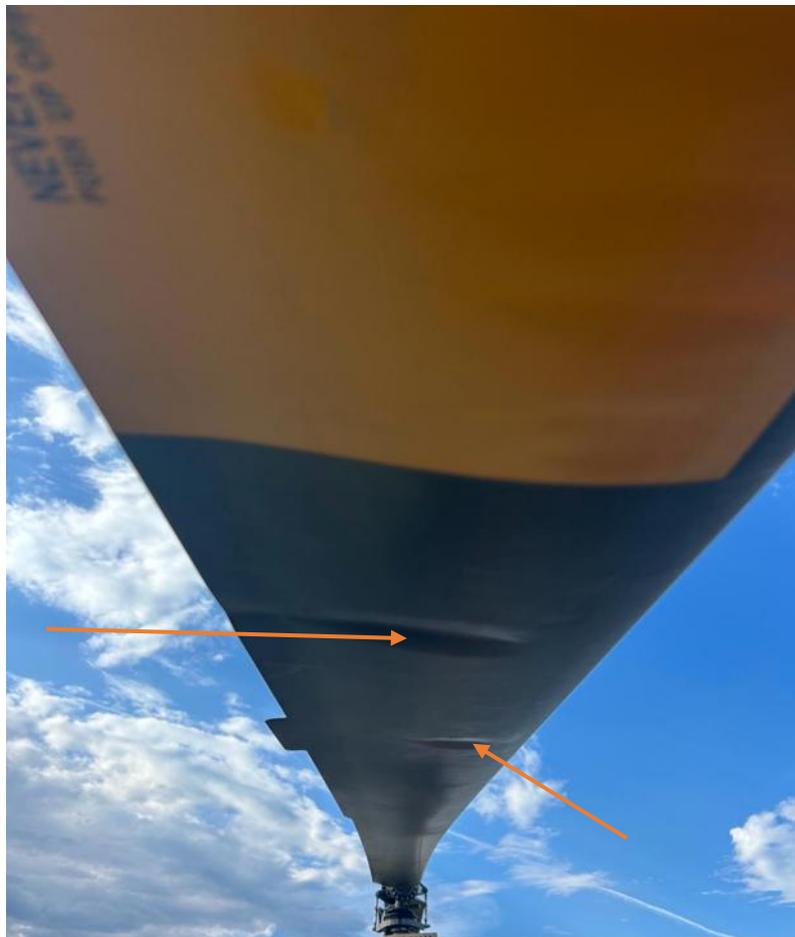
the pilots realised that the main rotor blades sustained damage after impacting some shrubs (in the bush) during the first transition and no person was injured.

Figure 3: Orange arrows showing damage to the main rotor. (Source: Pilot)

9. The main rotor impacted a bush near the landing zone and no person on was injured during the incident.

The main rotor blades impacted a bush near the landing zone.

Inadequate or no pre-flight planning.

In the interest of safety and to avoid injury or damage to property, pilots are advised to always conduct thorough pre-flight planning and identify all possible flight hazards and obstacles.
