LIMITED OCCURRENCE INVESTIGATION REPORT – FINAL

Reference Number	CA18/3/2/1444					
Classification	Serious Incident	Date	30 March 2024	Time	1410Z	
Type of Operation	Private (Part 94)					
Location						
Place of Departure	Wings Park Airfield, Eastern Cape Province		Place of Intended Landing	George Airport (FAGG), Western Cape Province		
Place of Occurrence	On a dirt road, north of the N2 National Road and south of Rondevlei between the towns of Wilderness and Sedgfield in the Western Cape province					
GPS Co-ordinates	Latitude	33°59'55.8" S	Longitude	22°42'32.3" E	Elevation	235ft
Aircraft Information						
Registration	ZU-MXK					
Make; Model; S/N	Kitplanes for Africa; Explorer UL-600 (Serial Number: 022-D-23 EXUL)					
Damage to Aircraft	Minor		Total Airframe Hours	17		
Pilot-in-command						
License Type	Commercial Pilot Licence (CPL)		Gender	Male		Age 31
Licence Valid	Yes	Total Hours	1 308.4		Total Hours on Type	12
Total Hours 30 Days	9		Total Flying Hours on Type Past 90 Days	9

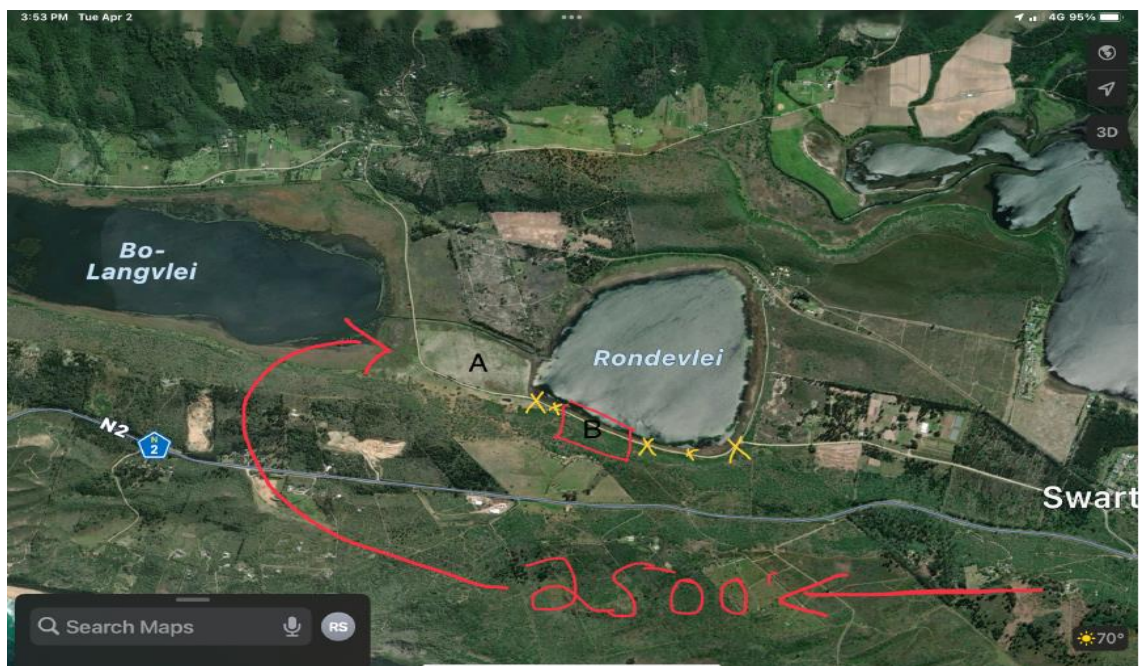
Figure 1: The approximate flight path. (Source: Pilot)

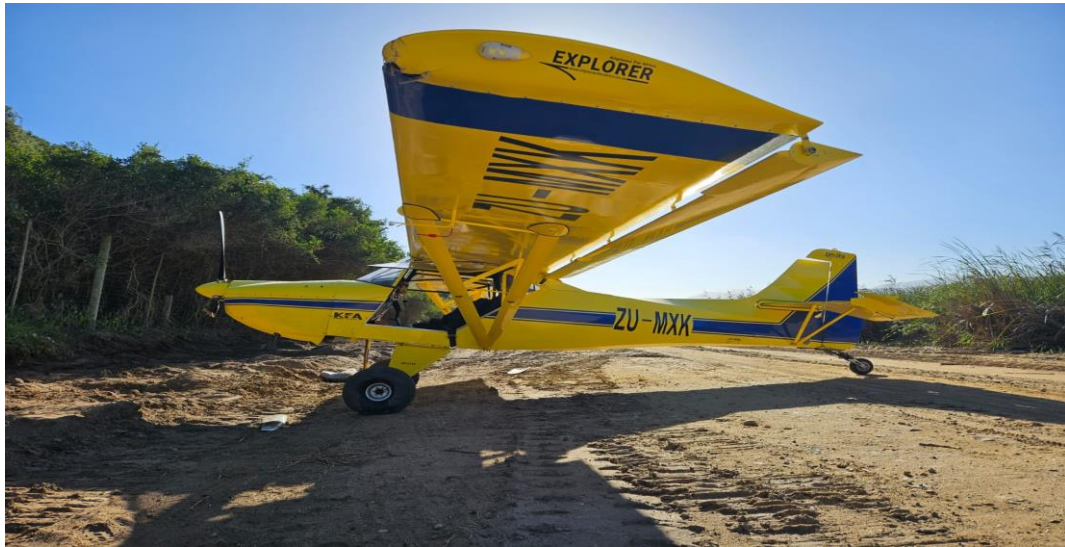
Figure 2: The aircraft after it had landed. (Source: Pilot)

Post-incident examination of the aircraft indicated no evidence of fuel leaks. The aircraft fuel caps were intact, and the fuel tanks were empty.
