**LIMITED OCCURRENCE INVESTIGATION REPORT – FINAL**

<b>Reference Number</b>	CA18/3/2/1445						
<b>Classification</b>	Serious Incident		<b>Date</b>	12 April 2024		<b>Time</b>	0905Z
<b>Type of Operation</b>	Training (Part 141)						
<b>Location</b>							
Place of Departure	Port Alfred Aerodrome (FAPA), Eastern Cape Province		Place of Intended Landing		Port Alfred Aerodrome (FAPA), Eastern Cape Province		
Place of Occurrence	Approximately 2 nautical miles (nm) west of Hamburg, Eastern Cape Province						
GPS Co-ordinates	Latitude	33°16' 39.00"S	Longitude	27°25'46.4"E	Elevation	1 379.2ft	
<b>Aircraft Information</b>							
Registration	ZS-SYF						
Make; Model; S/N	Piper Aircraft; PA-28R-201 (Serial Number: 2837016)						
Damage to Aircraft	Minor			Total Aircraft Hours	19 676.9		
<b>Pilot-in-command</b>							
Licence Type	Commercial Pilot Licence (CPL) Aeroplane		Gender	Male		Age	23
Licence Valid	Yes	Total Hours	887.8		Total Hours on Type	26.2	
Total Hours 30 Days	4.4		Total Flying on Type Past 90 Days		12.4

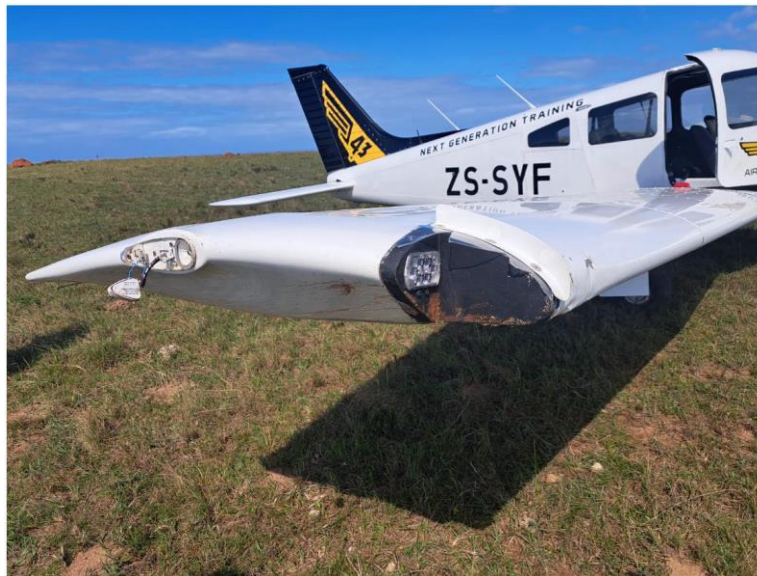
<b>People On-board</b>	2+1	<b>Injuries</b>	0	<b>Fatalities</b>	0	<b>Other (on ground)</b>	0
<b>What Happened</b>							
<p>On Friday morning, 12 April 2024, a flight instructor and two student pilots (one flying and the other observing) on-board a Piper 28R-201 aircraft with registration ZS-SYF took off on a training flight from Port Alfred Aerodrome (FAPA) in the Eastern Cape province with the intention to conduct touch-and-go landing exercises at East London Airport (FAEL) and, thereafter, return to FAPA. The flight was conducted under visual meteorological conditions (VMC) by day and under the provisions of Part 141 of the Civil Aviation Regulations (CAR) 2011 as amended.</p> <p>The instructor reported that the en route segments of the flight to FAEL and the touch-and-go landing exercises were uneventful. However, en route back to FAPA, approximately 2 nautical miles (nm) east of Hamburg whilst flying at an altitude of 1900 feet (ft), they noticed a propeller overspeed indication which was followed by loss of oil pressure and an increase in oil temperature. Moreover, the engine power/RPM (revolutions per minute) reduced and, thus, the aircraft was unable to maintain altitude. The instructor identified an open field and executed an emergency landing. During the landing roll, the right-side wing tip impacted an anthill. The aircraft sustained minor damage to the right-side wing tip and the navigation lights. All three occupants were not injured.</p>

**Figure 1:** Damage after impact with an anthill during landing. (Source: Operator)

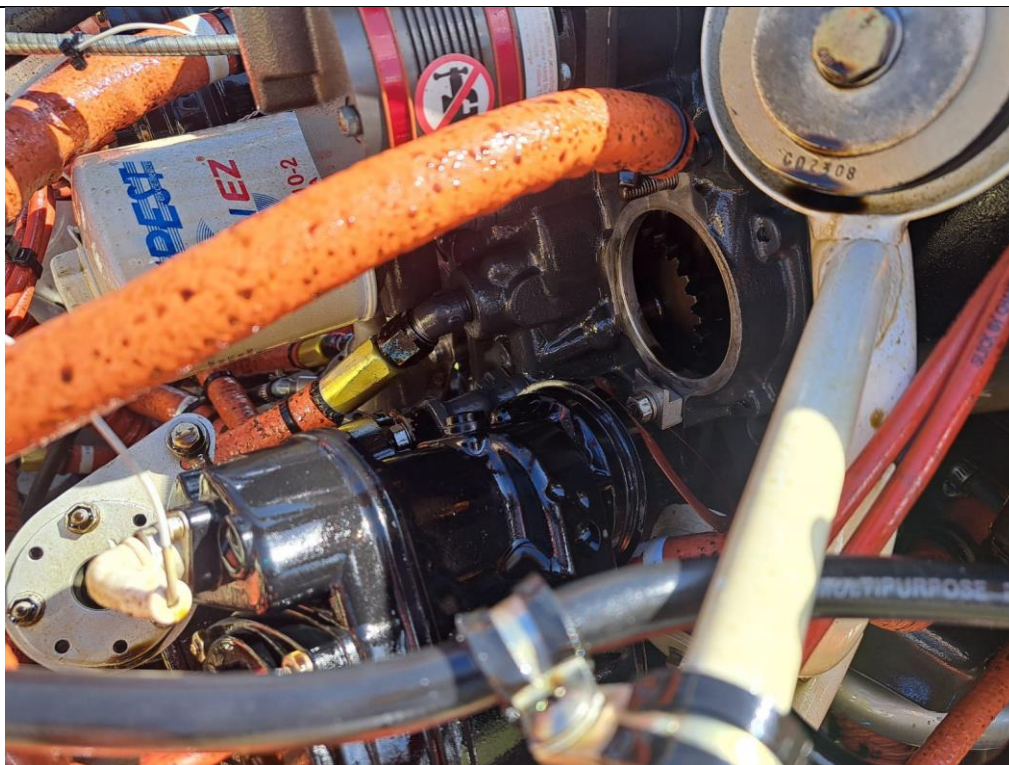
Post-incident inspection of the engine that was conducted by the operator revealed that the right-side magneto (Slick model) dislodged from the studs (mounts on the engine accessory housing) which resulted in oil loss/leakage and the subsequent loss of engine power.

*Right-side magneto top attaching stud attaching hardware vibrated loose and caused magneto to be forced out of mounting flange and became detached from engine accessory housing. This caused an excessive engine oil leak, and engine sump reserve soon depleted. This also caused the constant speed unit (CSU) propeller control to fail, and the propeller and engine speed could no longer be controlled or maintained; also, this caused inadequate lubrication to engine internals.*

**Figure 2:** The right-side magneto that separated from the engine and caused oil leakage. (Source: Operator)

<p>The right-side magneto was not properly torqued which resulted in its separation from the engine housing in-flight, as well as excessive loss of oil and reduced power. This was followed by a successful forced landing.</p>
<p><b>Contributing Factor(s)</b></p>
<p>Magneto that was not properly fitted or torqued.</p>
<p><b>Safety Action(s)</b></p>
<p>None.</p>
<p><b>Safety Message and/or Safety Recommendation/s</b></p>
<p><b>Safety message:</b> AMOs should always make sure that the AMEs adhere to manufacturer instructions. AMOs should also supervise the AMEs.</p>
<p><b>About this Report</b></p>
<p><i>The decision to conduct a limited investigation is based on factors including whether the cause is known and the evidence supporting the cause is clear, the level of safety benefit likely to be obtained from an investigation and that will determine the scope of an investigation. For this occurrence, a limited investigation has been conducted, and the Accident and Incident Investigations Division (AIID) has relied on the information submitted by the affected person/s and organisation/s to compile this limited report. The report has been compiled using information supplied in the initial notification, as well as from follow-up desk top enquiries to bring awareness of potential safety issues to the industry in respect of this occurrence, as well as possible safety action/s that the industry might want to consider in preventing a recurrence of a similar occurrence.</i></p> <p><i>All times given in this report are Co-ordinated Universal Time (UTC) and will be denoted by (Z). South African Standard Time is UTC plus 2 hours.</i></p>
