AIRCRAFT SERIOUS INCIDENT REPORT AND EXECUTIVE SUMMARY

Reference:		CA18/3/2/1446	
Aircraft Registration	ZS-PKB	Date of Accident	16 April 2024		Time of Accident	0553Z	
Type of Aircraft	Beechcraft 1900D			Type of Operation	Commercial (Part 135)		
Pilot-in-command Licence Type	Airline Transport Pilot Licence (ATPL)		Age	28	Licence Valid	Yes	
Pilot-in-command Flying Experience	Total Flying Hours		2 361.0		Hours on Type	602.5	
Last Point of Departure	O.R. Tambo International Airport (FAOR), Gauteng Province						
Next Point of Intended Landing	Venetia Mine Airfield (FAVM), Limpopo Province						
Damage to Aircraft	Minor						
Location of the accident site with reference to easily defined geographical points (GPS readings if possible)							
FAVM Runway 08 at Global Positioning System (GPS) co-ordinates 22°26'56.33" South 029°20'06.06" East, at an elevation of 2 315 feet (ft)							
Meteorological Information	Surface wind: 190°/12 knots: temperature, 24°C; dew point: 11°C

Probable Cause							
Incorrect approach speed (Vref) for flapless landing configuration resulted in a high sink rate and, thus, the subsequent hard landing on the gravel area, about 3m before the threshold of the Run

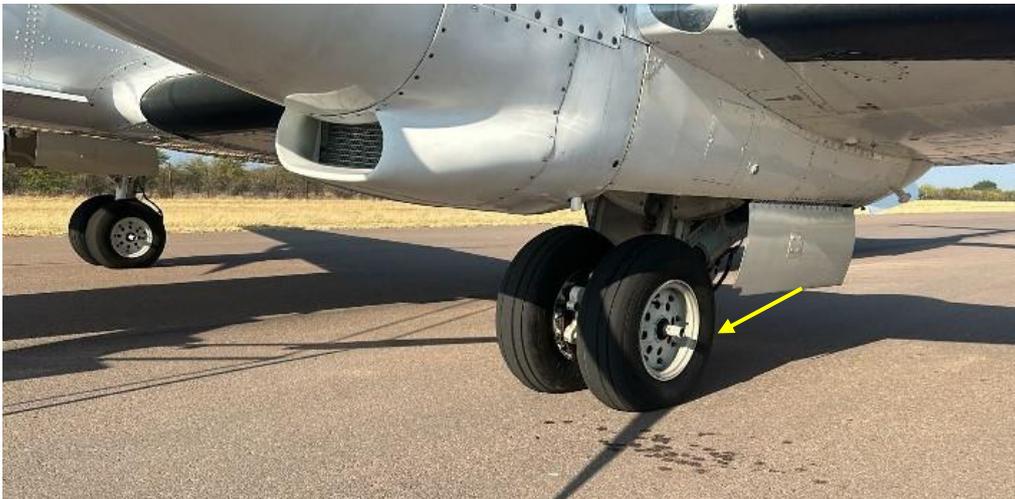
1.3.1 The left MLG drag brace was damaged during the serious incident.

Figure 2: The yellow arrow points to the collapsed left MLG – picture taken from the front of the aircraft.

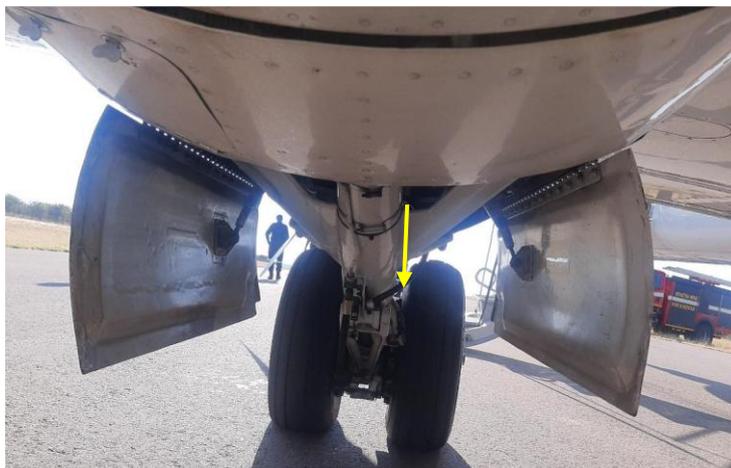
Figure 3: The collapsed left MLG (pivoted forward) – picture taken from behind the aircraft.

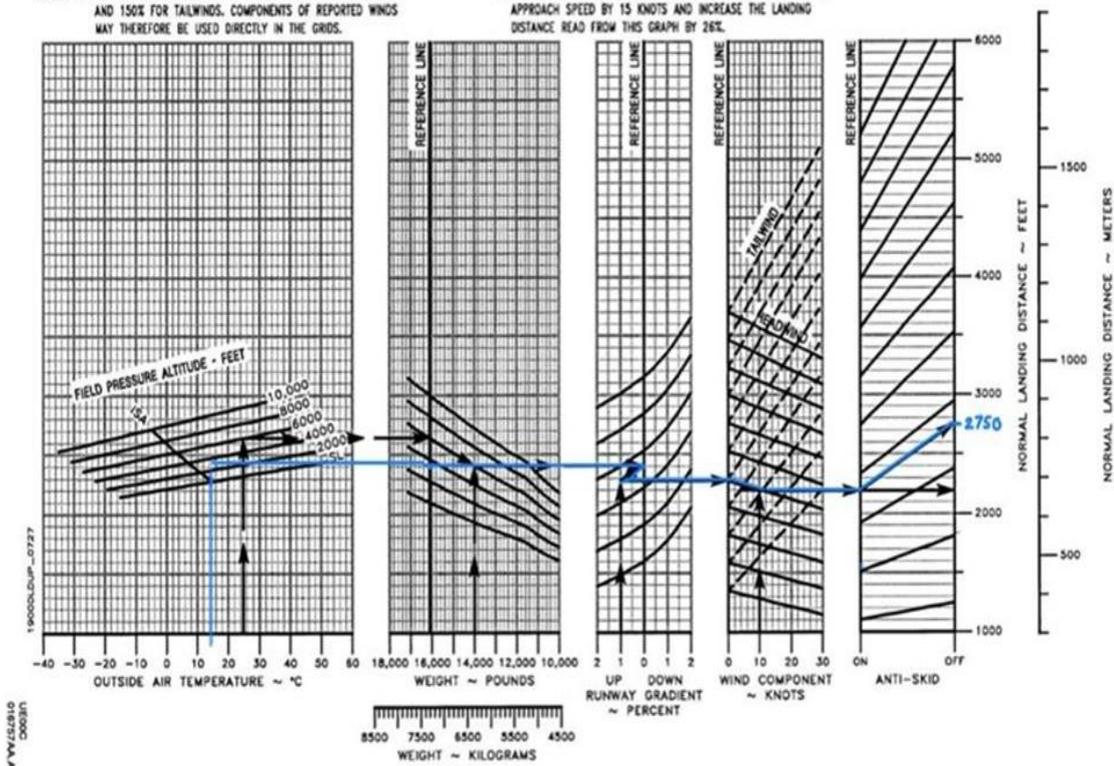
Figure 5: The performance calculation completed by the crew before departure from FAOR.
 (Source: Operator)

*Note: The temperature on the day was 24°C, and the field elevation for FAVM is 2 315ft. The aircraft landing weight was 16 765 lbs, the wind was 12 kts. Following the crew’s calculations, the aircraft needed 2 750ft (838.2m) of runway for landing.

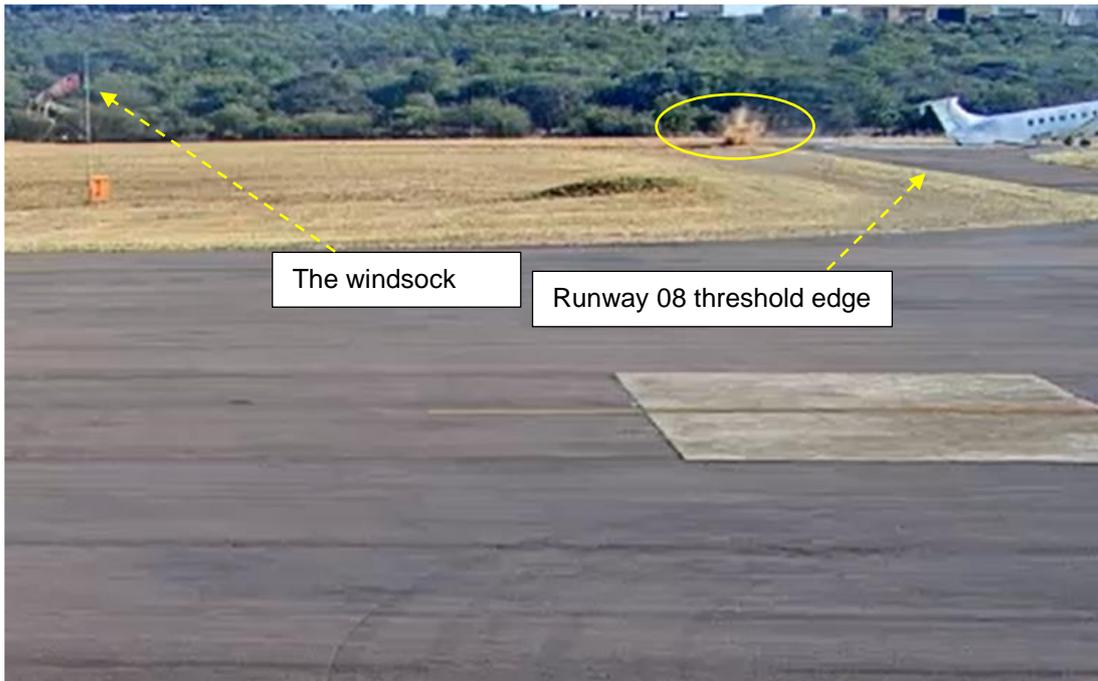
1.12.1 The close circuit television (CCTV) footage that was received from FAVM security management showed the aircraft's approach into the wind at 0553 (time stamped) on Runway 08. The flaps were in the up (0°) position and the aircraft touched down on the gravel (outside the designated landing area), 3m before the beginning of the asphalt runway threshold at a speed of 120 kts (CVR transcript). The aircraft entered the runway and continued to roll before it was brought to a stop approximately 900m from the runway threshold. After shutdown, the FO disembarked from the aircraft through the airstair and noticed that the left MLG drag link had separated because the bolts that secured it had sheared off, this caused the gear to pivot forward (partially collapsed) and, subsequently, damaged the front spar cap.

Figure 7: A still picture from the CCTV footage shows the direction of the windsock and a cloud of dust that rose (yellow circle) after the main wheels touched down on the gravel area, short of the runway threshold.

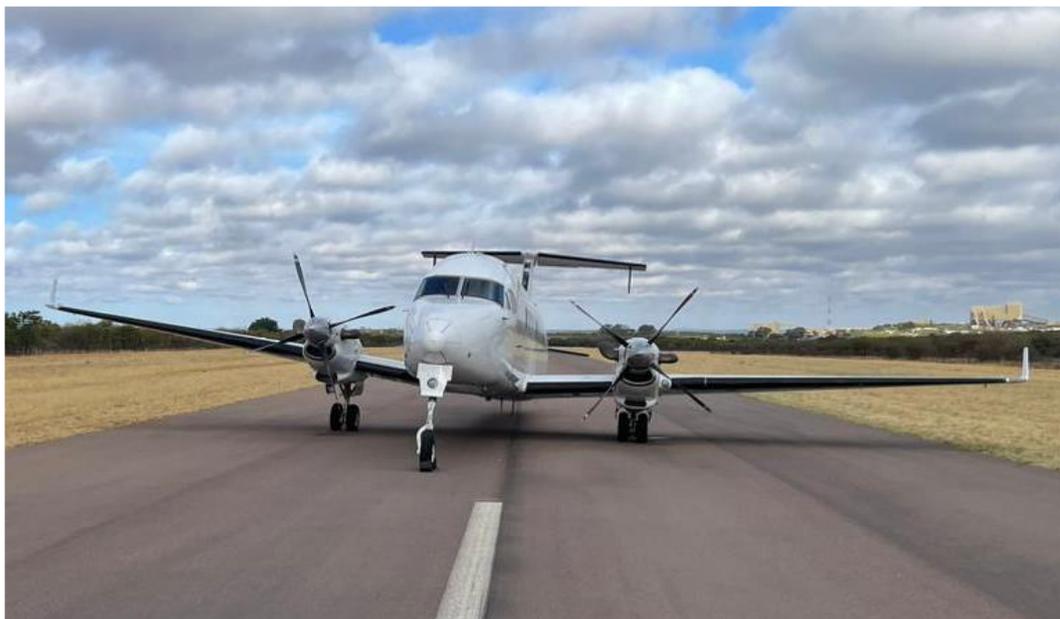
Figure 8: Front view of the aircraft which is leaning to the left, and the left MLG that had pivoted forward.

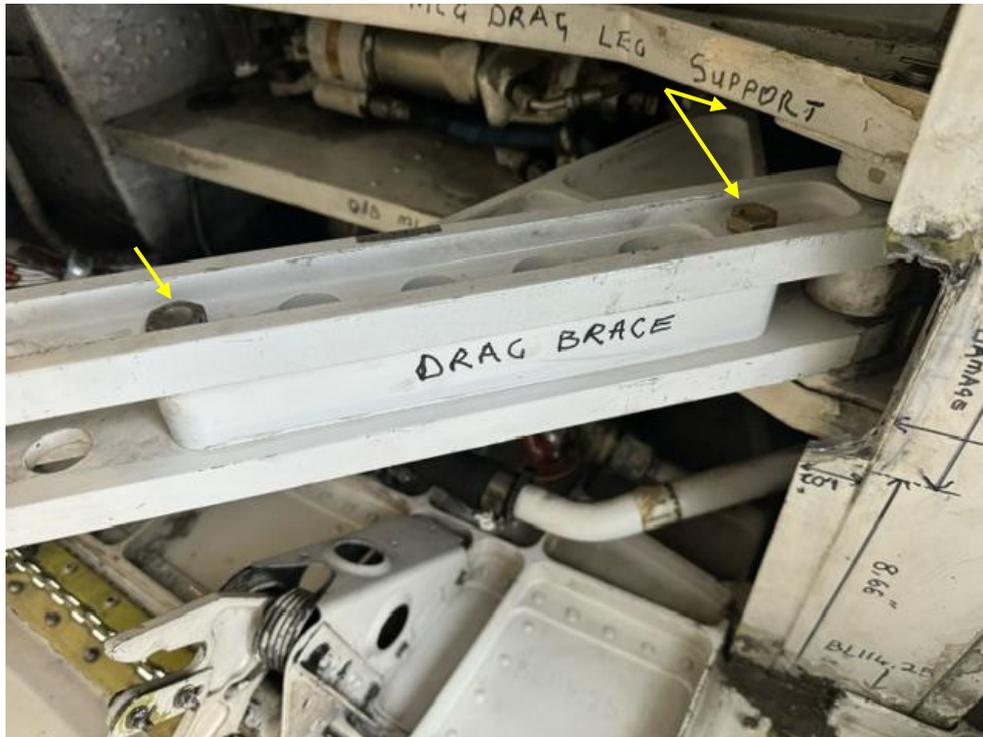
Figure 9: The replaced left MLG drag brace. The yellow arrows point to the bolts that secure the drag brace.

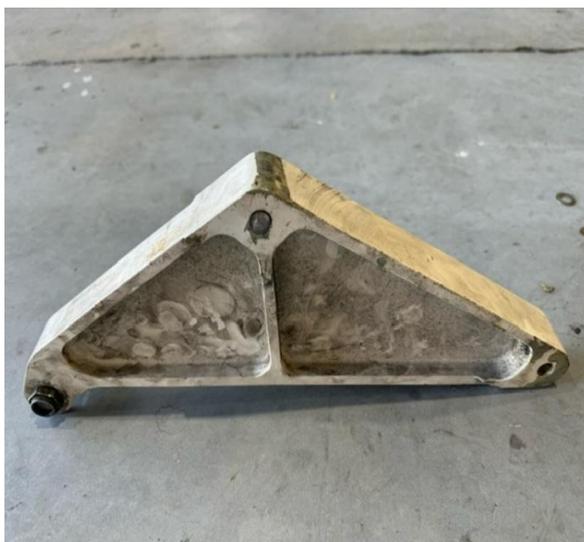
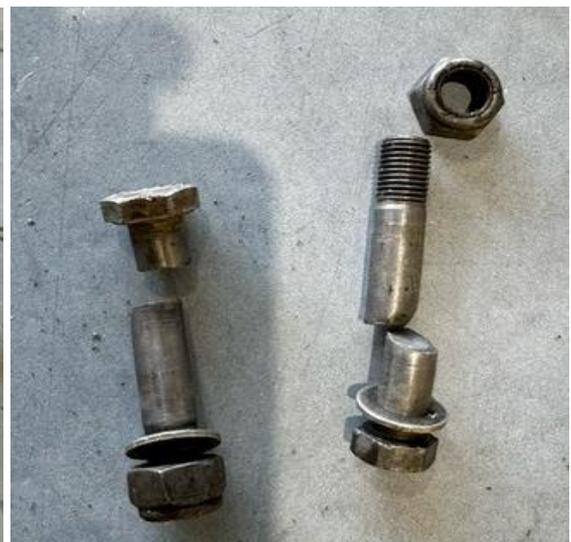
1.12.2 The crew and the airfield security personnel inspected the runway during which the front spar cap material was found approximately 40m from the threshold of Runway 08. The first drag link bolt head that sheared off was found approximately 150m, and the bolt shank piece approximately 70m. After inspecting the left MLG wheel well area, engineers found the remaining piece of the second bolt that had sheared off.

Figures 10 and 11: The left MLG drag brace that was replaced (left picture). The drag brace fasteners that had sheared off (right picture). (Source: Operator)

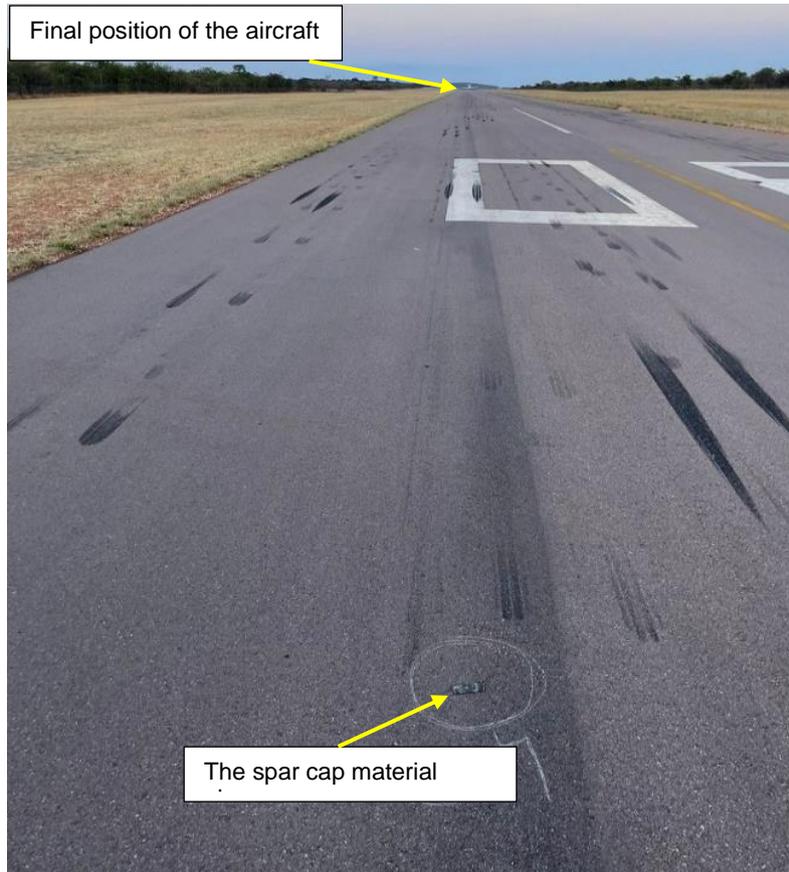
Figure 12: The yellow arrows point to the piece of the front spar cap and the final position of the aircraft. (Source: Operator)

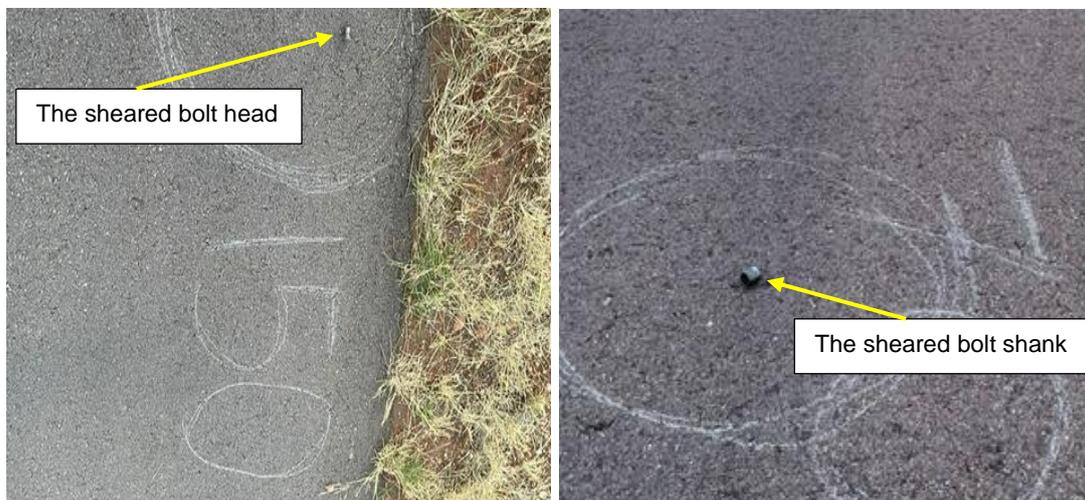
Figures 13 and 14: The sheared bolt head (left picture) and the sheared bolt shank (right picture).

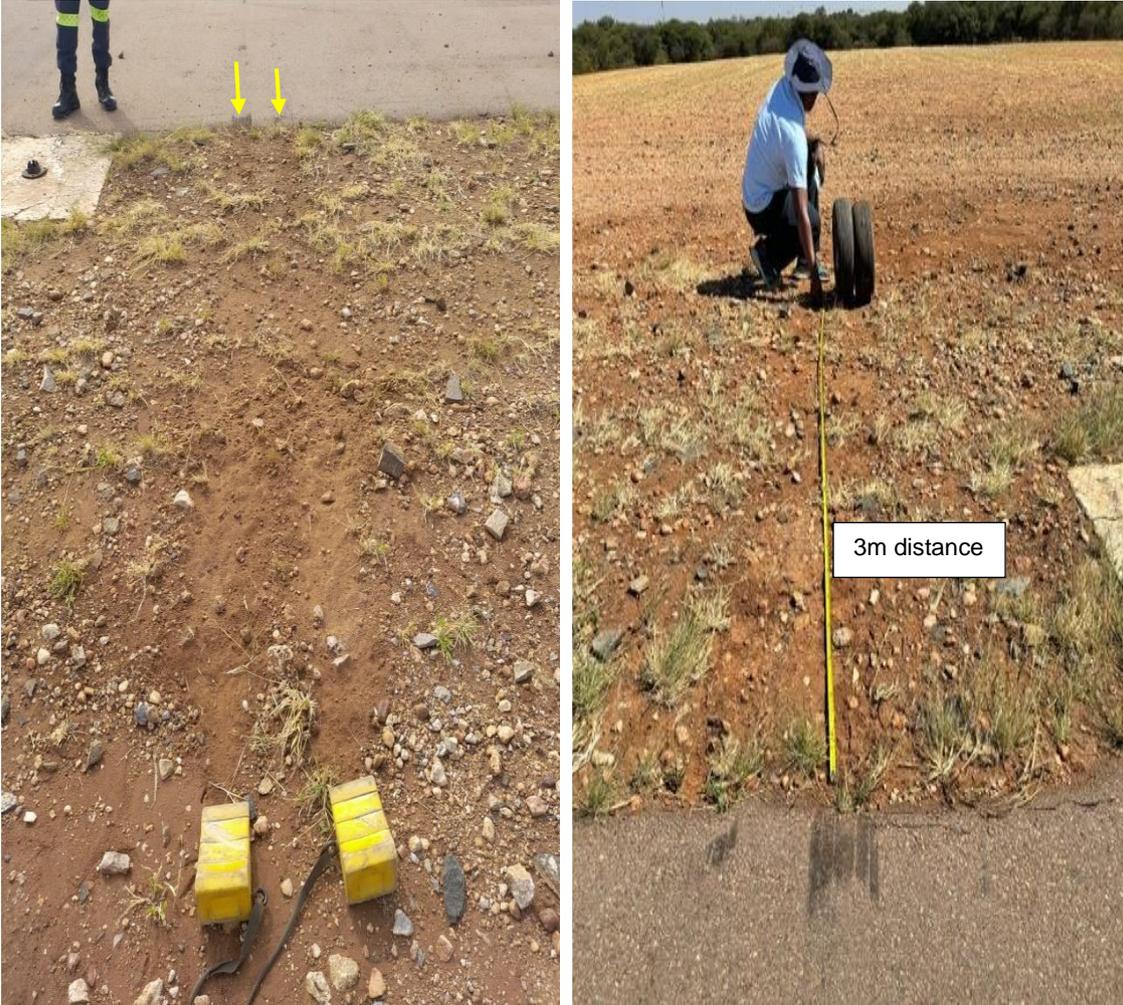
Figures 15 and 16: The left gear main wheels touchdown point marked with the wheel chocks (left picture). The measured 3m distance between the touchdown point and the runway threshold edge (right picture).

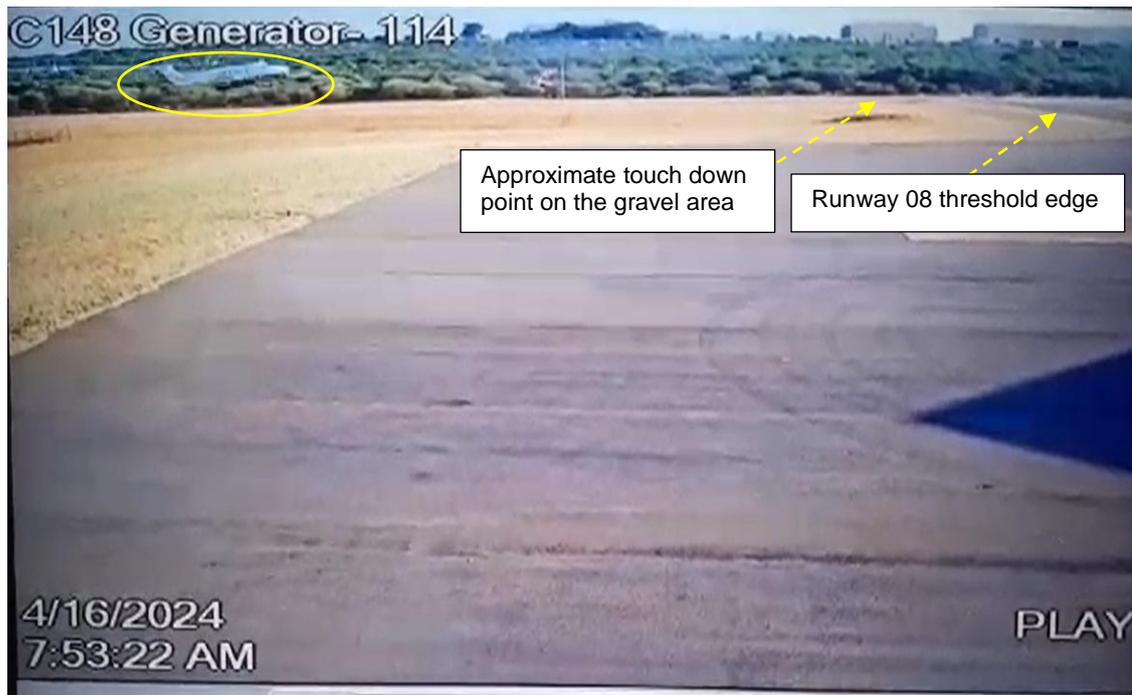
Figure 17: A still picture from a CCTV footage shows the aircraft attitude before touchdown on the gravel area, short of the threshold of Runway 08.

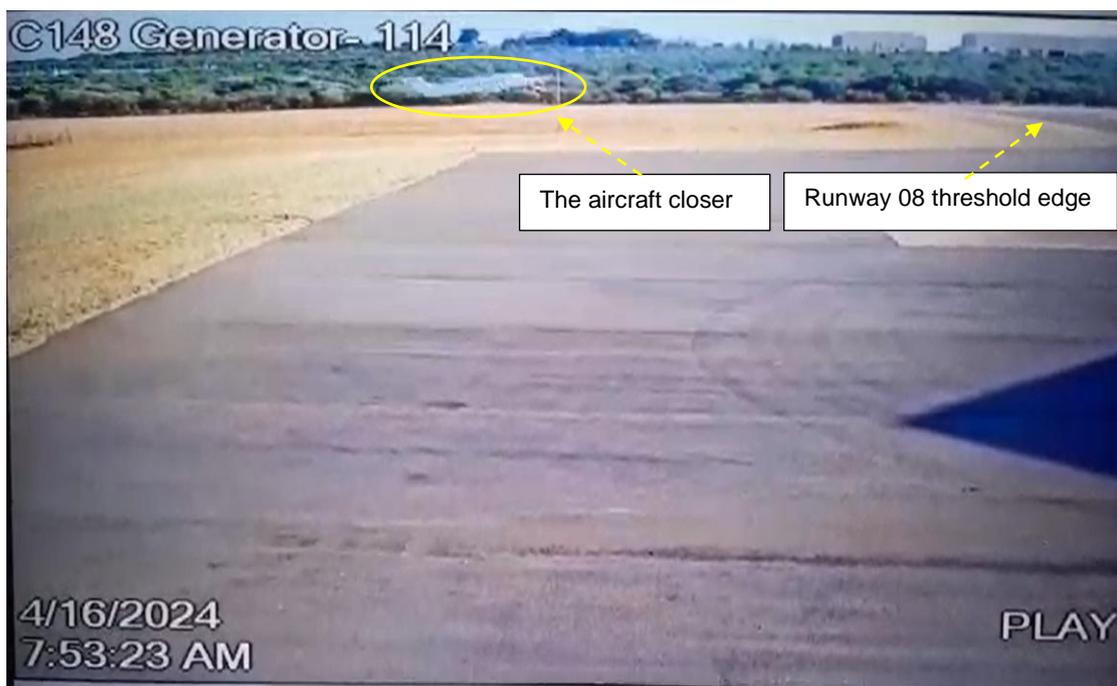
Figure 18: Another still picture from a CCTV footage that shows the aircraft attitude before touchdown on the gravel area, short of Runway 08 threshold.

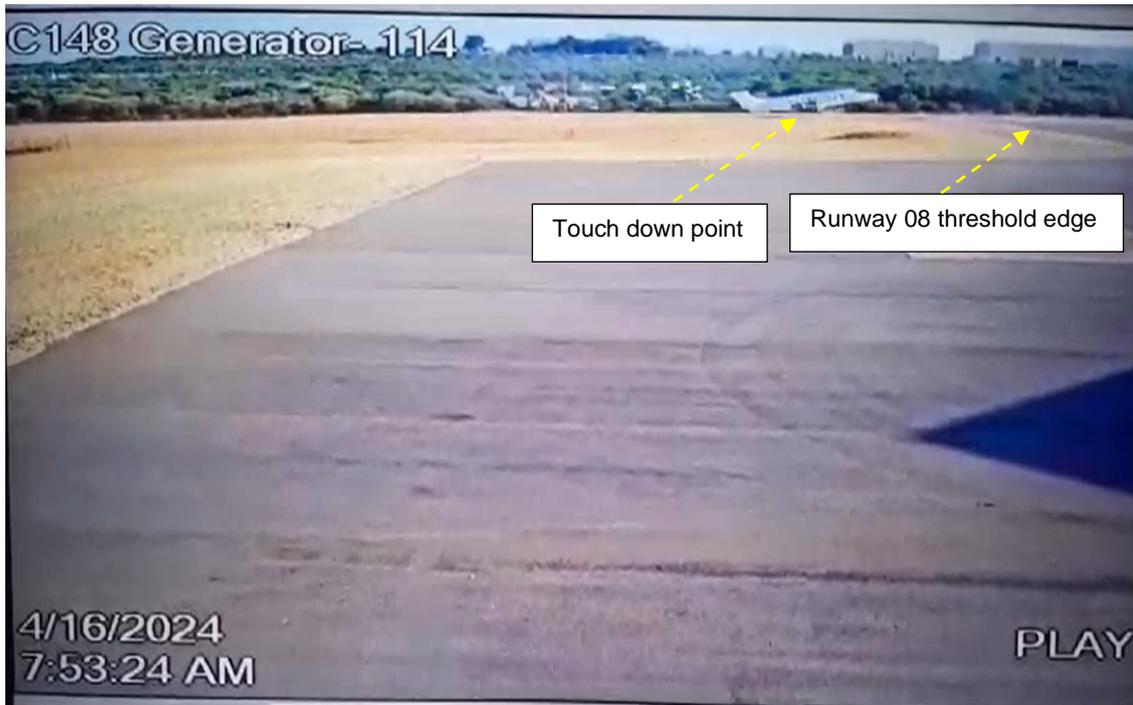
Figure 19: The CCTV footage shows the aircraft during touchdown on the gravel area.
