**LIMITED OCCURRENCE INVESTIGATION REPORT – FINAL**

<b>Reference Number</b>	CA18/3/2/1448						
<b>Classification</b>	Serious Incident	<b>Date</b>	22 April 2024			<b>Time</b>	0500Z
<b>Type of Operation</b>	Private (Part 94)						
<b>Location</b>							
Place of Departure	New Tempe Aerodrome (FATP), Free State Province		Place of Intended Landing	Springs Aerodrome (FASI) Gauteng Province			
Place of Occurrence	On a gravel road in a private farm at Brandfort, north-east of New Tempe Aerodrome (FATP)						
GPS Co-ordinates	Latitude	28° 44' 49"S	Longitude	026°22'18"E	Elevation	4 450ft	
<b>Aircraft Information</b>							
Registration	ZU-DXZ						
Make; Model; S/N	Shadow Lite CC, J160 (Serial Number: 026)						
Damage to Aircraft	None			Total Aircraft Hours	2 686.10		
<b>Pilot-in-command</b>							
Licence Type	Commercial Pilot Licence (CPL)		Gender	Male		Age	40
Licence Valid	Yes	Total Hours	3 624		Total Hours on Type	74.0	
Total Hours 30 Days	0.6		Total Flying on Type Past 90 Days	0.6

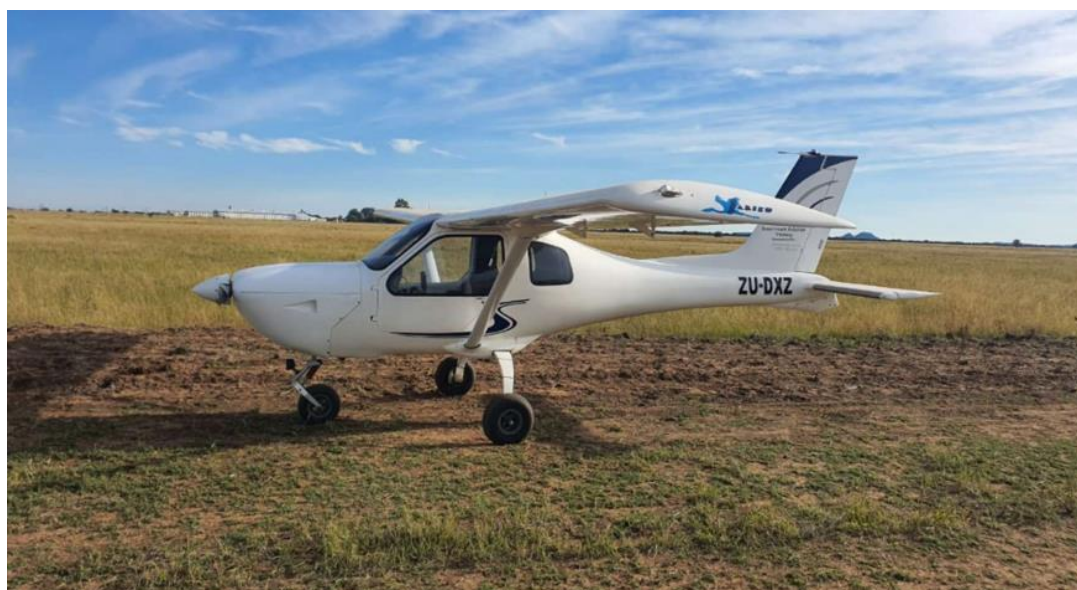
**Figure 2:** The aircraft as it came to a stop after the forced landing on a farm. (Source: Pilot)

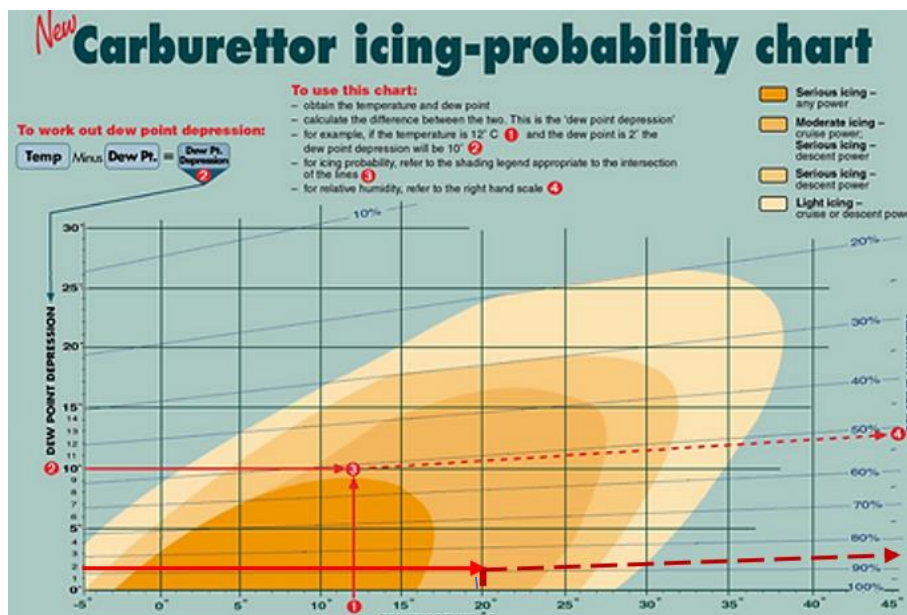
**Figure 3:** The carburettor icing probability chart calculation.

According to the carburettor icing chart calculations, the temperature was 20°C and the dew point was 19°C; therefore, the dew point depression was 1°C. When plotting data on the carburettor icing chart, the relative humidity was calculated at approximately 92%, with moderate icing conditions on cruise and serious icing conditions on descent. When the pilot was asked if he applied carburettor heat after experiencing the engine power loss before it stopped, he stated that he did not as there

was no visible moisture in the area and that he thought the carburettor ice would be an unlikely problem.
