**LIMITED OCCURRENCE INVESTIGATION REPORT – FINAL**

<b>Reference Number</b>	CA18/3/2/1450						
<b>Classification</b>	Serious Incident	<b>Date</b>	10 May 2024	<b>Time</b>	0735Z		
<b>Type of Operation</b>	Private (Part 94)						
<b>Location</b>							
<b>Place of Departure</b>	Kroonstad Aerodrome (FAKS), Free State Province		<b>Place of Intended Landing</b>		Bram Fisher Airport (FABL), Free State Province		
<b>Place of Occurrence</b>	On the N1 Highway, approximately 12 nautical miles (nm) south-west of Kroonstad Aerodrome FAKS						
<b>GPS Co-ordinates</b>	<b>Latitude</b>	27° 41'16.39" S	<b>Longitude</b>	027° 14'26.97" E	<b>Elevation</b>	4534 feet	
<b>Aircraft Information</b>							
<b>Registration</b>	ZS-BGL						
<b>Make; Model; S/N</b>	De Haviland; DH-82A Tiger Moth II (Serial Number: T7852)						
<b>Damage to Aircraft</b>	None			<b>Total Aircraft Hours</b>	4 957.9		
<b>Pilot-in-command</b>							
<b>Licence Type</b>	Airline Transport Pilot Licence (ATPL)		<b>Gender</b>	Male	<b>Age</b>	67

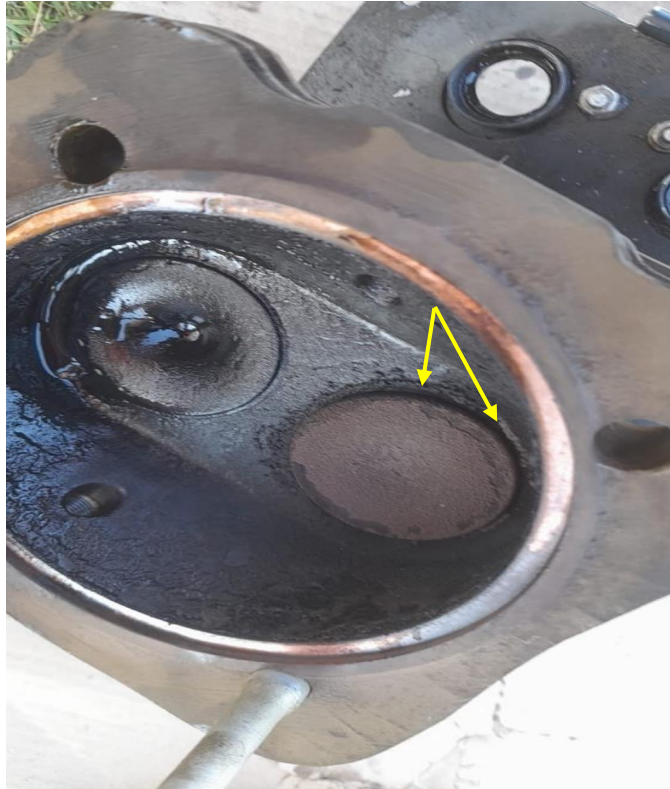
The aircraft was recovered to the approved person's (AP) facility at Rand Airport (FAGM) in Gauteng province where the engine was subjected to a teardown examination. The upper spark plugs and rocker box covers were removed, and the propeller was rotated by hand. Rotational continuity was established throughout the engine. Thumb compression was obtained on cylinder No. 1, 2 and 4. No compression was obtained on cylinder No. 3, which was removed for further examination. The No. 3 cylinder was intact and undamaged. The exhaust and intake valve springs were intact and oil-coated, as were the intake and exhaust valve rocker arms. The valve springs and keepers were removed. The intake valve slid out of the valve guide freely. The exhaust valve seat area exhibited carbon build-up. This is the area that maintains the airtightness of the combustion chamber and it could not seal properly, thus, had resulted in poor compression in the No. 3 cylinder during the compression stroke which led to the engine power loss.

**Figure 3:** The partially opened No. 3-cylinder exhaust valve. (Source: Operator)

6. The Certificate of Release to Service (CRS) was issued on 10 November 2023 at 4950.4 airframe hours with an expiry date of 9 November 2024 or at 5050.4 airframe hours, whichever comes first. The aircraft accrued 7.54 hours after the annual inspection.
7. The aircraft was maintained by an approved person (AP) and had an Approved Person Certificate that was issued by the Regulator (SACAA) on 27 June 2020 with an expiry date of 26 June 2024.
8. The engine power loss was due to the No. 3 cylinder exhaust valve which did not seal properly because of carbon build up in the valve seat, resulting in poor compression.

Engine power loss due to poor compression in the No.3 cylinder which was caused by the exhaust valve that did not seal properly due to carbon build up in the valve seat; this consequently led to poor compression and a successful forced landing on the N1 Highway.

Probable gradual build-up of lead Oxy Bromide which is from tetra-ethyl lead added to Avgas 100LL fuel, as well as operating the engine at low power settings (to cool off).
