**LIMITED OCCURRENCE INVESTIGATION REPORT – FINAL**

<b>Reference Number</b>	CA18/3/2/1451						
<b>Classification</b>	Serious Incident	<b>Date</b>	22 May 2024	<b>Time</b>	0840Z		
<b>Type of Operation</b>	Training (Part 141)						
<b>Location</b>							
<b>Place of Departure</b>	Ermelo Aerodrome (FAEO), Mpumalanga Province		<b>Place of Intended Landing</b>	Ermelo Aerodrome (FAEO), Mpumalanga Province			
<b>Place of Occurrence</b>	Runway 31 at Ermelo Aerodrome (FAEO), Mpumalanga Province						
<b>GPS Co-ordinates</b>	<b>Latitude</b>	26°29'42.95" S	<b>Longitude</b>	029°58'47.98" E	<b>Elevation</b>	5 795ft	
<b>Aircraft Information</b>							
<b>Registration</b>	ZS-FOW						
<b>Make; Model; S/N</b>	Piper Aircraft Corporation; PA-28-235 (Serial Number: 28-11150)						
<b>Damage to Aircraft</b>	Minor		<b>Total Airframe Hours</b>	4 328.2			
<b>Pilot-in-command</b>							
<b>Licence Type</b>	Student Pilot Licence (SPL)		<b>Gender</b>	Male		<b>Age</b>	42
<b>Licence Valid</b>	Yes	<b>Total Hours</b>	49.6		<b>Total Hours on Type</b>	17.7

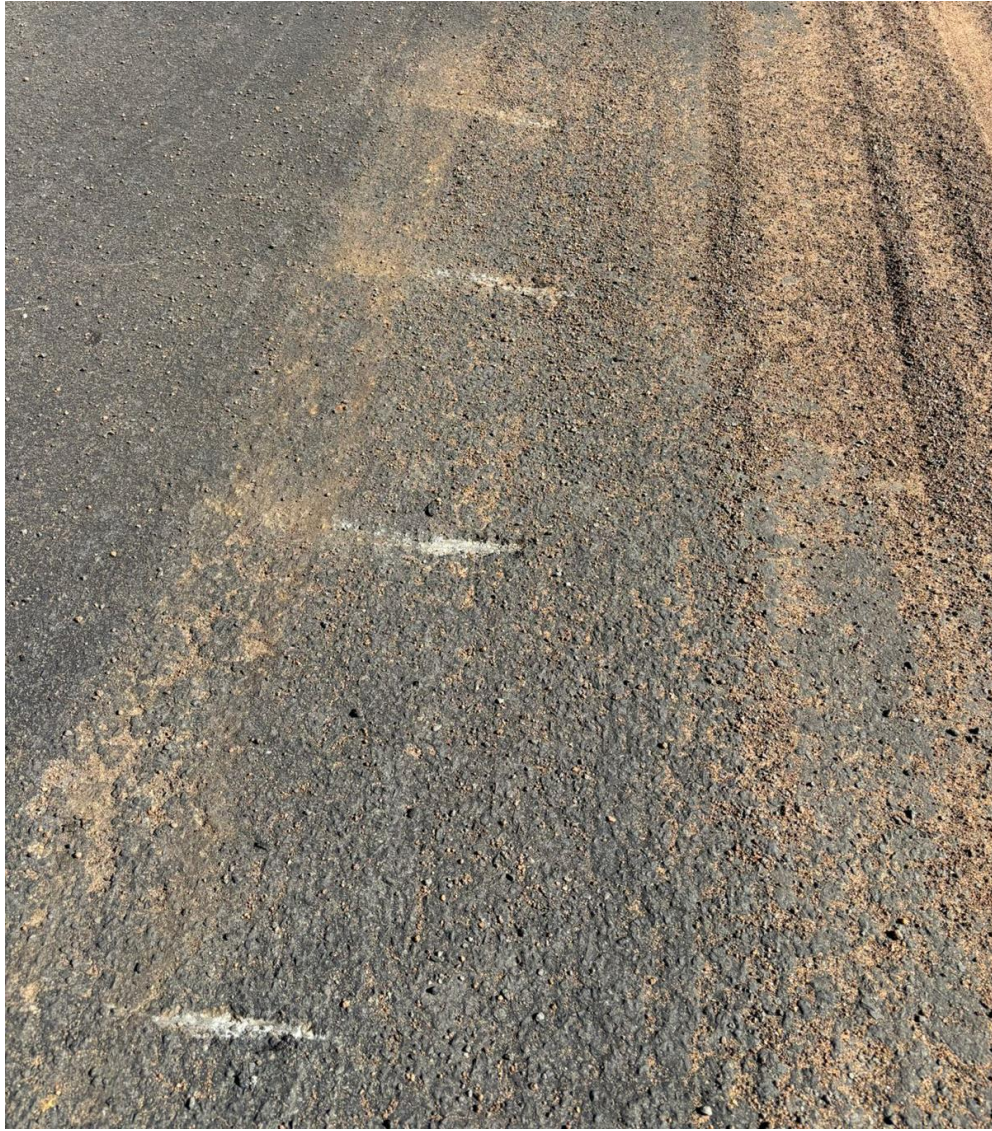
**Figure 2:** Propeller strike marks on the runway. (Source Pilot)

3.	<u>Aerodrome</u>
3.1	FAEO is a licensed aerodrome. The student pilot elected to use Runway 31.
4.	<u>Approved Training Organisation (ATO)</u>
4.1	The ATO had an operational certificate that was issued by the Regulator (SACAA) on 27 January 2022 with an expiry date of 30 November 2027.
<b>Probable Cause</b>	
The student pilot approached the runway with a tailwind, which resulted in a higher ground speed, and the aircraft porpoised as he attempted to land on the runway. The propeller blade tips struck the runway surface as the aircraft was in a nose-low attitude.	
<b>Contributing Factors</b>

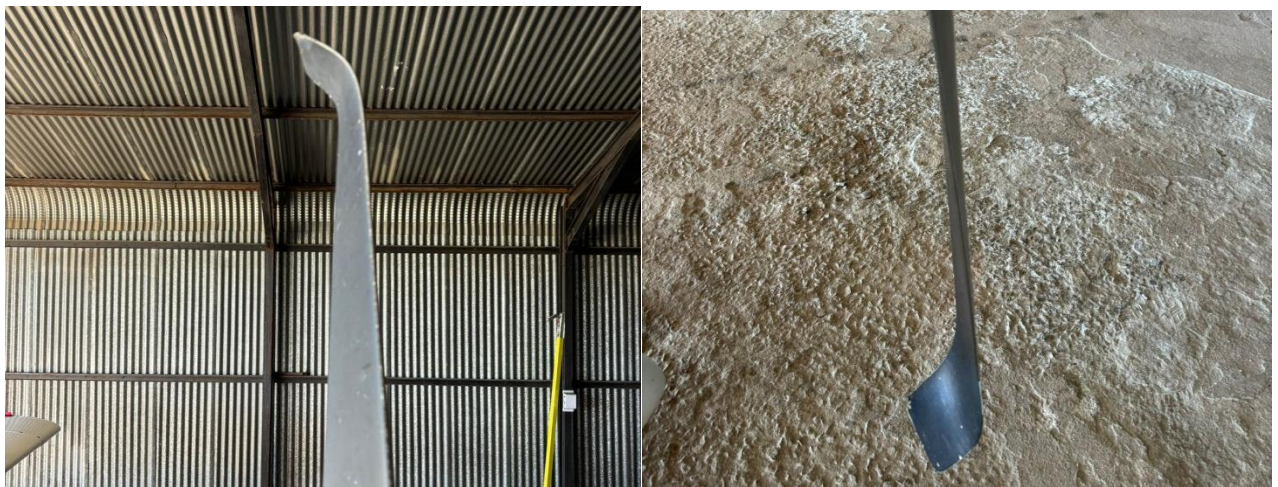
The aircraft sustained minor damage to the two propeller blades. No person was injured during the serious incident.

**Figure 3:** The propeller blade tips with bent signatures. (Source Pilot)
