LIMITED OCCURRENCE INVESTIGATION REPORT – FINAL

Reference Number	CA18/3/2/1452						
Classification	Serious Incident	Date	22 June 2024		Time	0652Z	
Type of Operation	Private (Part 94)						
Location							
Place of Departure	Zandspruit Aero Estate Private Airstrip in Hoedspruit, Limpopo Province			Place of Intended Landing	Zandspruit Aero Estate Private Airstrip in Hoedspruit, Limpopo Province		
Place of Occurrence	Runway 35 at Zandspruit Aero Estate in Hoedspruit, Limpopo Province						
GPS Co-ordinates	Latitude	24°22'23" S	Longitude	030°55'39" E	Elevation	1 679 ft	
Aircraft Information							
Registration	ZU-IJC						
Make; Model; S/N	Kitplanes for Africa; KFA Bushbaby (Serial Number: 32)						
Damage to Aircraft	Minor			Total Aircraft Hours	401.1		
Pilot-in-command							
Licence Type	National Pilot Licence (NPL)		Gender	Male		Age	40
Licence Valid	Yes	Total Hours	80.5		Total Hours on Type	26.4	
Total Hours 30 Days	1.0		Total Flying on Type Past 90 Days	5.6

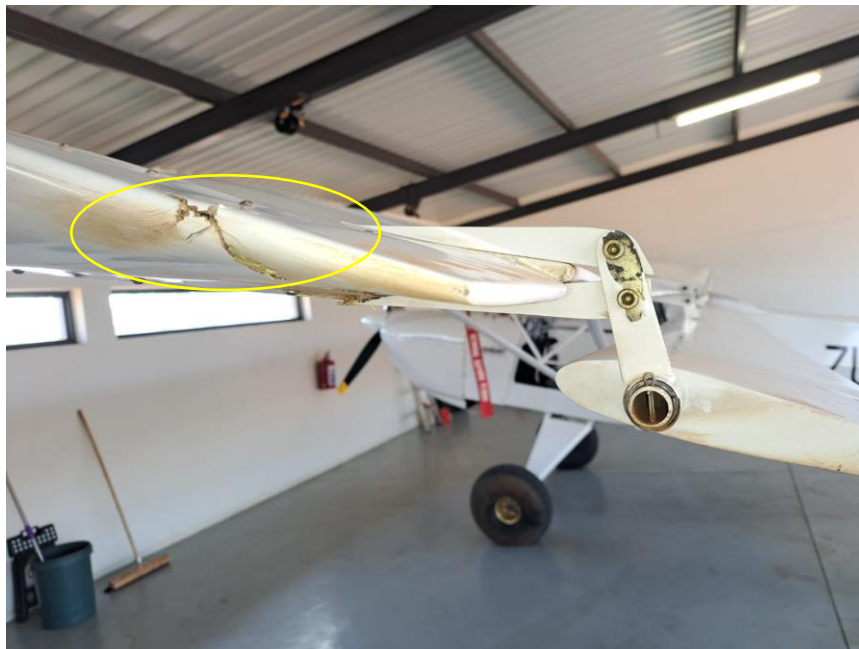
Figure 2: The aircraft after it was recovered to the hangar at the airstrip. The yellow circle shows the damaged left-wing tip fairing. (Source: Pilot)

7. The weather was not a factor to this serious incident.
8. The pilot landed the aircraft, and during the ground roll, he lost directional control and the aircraft ground looped.

Failure to compensate with the right rudder during the landing roll on Runway 35 resulted in the pilot losing directional control of the aircraft which veered off to the left; consequently, the aircraft ground looped and the left-wing tip impacted the runway.
