AIRCRAFT SERIOUS INCIDENT REPORT AND EXECUTIVE SUMMARY

Reference:		CA18/3/2/1454	
Aircraft Registration	ZS-OUV	Date of Incident	22 August 2024		Time of Incident	1445Z	
Type of Aircraft	Embraer ERJ-135LR		Type of Operation		Air Transport Operation, Passenger (Part 121)		
Pilot-in-command Licence Type	Airline Transport Pilot Licence		Age	31	Licence Valid	Yes	
Pilot-in-command Flying Experience	Total Flying Hours		4 182.3	Hours on Type	1 257.8		
Last Point of Departure	O. R. Tambo International Aerodrome (FAOR), Gauteng Province						
Next Point of Intended Landing	Sishen Airport (FASS), Northern Cape Province						
Damage to Aircraft	None						
Location of the incident site with reference to easily defined geographical points (GPS readings if possible)							
Abeam Potchefstroom during the climb phase whilst passing flight level 245 (GPS position 26° 51'63" South 027°2 5'23" East)							
Meteorological Information	Wind direction: 280°/2kts; Temperature: 26°C; Dew point: 15°C; CAVOK

Synopsis

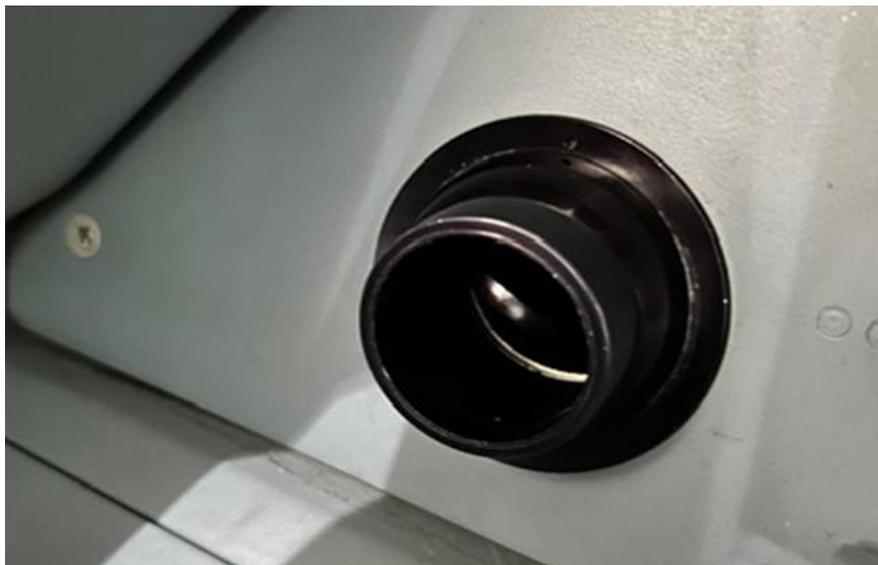
1.1.2. The captain, who was the pilot flying (PF), stated that the aircraft departed from FAOR at 1354Z. Whilst overhead Potchefstroom in North West province and climbing through 24 500 feet (ft) above mean sea level (AMSL) to the intended 33 000ft as per the flight plan, the crew noticed a burning smell in the cockpit and, after a few minutes, observed white smoke emanating from the Number 1 gasper vent.

Figure 1: The Embraer 135LR gasper vent. (Source: Operator)

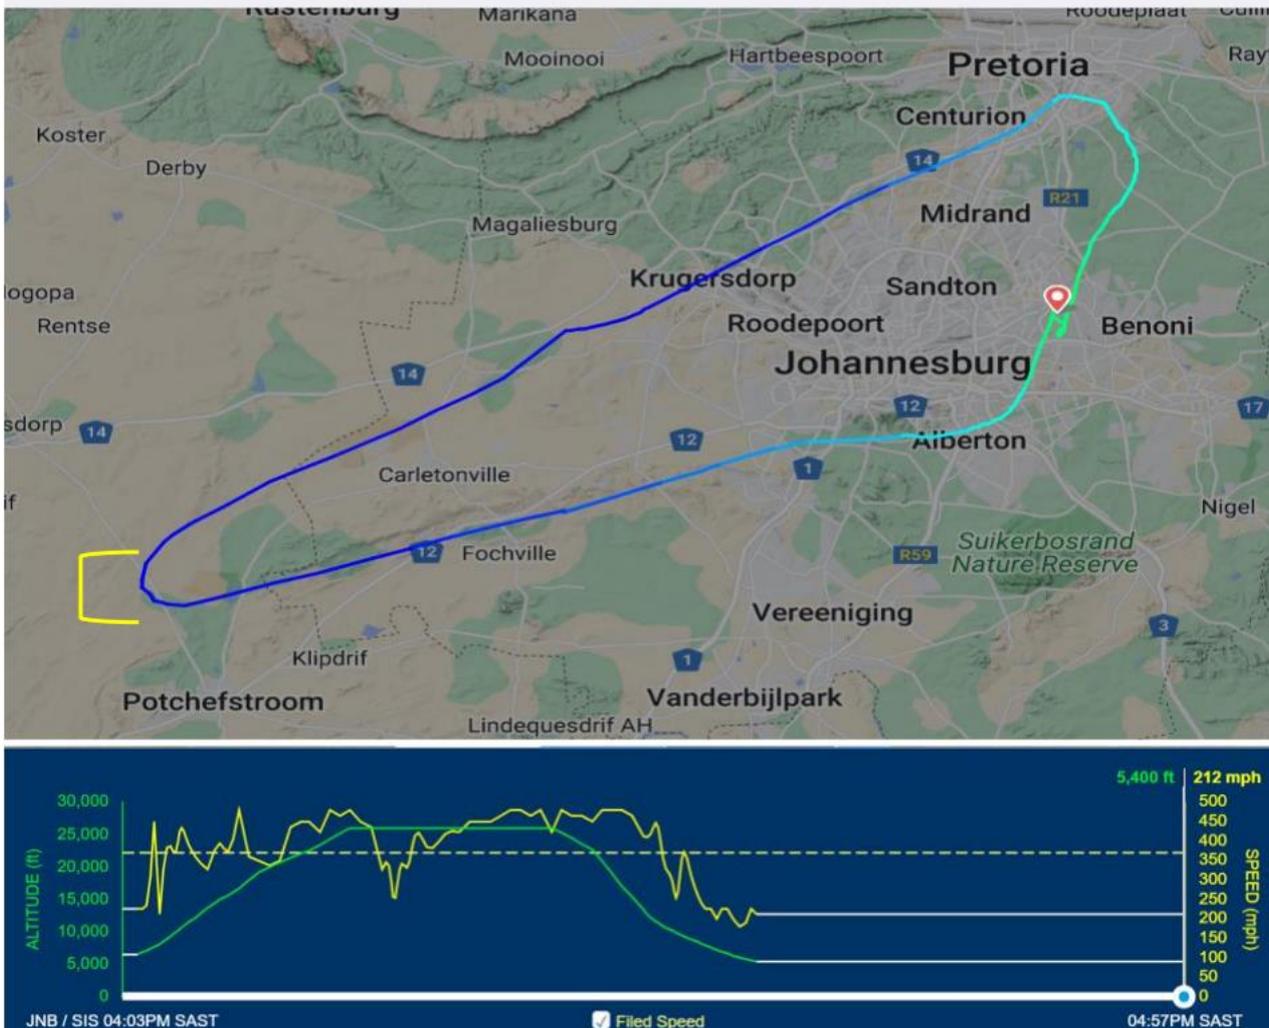
Figure 2: The aircraft’s flight path and an air turn back to FAOR. The yellow mark on the map indicates the point at which the crew initiated the air turnback. (Source: Flight Aware)
