LIMITED OCCURRENCE INVESTIGATION REPORT – FINAL

Reference Number	CA18/3/2/1455						
Classification	Serious Incident	Date	20 September 2024	Time	0930Z		
Type of Operation	Private (Part 94)						
Location							
Place of Departure	Old Bisset Farm near Tzaneen (FATZ), Limpopo Province		Place of Intended Landing	Old Bisset Farm near Tzaneen (FATZ), Limpopo Province			
Place of Occurrence	Tzaneen Dam shore at 23°50'9.34" South 030°8'8.52" East co-ordinates, at an elevation of 2 537 ft						
GPS Co-ordinates	Latitude	23° 50' 9.34" S	Longitude	030° 8' 8.52" E	Elevation	2 537 ft	
Aircraft Information							
Registration	ZU-CLX						
Make; Model; S/N	Solo Wings; Windlass Aquilla; (S/N: WA 919)						
Damage to Aircraft	None		Total Aircraft Hours	495.5			
Pilot-in-command							
Licence Type	National Pilot Licence (NPL)		Gender	Male	Age	31	
Licence Valid	Yes	Total Hours	472.7		Total Hours on Type	424.2	
Total Hours 30 days	5.4		Total Flying on Type Past 90 days	16.3

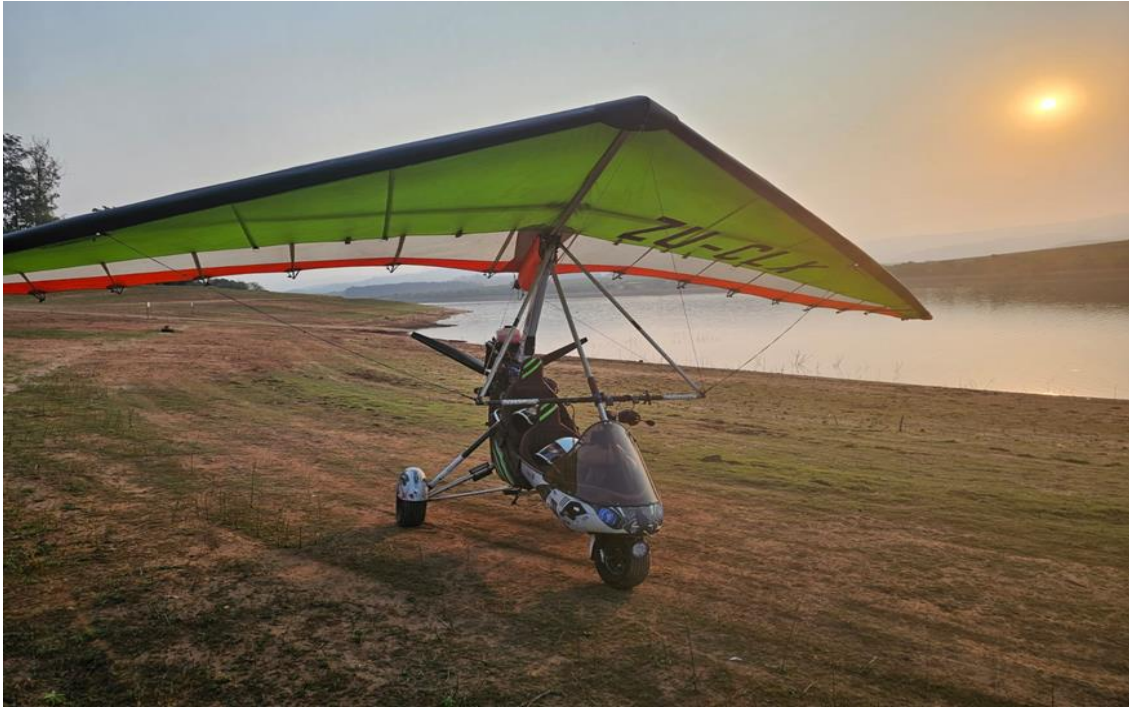
The pilot reported that he conducted pre-flight and run-up checks. The engine performance was normal with all the indications in the green range with no abnormalities noted. The pilot stated that they took off at approximately 0900Z and flew in the vicinity of the Tzaneen Dam. After approximately 30 minutes into the flight at 3000 feet (ft) above ground level (AGL), the engine ran rough and stopped. The pilot stated that he checked the magnetos and attempted to restart the engine but to no avail. He then glided to an open field on the shore of the Tzaneen Dam and executed a forced landing. The aircraft was not damaged, and the occupants were not injured.

Figure 1: The aircraft after landing. (Source: Google Earth)

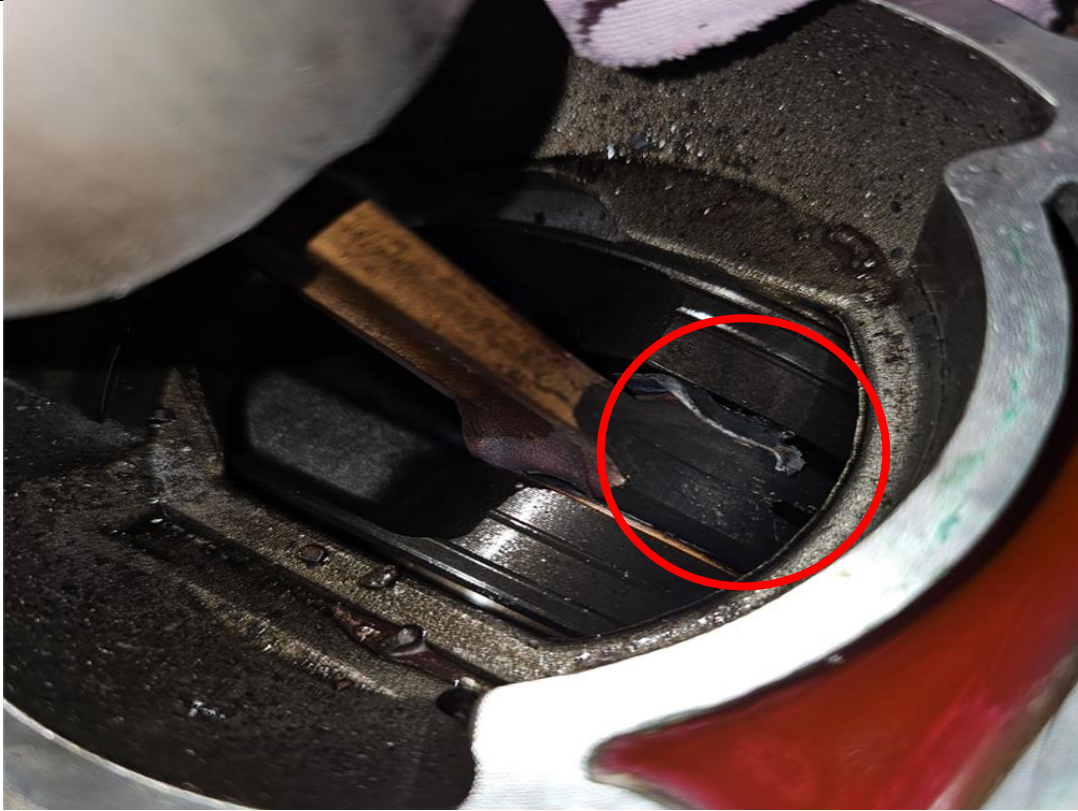
The aircraft was recovered by road to the owner's facility. The Rotax 582 is a two-stroke, two-cylinder in-line engine. During the post-flight teardown inspection which was conducted by an Approved Person (AP), it was found that the propeller resisted turning by hand. The engine components were found in good condition with oil in the reservoir. However, the No 1 cylinder big-end bearing (Figure 2) on the Rotax 582 motor was damaged. The cause of the bearing failure was attributed to inadequate engine lubrication due to an airlock or blockage in the engine's auto-lube system.

Figure 2: The red circle indicates the failed big-end bearing. (Source: Pilot)

<p>4. <u>Conclusion</u></p> <p>4.1. The aircraft experienced a contained engine failure, whereafter the pilot executed a successful forced landing. Post-incident inspection revealed that the big-end bearing of the No 1 piston cylinder had failed. The failure was attributed to inadequate lubrication likely caused by a blockage or airlock in the auto-lube system.</p>
<p>Probable Cause(s)</p>
<p>The engine failed in-flight as a result of the failure of the big-end bearing of the No.1 piston cylinder due to inadequate lubrication. The pilot subsequently performed a successful forced landing.</p>
<p>Contributing Factor(s)</p>
<p>Inadequate lubrication.</p>
<p>Safety Action(s)</p>
<p>None.</p>
<p>Safety Message and/or Safety Recommendation/s</p>
<p>None.</p>
<p>About this Report</p>
<p><i>The decision to conduct a limited investigation is based on factors including whether the cause is known and the evidence supporting the cause is clear, the level of safety benefit likely to be obtained from an investigation and that will determine the scope of an investigation. For this occurrence, a limited investigation has been conducted, and the Accident and Incident Investigations Division (AIID) has relied on the information submitted by the affected person/s and organisation/s to compile this limited report. The report has been compiled using information supplied in the initial notification, as well as from follow-up desk top enquiries to bring awareness of potential safety issues to the industry in respect of this occurrence, as well as possible safety action/s that the industry might want to consider in preventing a recurrence of a similar occurrence.</i></p> <p><i>All times given in this report are Co-ordinated Universal Time (UTC) and will be denoted by (Z). South African Standard Time is UTC plus 2 hours.</i></p>
