LIMITED OCCURRENCE INVESTIGATION REPORT – FINAL

| Reference Number | CA18/3/2/1456 | | | | | | |
| Registration | ZS-SKX | | | | | | |
| Make; Model; S/N | Hoffmann Flugzeugbau GMBH; Dimona H36 Motor Glider (Serial Number: 3626) | | | | | | |

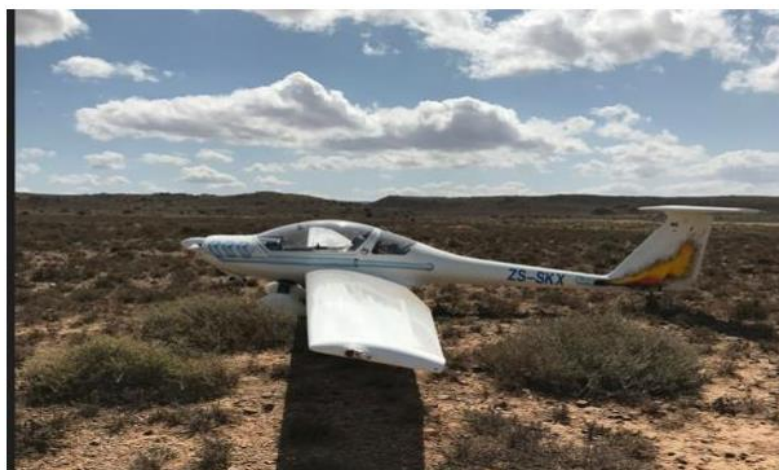
Figure 2: The motor glider at the incident site with dissipating cumulus clouds visible in the background. (Source: Pilot)

- 5) The official weather report aligns with the pilot's statement that the thermals were weak. There were no clouds over the area of the serious incident to support the formation of thermals; this, therefore, makes the weather a contributing factor as the pilot was unable to use thermals to reach his destination.

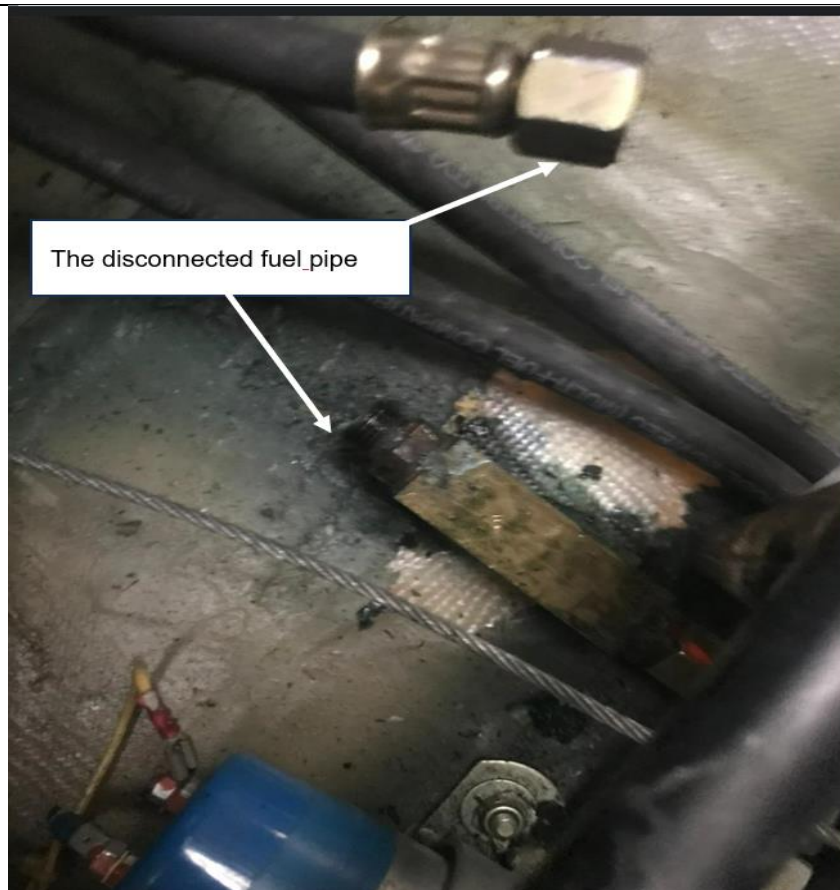
The 82-litre aluminium tank was found empty, it was removed and inspected for cracks and leaks. Some minor fuel leakage was noted on the fuel gauge sender unit on the top of the tank; the tank was later tightened. Fuel lines were inspected and chaffs, wear or cracks were not found; all were in good condition. However, one flexible fuel pipe was found disconnected from its fittings (see Figure 3). It was evident that during the last annual inspection, the flexible fuel pipe was incorrectly tightened. As a result, it became loose and, due to vibration during flights, it eventually disconnected. This disconnection caused the fuel to leak which led to the engine stopping mid-flight. According to the engineers, the flexible fuel pipe is located on the bottom part of the fuel tank and is not visible during the pre-flight checks; it could only be accessed during annual inspections when all panels are removed. The flexible fuel pipe was reconnected to its fittings and tightened as per the instructions outlined in the Motor Glider Manual. The tank was reinstalled and 10L of fuel was added to conduct a leak test; no leaks were noted. The fuel pump was run, and normal fuel pressure was observed.

Figure 3: The disconnected flexible fuel pipe. (Source: Engineers)

- 6) Although the engineers reported that the flexible fuel pipe was re-tightened during installation in the last maintenance, it is evident that the flexible fuel pipe was not tightened in accordance with the instructions outlined in the Motor Glider Manual. This meant that maintenance was not undertaken correctly as the flexible fuel pipe became loose and disconnected from its fittings due to vibration which resulted in fuel leakage and the subsequent engine failure.

| The motor glider experienced an in-flight engine stoppage due to fuel exhaustion which was caused by a loosened flexible fuel pipe that eventually disconnected due to vibration. This led to fuel leakage and the resultant engine failure. |

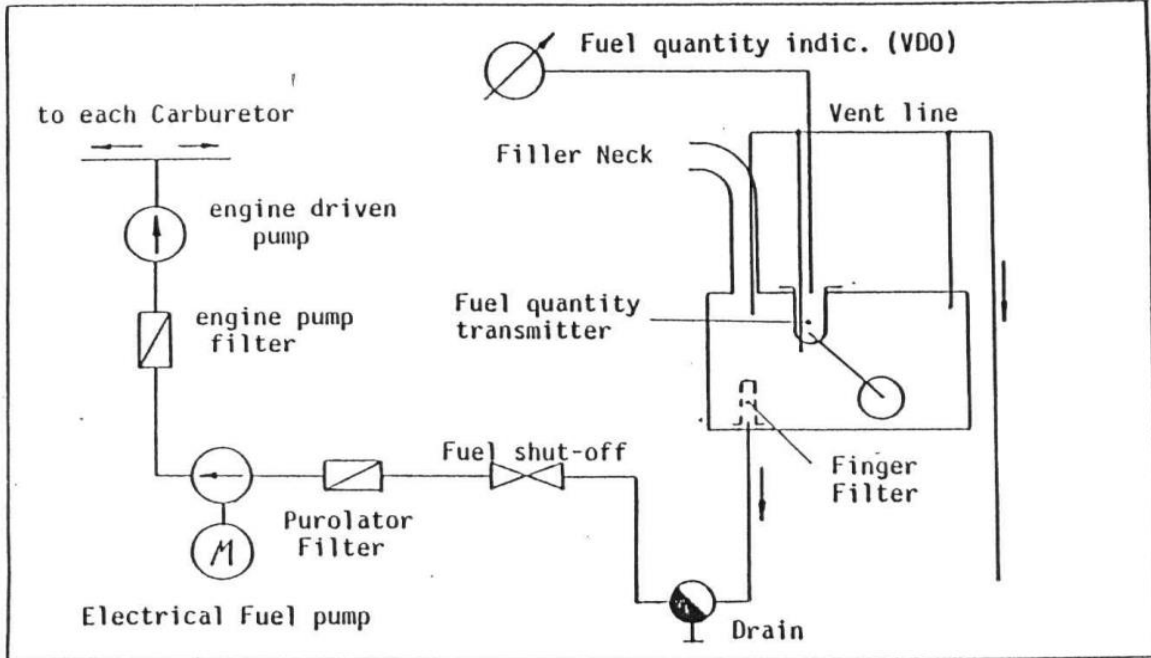
The flexible fuel pipe is located at the bottom of the fuel tank to the fitting. The fitting goes to a tee fuel drain under the motor glider and feeds the main fuel to the carburettors.

Illustration 1: Fuel system schematic.
