LIMITED OCCURRENCE INVESTIGATION REPORT – FINAL

Reference Number	CA18/3/2/1457						
Classification	Serious Incident		Date	25 October 2024		Time	0830Z
Type of Operation	Private (Part 94)						
Location							
Place of Departure	Springs Aerodrome (FASI), Gauteng Province		Place of Intended Landing	Brits Aerodrome (FABS), North West Province			
Place of Occurrence	North of N12 Highway in Benoni, Gauteng Province						
GPS Co-ordinates	Latitude	26° 9'12.64"S	Longitude	28°26'56.89"E	Elevation	5230 ft	
Aircraft Information							
Registration	ZU-BSA						
Make; Model; S/N	Shadow Lite CC; Jabiru SK (Serial Number: 167)						
Damage to Aircraft	Substantial			Total Aircraft Hours	2029.1		
Pilot-in-command							
Licence Type	Private Pilot Licence (PPL) Aeroplane		Gender	Female		Age	37
Licence Valid	Yes	Total Hours	564.6		Total Hours on Type	525.5	
Total Hours 30 Days	5.9		Total Flying on Type Past 90 Days	25			
People On-board	1+0	Injuries	0	Fatalities	0	Other (on ground)	0

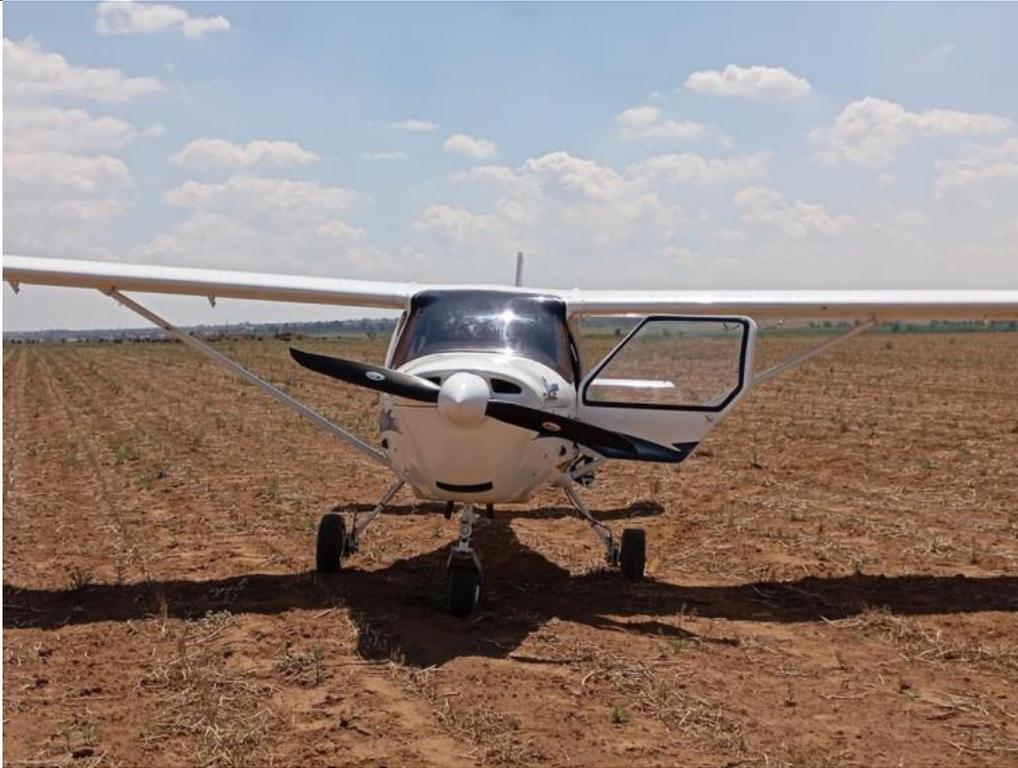
What Happened							
<p>On Friday morning, 25 October 2024, a pilot on-board a Jabiru SK aircraft with registration ZU-BSA was on a private flight from Springs Aerodrome (FASI) in Gauteng province to Brits Aerodrome (FABS) in North West province when the serious incident occurred. Visual meteorological conditions (VMC) by day prevailed at the time of the flight which was conducted under the provisions of Part 94 of the Civil Aviation Regulations (CAR) 2011 as amended.</p> <p>The pilot reported that she felt the aircraft's engine vibrate about 25 minutes into the flight. She then broadcasted a Mayday call on Traffic Information Broadcast by Aircraft (TIBA) frequency 124.8-Megahertz (MHz) and proceeded to conduct a precautionary landing on an open field next to the N12 highway near Daveyton in the East Rand, Gauteng province. During landing, the right main gear impacted a rock which damaged the wheel. After bringing the aircraft to a stop, the pilot switched off the master switch and disembarked from the aircraft unassisted and uninjured. The aircraft sustained damage to the wheel.</p>

Figure 1: The aircraft after landing on an open field.

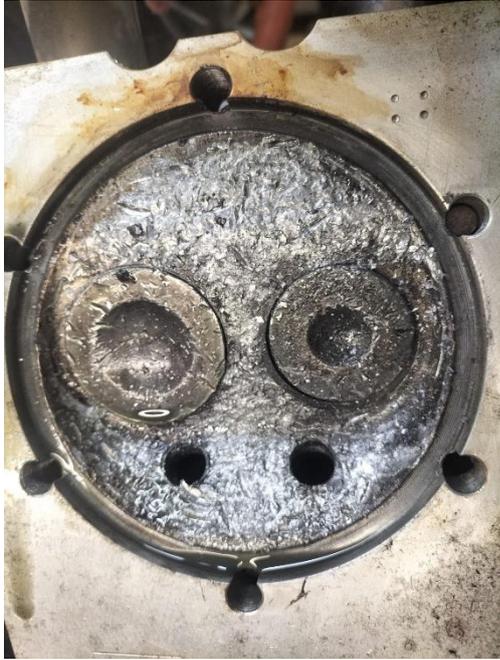
- *Cylinder No.4 Piston Completely shattered.*
- *Connecting Rod on Cylinder No. 4 completely deformed, bent and twisted (see Figure 4).*
- *Cylinder Head of Cylinder No. 4 also badly pitted from the failed Piston. Both the inlet and Exhaust Valves are still fully in tacked (see Figure 3).*

Figure 3: Damage in the top of the cylinder and the valves. **Figure 4:** Deformed piston connecting rod. (Source: Owner)

It is very clear that a complete Piston failure caused this destruction of Cylinder No. 4. and was not caused from a Valve failure as both Valves are still intact.

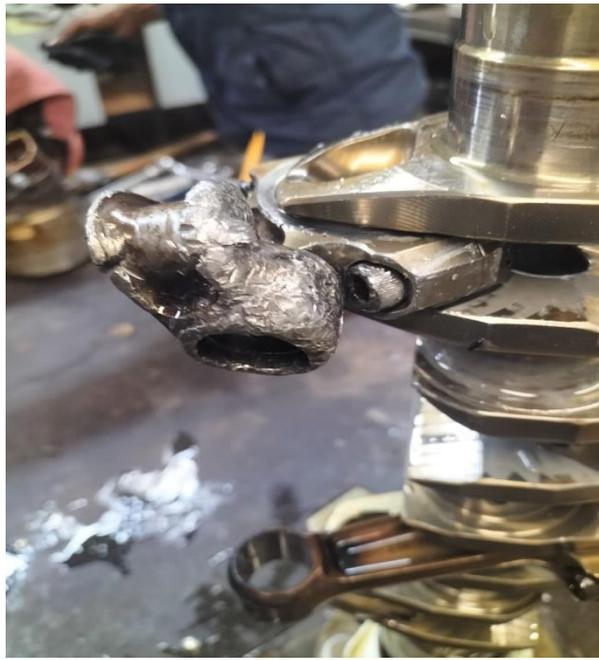
The loose Piston Pin undamaged Circlip found in the Oil Sump could have maybe led to a Piston Pin moving out of position causing the Pin to hook onto the Engine Block and broke the Piston to pieces. This also resulted to the complete deformation of the Connecting Rod. A second possibility is a cracked Piston that just failed, causing all this damage.

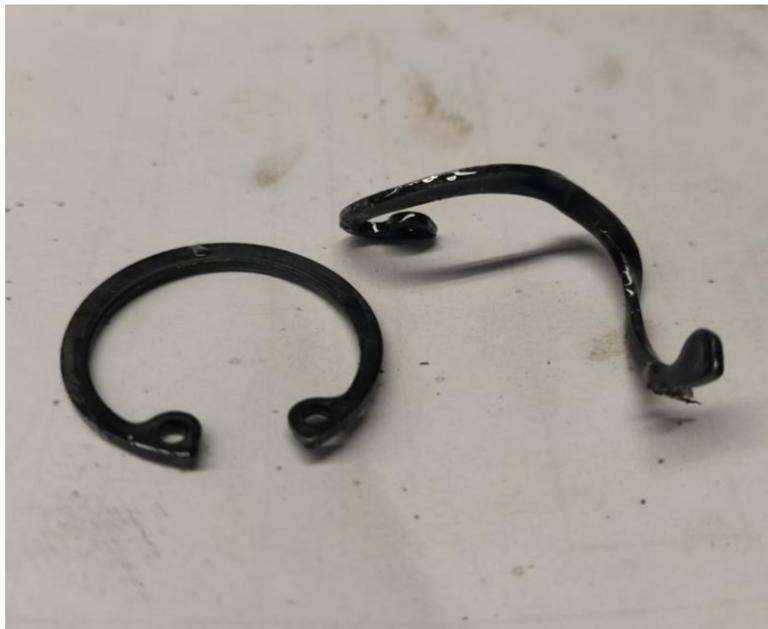
Figure 5: Piston pin un/damaged circlip. (Source: Owner)

- *Damage to the Cylinder in Figure 4 is from the failed piston.*
- *A Hand full of Aluminium particles was found in the Sump that is clearly parts of the shattered piston.*
- *A loose full Circlip that holds the Piston Pin in position is also visible between the debris in the Oil Sump (See Figure 5).*

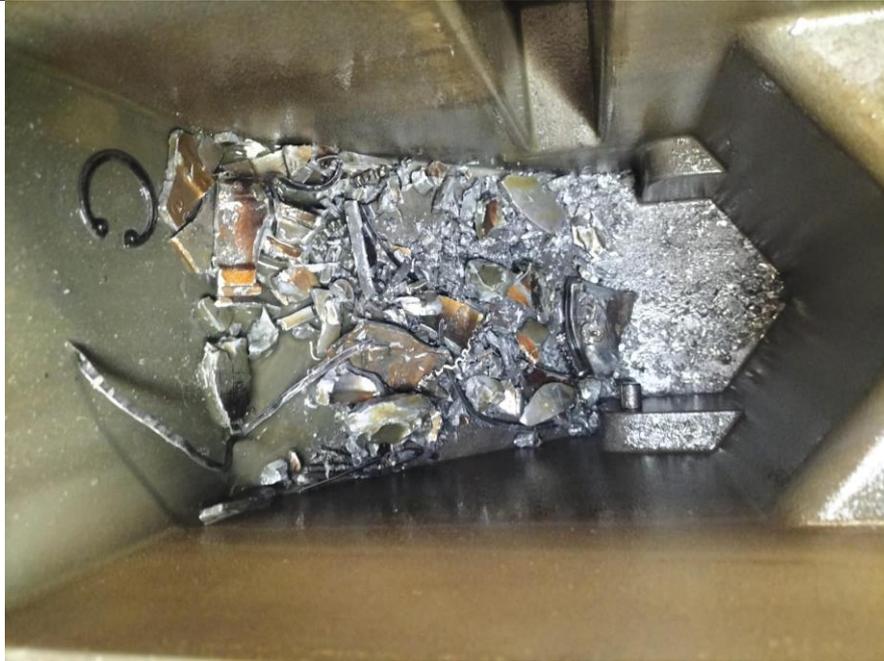
Figure 6: Piston assembly debris in the oil sump. (Source: Owner)
