LIMITED OCCURRENCE INVESTIGATION REPORT – FINAL

Reference Number		CA18/3/2/1459					
Classification		Date		Time			
Type of Operation	Private (Part 91)						
Location							
Place of Departure	Springs Airfield (FASI), Gauteng Province		Place of Intended Landing	Bethlehem Aerodrome (FABM), Free State Province			
Place of Occurrence	3.7 kilometres north-east of Reitz Airfield (FARZ), Free State Province						
GPS Co-ordinates	Latitude	27°45'32.51"S	Longitude	28°23'49.90"E	Elevation	5 275ft	
Aircraft Information							
Registration	ZS-WHV						
Make; Model; S/N	Piper Aircraft Corporation; PA-28-180 (Serial Number: 28-1019)						
Damage to Aircraft	None			Total Aircraft Hours	8165.09		
Pilot-in-command							
Licence Type	Commercial Pilot Licence (CPL)		Gender	Female	Age	21	
Licence Valid	Yes	Total Hours	367.1	Total Hours on Type	125		
Total Hours 30 Days	22.2		Total Flying on Type Past 90 Days	75.4			
People On-board	1+1	Injuries	0	Fatalities	0	Other (on the ground)	0

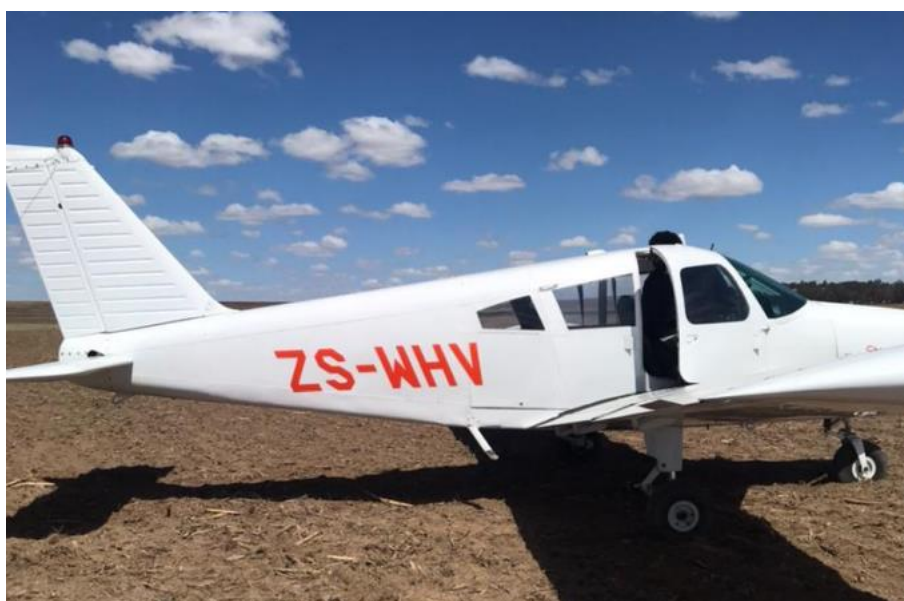
the transponder. After deducing that she would not reach Reitz Airfield (FARZ) as the aircraft could not maintain height, she decided to configure the aircraft to force land on a field approximately 3.7 km north-west of FARZ. She then turned off the master switch after she had brought the aircraft to a stop. The aircraft was not damaged; both occupants disembarked from the aircraft unassisted and unharmed.

Figure 2: The right-side view of the aircraft at the accident site. (Source: Pilot).

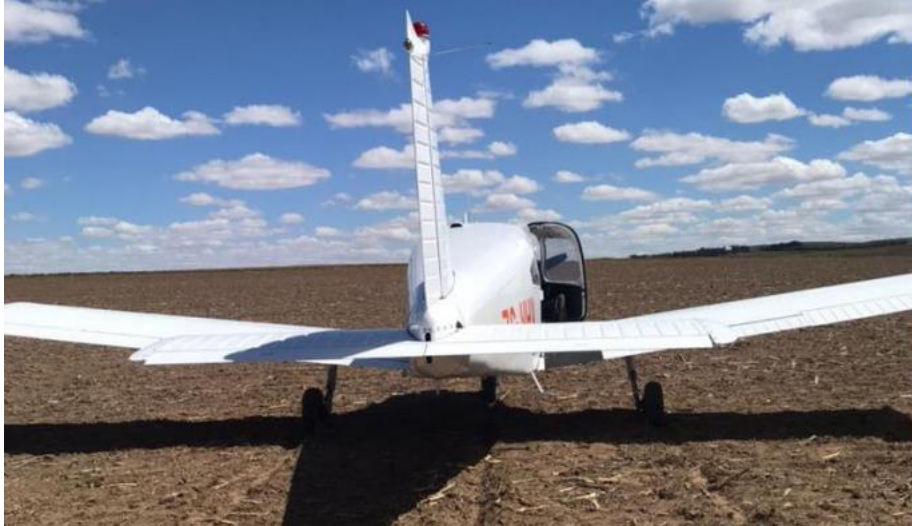
Figure 3: The rear view of the aircraft. (Source: Pilot)

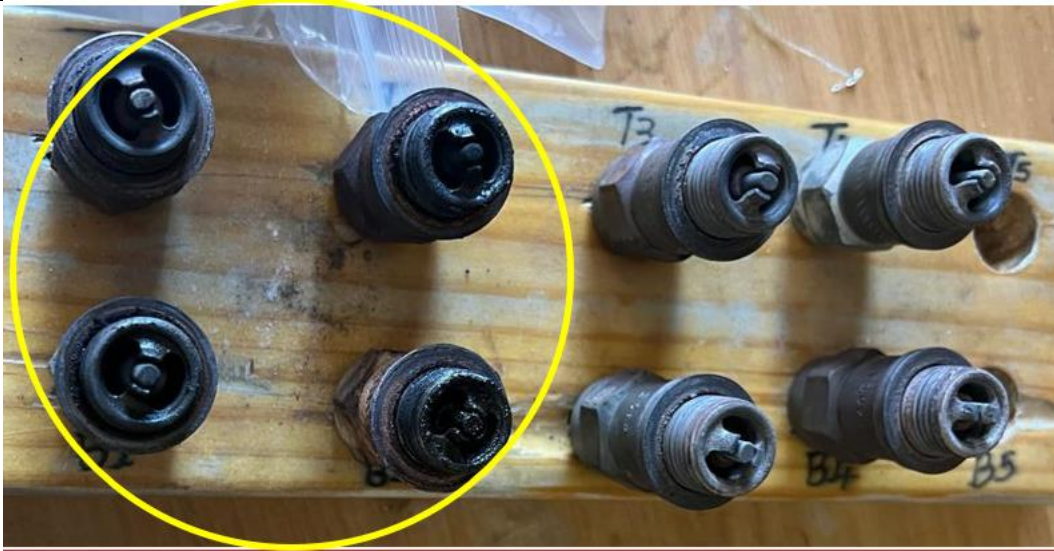
On Monday afternoon, 30 October 2024, the aircraft maintenance engineers (AMEs) recovered the aircraft to the South African Civil Aviation Authority-approved aircraft maintenance organisation (AMO) at FASI. The engineers, in the presence of the investigator, inspected the engine for damage, and found no anomalies. About 136 litres of fuel remained in the tanks; the fuel was free of contaminants. The Lycoming engine with serial number L-5582-36 was inspected as per the instructions outlined in the operator's manual. The spark plugs were removed, and four of the eight spark plugs were found contaminated with oil and carbon deposits (see Figure 4).

According to the reviewed maintenance history, the spark plugs were installed during the engine overhaul on 12 July 2021. According to the Pilot's Operating Handbook (POH), the spark plugs are on-condition items that are inspected every 100 hours. At the time of the serious incident, they had accumulated 480 hours (hrs) with four inspection intervals conducted. Figure 4 shows the eight spark plugs that were removed from the aircraft after the serious incident. Four of them were contaminated with oil and carbon deposits which reduced engine performance because they were not producing sparks, whilst the other four were in good condition and operated normally.

Figure 4: The yellow circle indicates the fouled spark plugs.

- 6) The engine was equipped with eight spark plugs, four of which were contaminated; this reduced engine performance. The other four spark plugs were in good condition. The affected spark plugs were caused by the worn-out oil control rings.

The aircraft's engine lost power due to the fouled spark plugs which were contaminated as a result of worn-out oil control rings. The pilot successfully executed a forced landing on an open field.

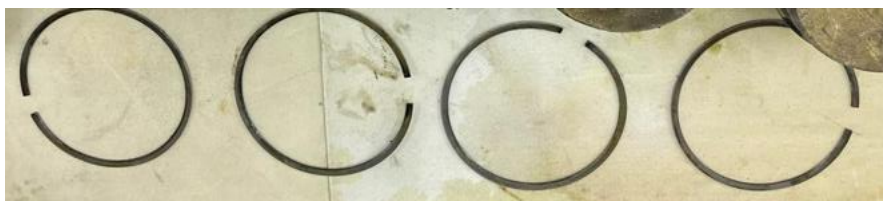
Further investigation revealed that the oil and carbon deposits on the spark plugs resulted from worn-out oil control rings (see Figure 7). According to the Lycoming Engine Overhaul Manual, the piston rings, including the oil control rings, are on-condition items which are inspected during engine overhaul. The engine is overhauled every 2000 hours. According to the maintenance records, the engine was overhauled four times, with the last overhaul conducted on 12 July 2021 at 7685.09 hours. The engine had been operated for 480 hours when the oil control rings became worn out.

During the compression test, the oil control rings were found to have lost sufficient radial tension to seal the pistons effectively. The measurements indicated that the clearance between the piston ring and the ring groove exceeded the worn-out limit of 0.006 inches. The Lycoming engine overhaul manual specifies that the clearance between the piston ring and the groove should be between 0.0015 and 0.0035 inches.

Figure 8: Worn oil control rings.

- 7) The worn-out oil control rings caused excessive oil on cylinder walls which led to the fouling of the spark plugs with oil and carbon deposits. This resulted in reduced engine performance.
