AIRCRAFT SERIOUS INCIDENT REPORT AND EXECUTIVE SUMMARY

Reference:		CA18/3/2/1460	
Aircraft Registration	ZS-ZWY	Date of Serious Incident	27 October 2024		Time of Serious Incident	1058Z	
Type of Aircraft	Boeing 737-800		Type of Operation		Air Transport Operation, Passenger (Part 121)		
Pilot-in-command Licence Type	Airline Transport Licence (ATPL)		Age	34	Licence Valid	Yes	
Pilot-in-command Flying Experience	Total Flying Hours		6 534		Hours on Type	3 400	
Last Point of Departure	Cape Town International Airport (FACT), Western Cape Province						
Next Point of Intended Landing	Lanseria International Airport (FALA), Gauteng Province						
Damage to Aircraft	Minor						
Location of the incident site with reference to easily defined geographical points (GPS readings if possible)							
Runway 07 at Lanseria International Airport (FALA) at Global Positioning System (GPS) co-ordinates determined to be 25°56'22.89" South 027°55'32.07" East, at an elevation of 4521 feet (ft)

Probable Cause

The failure was likely caused by the disintegration of the inner bearing mount due to thermal embrittlement of the base material. This embrittlement resulted from exposure to extreme heat, which was gen

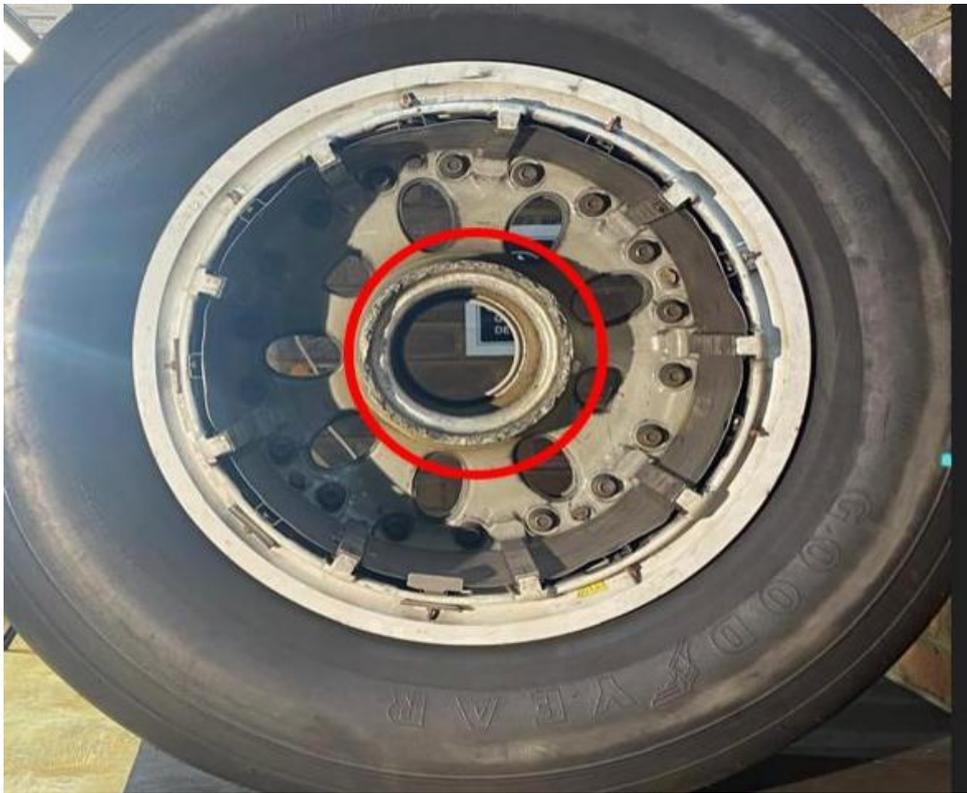
1.3.1. The Number 4 main wheel assembly sustained significant damage, specifically to the inboard hub and the inner bearing. The inboard hub exhibited structural fracturing and surface discolouration, indicative of thermal and mechanical distress. The inner bearing showed signs of overheating, material degradation, and physical damage consistent with excessive friction or possible bearing stoppage. The extent of the damage rendered both components unserviceable and necessitated their removal for further analysis.

Figure 3: The red circle highlights the area of damage.

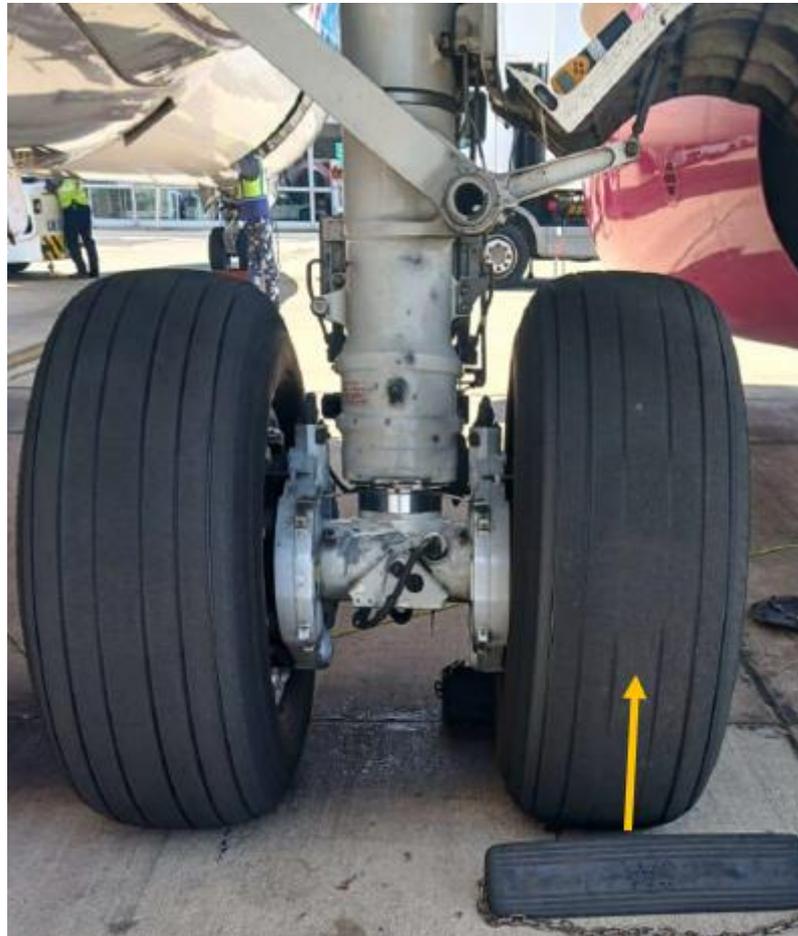
The operator's AME stated that he conducted a transit check (walk-around) after the aircraft was parked and noticed smoke emanating from the Number 4 main wheel assembly, as well as that the wheel was orientated at an angle (misaligned) in relation to the axle, which was an anomaly.

Figure 5: Vertical misalignment of the Number 4 main wheel. (Source: Operator)

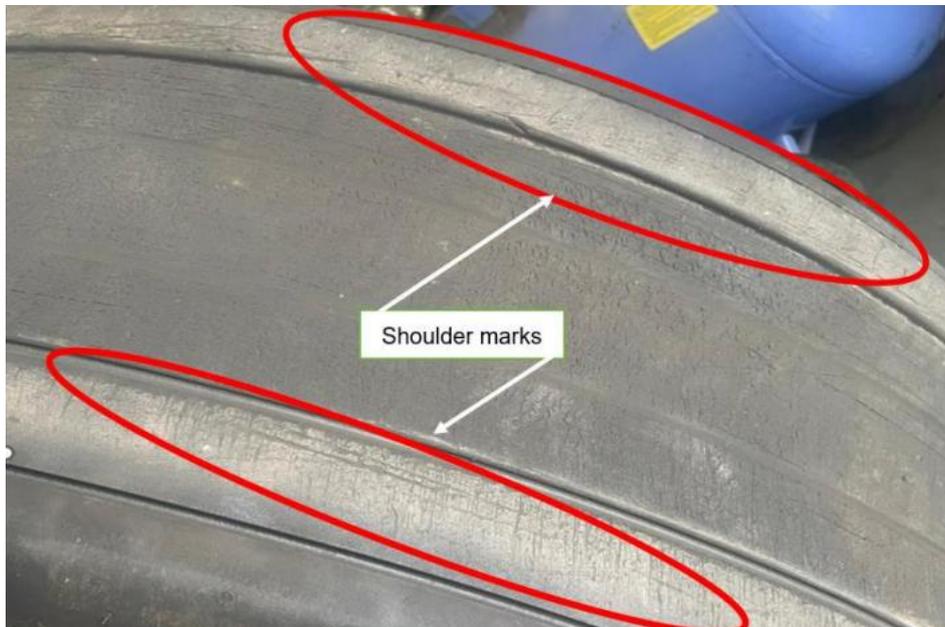
1.12.2. The Number 4 tyre exhibited visible signs of deflation, particularly along the shoulder region. The deformation pattern observed suggested that the tyre may have lost pressure prior to or during the occurrence. No obvious penetration damage or complete structural separation was noted during the initial visual inspection.

Figure 6: The marks on the Number 4 main tyre shoulder.

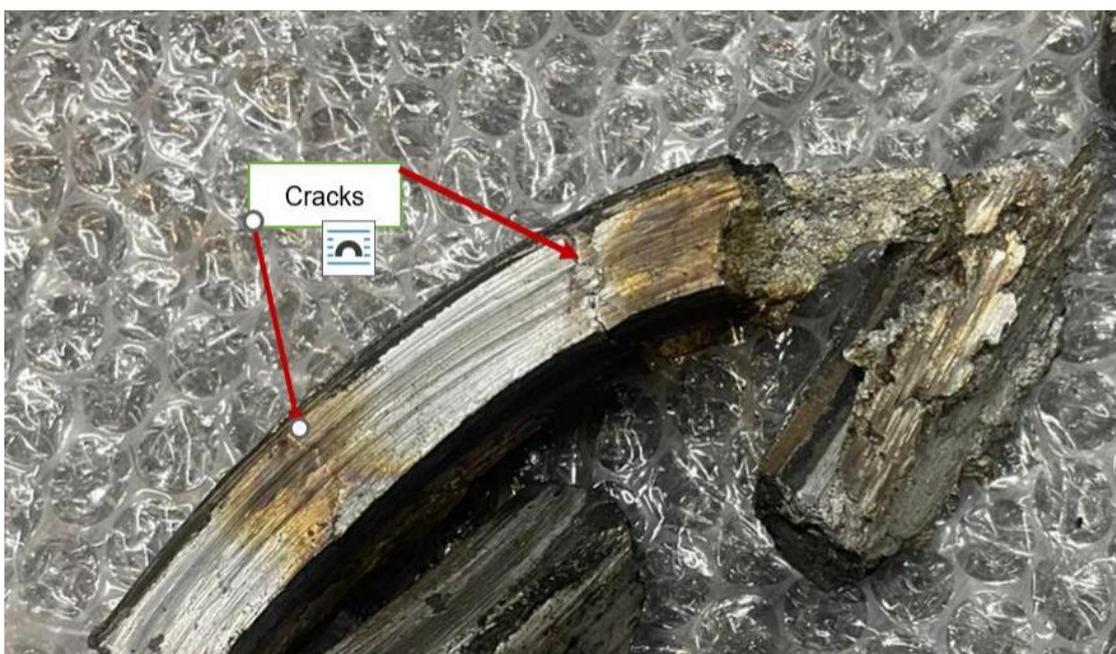
1.12.3. The fractured hub components exhibited multiple cracks as well as a distinct yellowish discolouration on several surfaces. The presence of cracks was indicative of structural failure, likely initiated or exacerbated by thermal or mechanical overstress. The yellowish discolouration was a characteristic of heat exposure and might have suggested localised overheating, possibly resulting from frictional contact or bearing stoppage.

Figure 7: The pieces of the fractured hub.

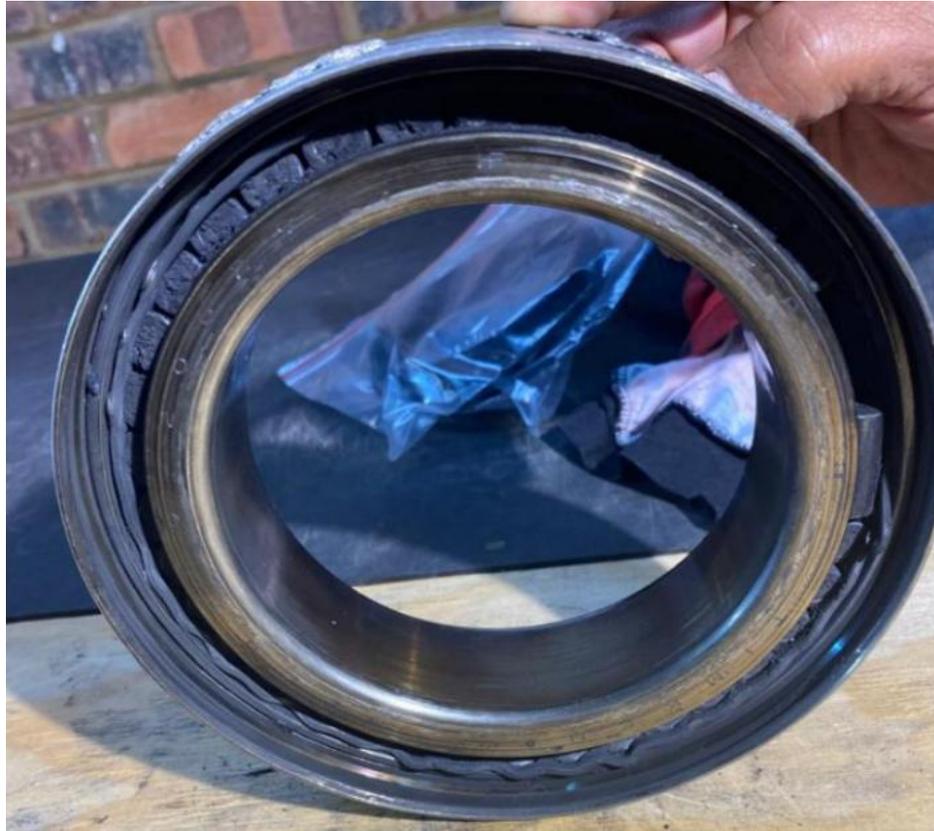
1.12.4. The Number 4 inner bearing exhibited clear indications of thermal distress, including visible discolouration and surface damage consistent with overheating. The observed discolouration suggested exposure to elevated temperatures beyond normal operating conditions, whilst the surface damage was likely indicative of material degradation such as micro-cracking, hardening or spalling. These findings were consistent with excessive friction.

Figure 8: The Number 4 inner bearing.

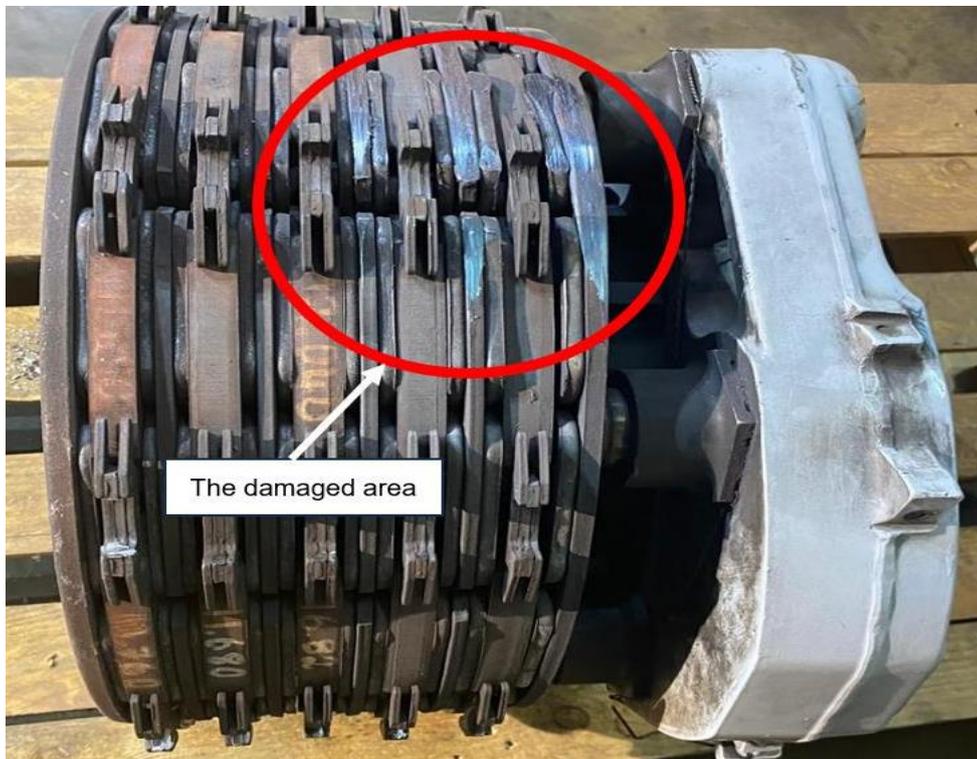
1.12.5. The main wheel assembly sustained extensive damage and was assessed as beyond economical repair. As a result, it was removed from service and scrapped in accordance with the applicable maintenance and disposal procedures. The Number 4 brake assembly, although damaged, appeared repairable. A detailed inspection and functional assessment would be required to confirm its suitability for continued service, pending compliance with the manufacturer's repair and overhaul specifications.

Figure 9: Scoring damage on the brake assembly components.

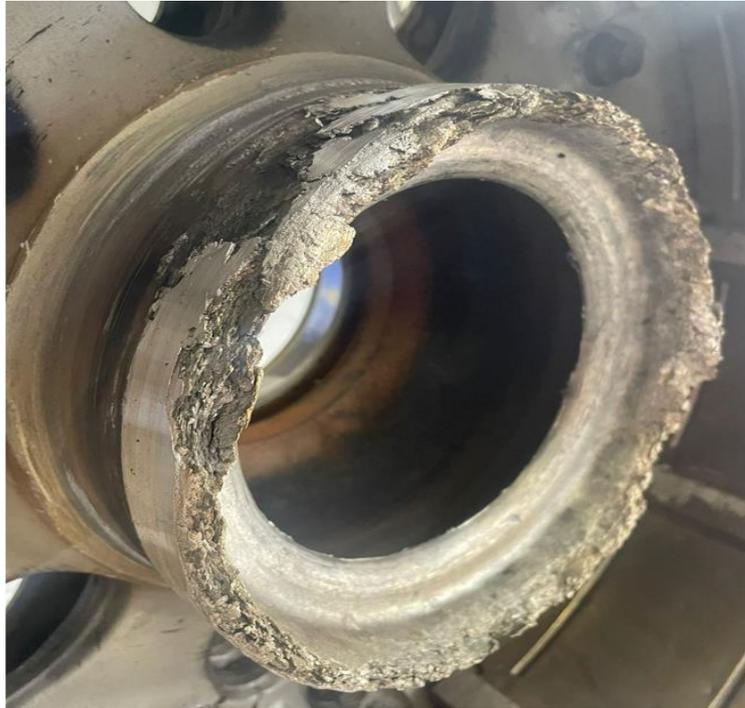
The inner bearing mount disintegrated due to thermal embrittlement of the base material caused by exposure to extreme heat. The extreme heat was caused by frictional heating brought about by bearing sleeve rotation within the wheel hub bearing bore. The sleeve rotation within the bearing bore was caused by the ceased inner wheel bearing.

Figure 10: The inner wheel half bearing mount with signs of thermal embrittlement.

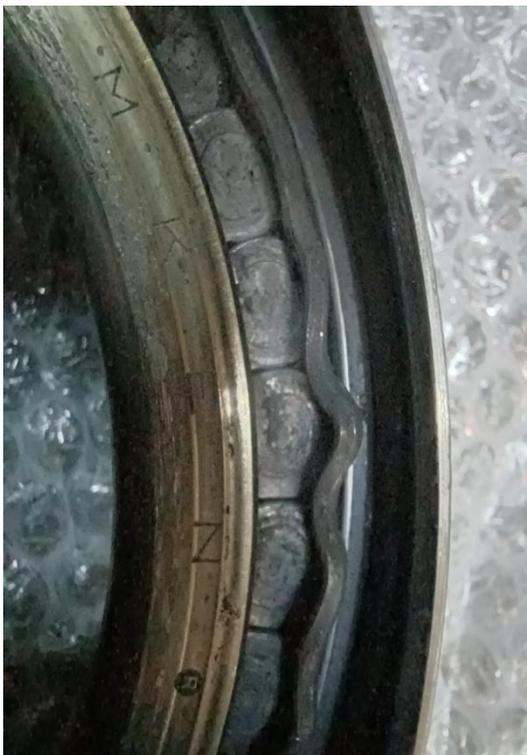
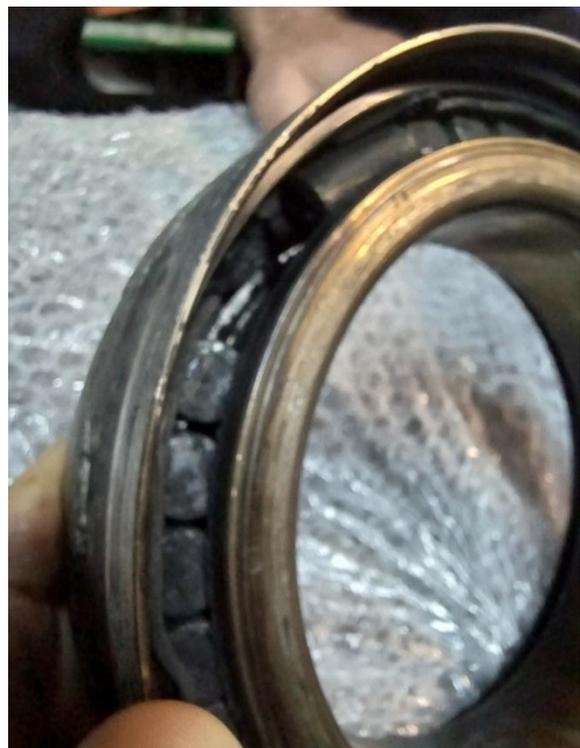
Figures 11 and 12: The ceased inboard wheel bearing.

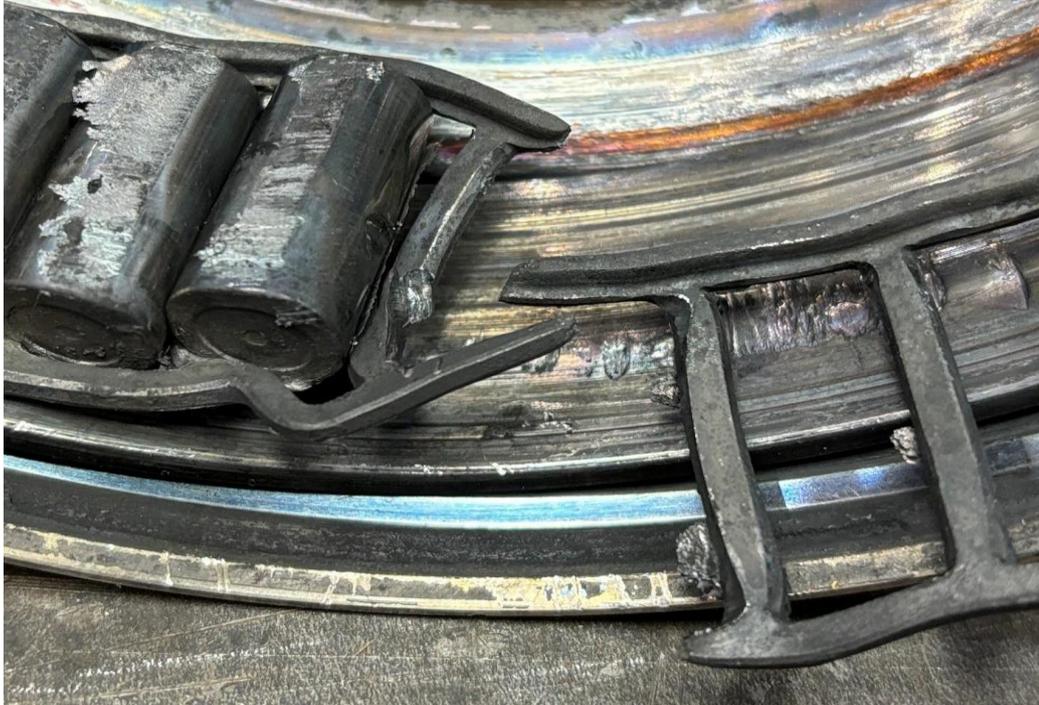
The root cause of the bearing failure was determined to be cage entrapment and breakage, which led to roller skewing and sliding. This, ultimately, caused the bearing to stop, resulting in the rotation of the outer bearing cup and sleeve within the hub, thereby, generating extreme frictional heat.

Figure 13: The Number 4 inboard bearing cage stretch and damage from roller sliding.

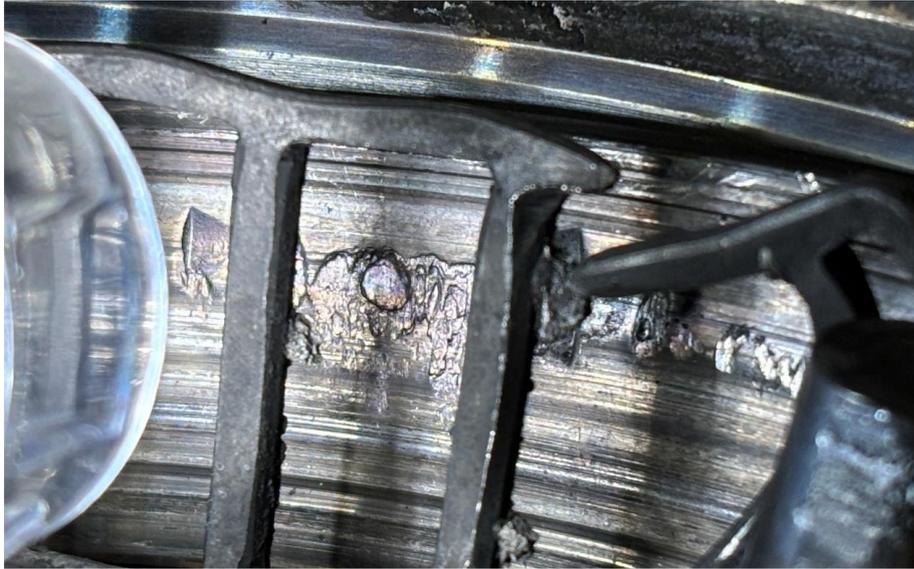
Figure 14: Spalling damage observed on the bearing rolling surface.

However, the spalling observed is typically caused by rolling contact fatigue and cannot be caused by the roller sliding and final-stage damage progression. This means the spalling was there before the final-stage damage occurred. This gives an indication of the condition of the bearing prior to the final stage damage progression, and the condition of the bearing may have contributed to a loss-of-preload setting, and the onset of cage damage.

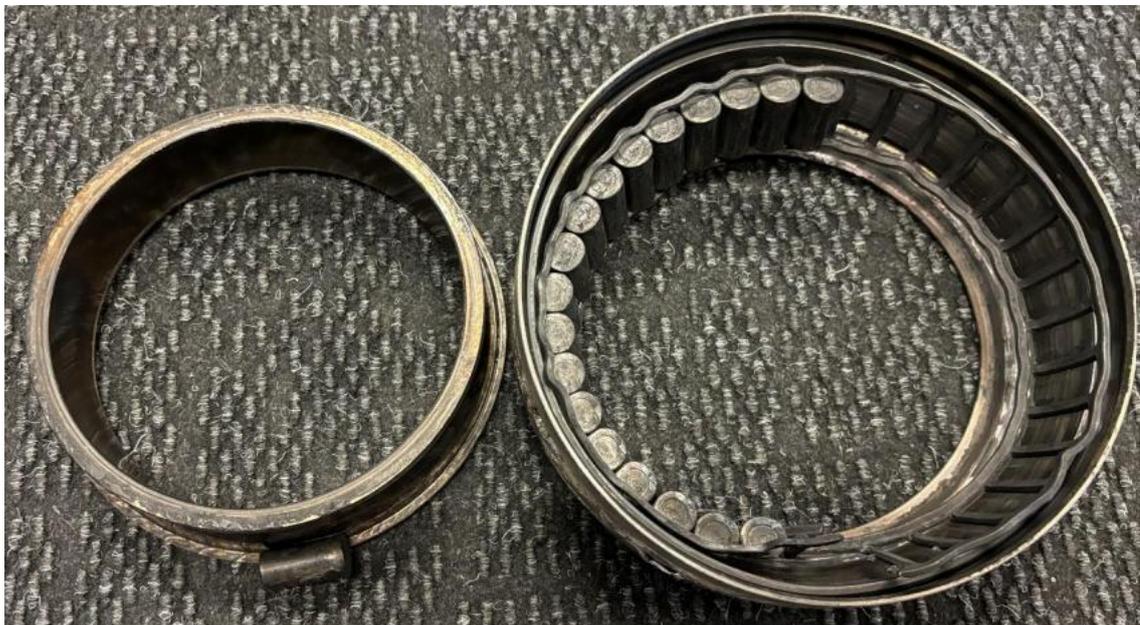
The inboard bearing damage was concentrated on one side of the bearing. The cage had broken, and one roller skewed 90° and got wedged between the bearing cage and the cone race (inner ring race).

Figure 15: The inboard bearing cone race and bearing cage.

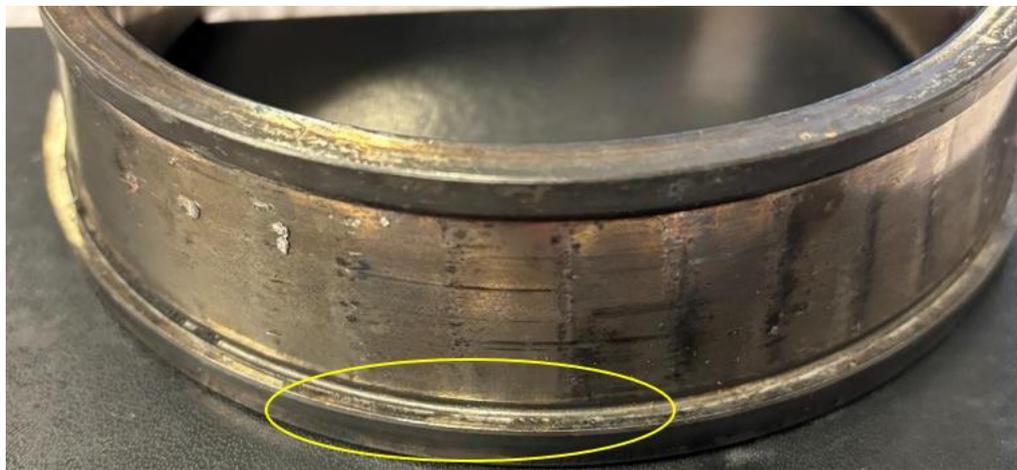
The cone race area with minimal damage showed indications of consequential heat, and minimal race damage, as well as minimal large-end rib damage (highlighted) (see Figure 16).

Figure 16: Inboard cone race.

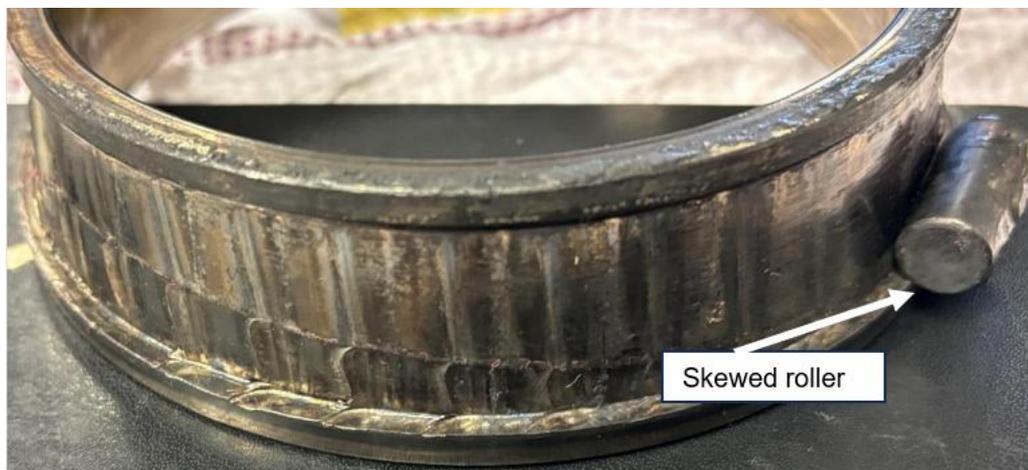
The IB cone race showed severe heat damage including plastic deformation of the race and rib where rollers have 'dug in', as well as indications of roller skewing. The one skewed and welded roller is also visible in Figure 17.

Figure 17: Cone with skewed roller.

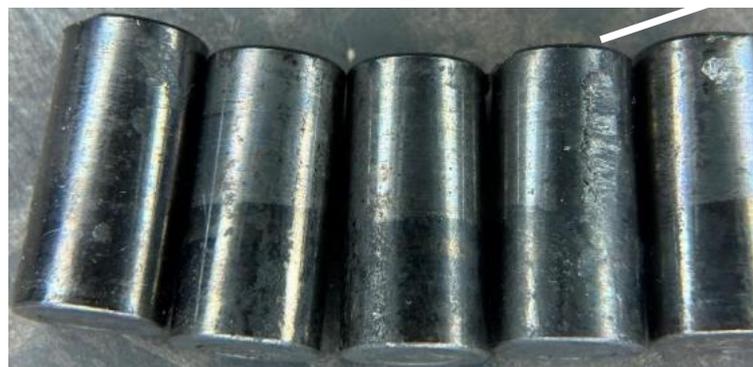
Some roller bodies suffered relatively little damage – other than sliding on the cup race – and the roller large ends were still in good condition. As a result of this, lubrication is not suspected as deficient. See Figures 18 and 19. The roller sliding was a major source of the generated heat.

Figure 18: The overheated rollers.

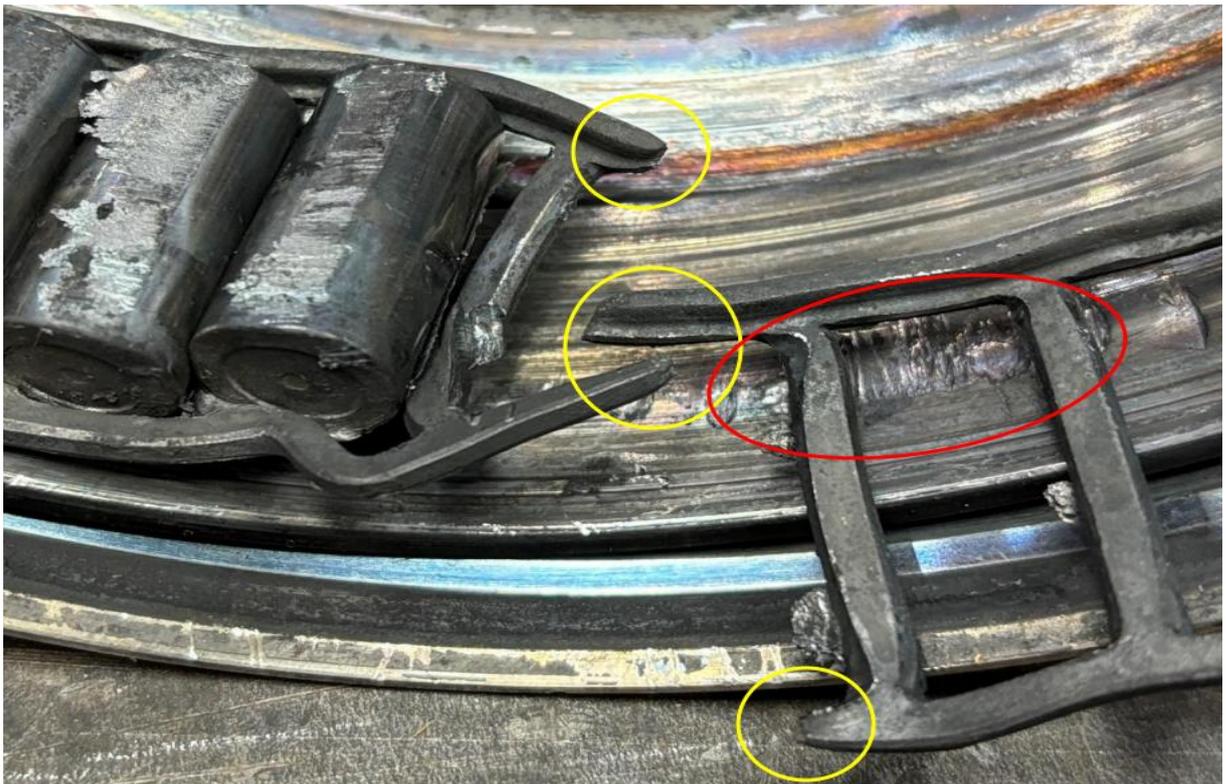
The cage breakage showed narrowing of the material at the breakage site (highlighted yellow in Figure 20) – this is known as ‘necking’, and showed the cage broke due to tension (see Figure 20). This is most likely due to the cage which was trapped by a portion of rollers – roller skewing and sliding with resultant extensive heat generation would have resulted from this. Cage entrapment in this scenario would be due mainly to stretch that took place as a result of cage bridge impacts, as well as cage bridge wear caused by roller skewing. This comes from insufficient preload.

Figure 20 also shows an area of spalling approx. 1-2cm² (highlighted red).

Figure 20: Skewed rollers.

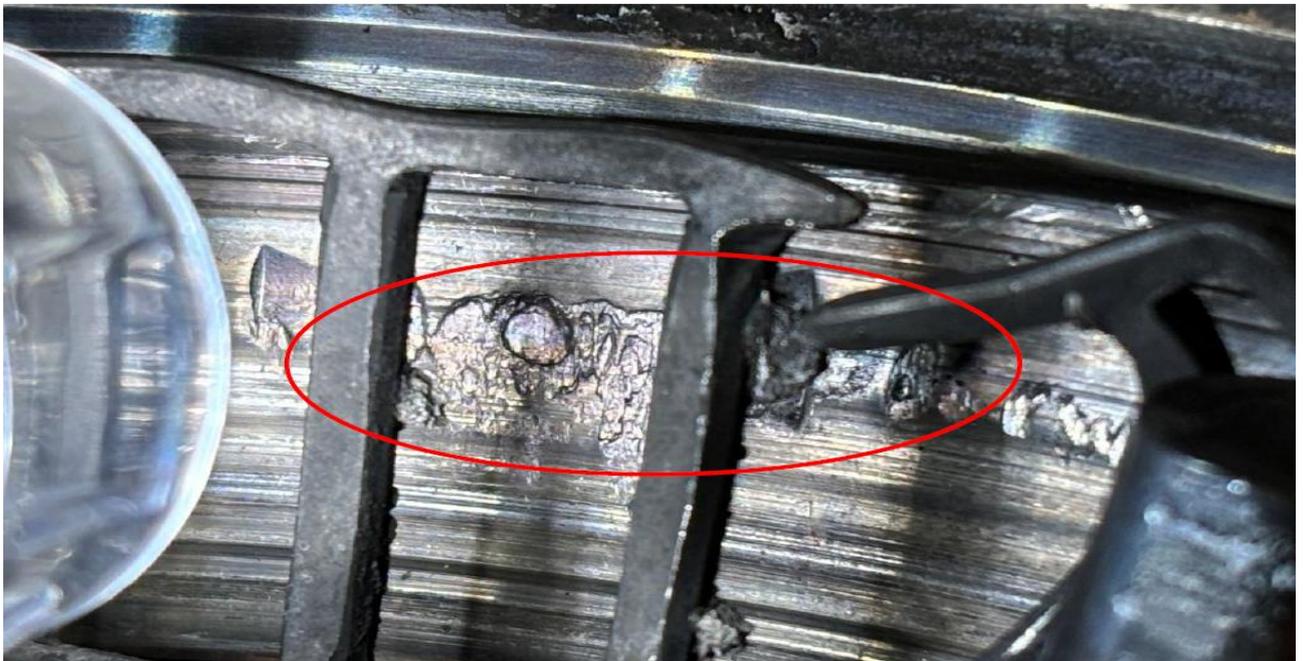
Spalling results from metal fatigue due to rolling contact but can be initiated/aggravated by thin lubricant films. In this case, lubrication was not suspected to have any influence, and the bearing damage progression also did not support a lubrication deficiency.

Figure 21: The red oval shape highlights the spalled area in greater detail.

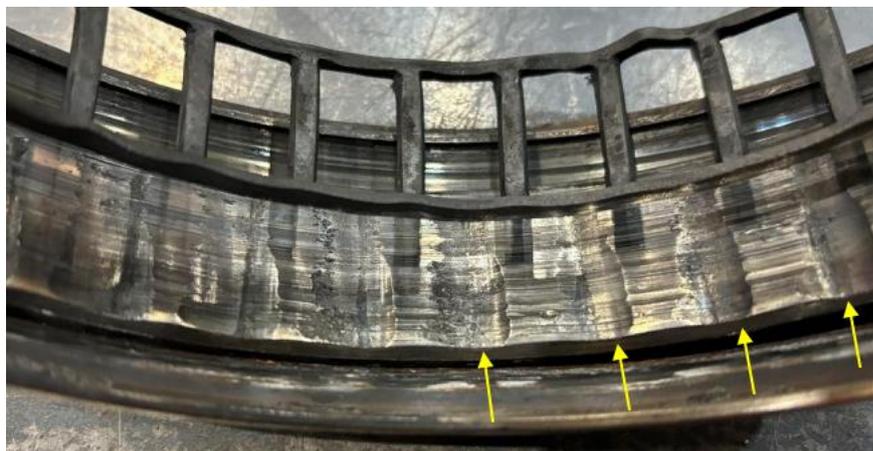
Severe damage to the cup race occurred due to roller sliding. There were also significant axial lines of plastic deformation visible in Figure 22 / Figure 23 (arrowed) – these are not brinels, but plastic deformation from roller contact due to the extreme heat levels after the aircraft came to a halt. It was, thus, purely consequential damage.

Figure 22: Roller contact.

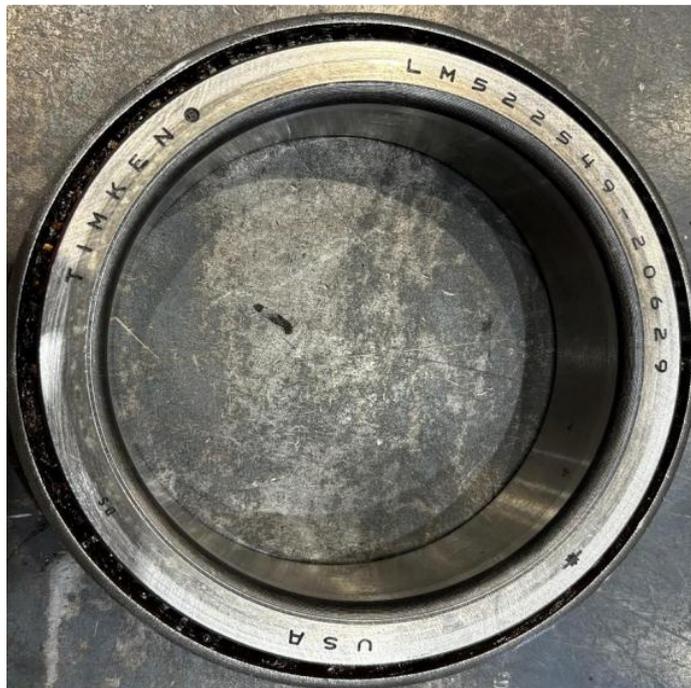
This cone was still intact with no significant damage, as shown in Figure 22.

Figure 23: Outboard cone.

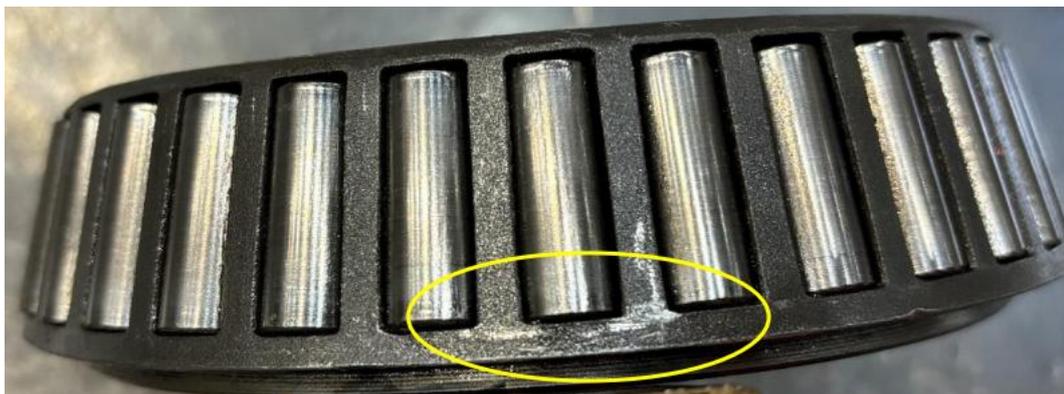
- Figure 24 shows handling marks – these could have been caused at any stage of operation (mounting/failure/dismounting), and are not significant,*
- Figure 25 shows cage bridge contact marks over 4 rollers only – under magnification these marks appear to have been made by abrasion in the direction of rotation (Figure 26). Cage deformation and radial movement was limited (that is, not abnormal), and this was most likely caused by isolated contamination.*

Figure 24: Rollers with contact marks.

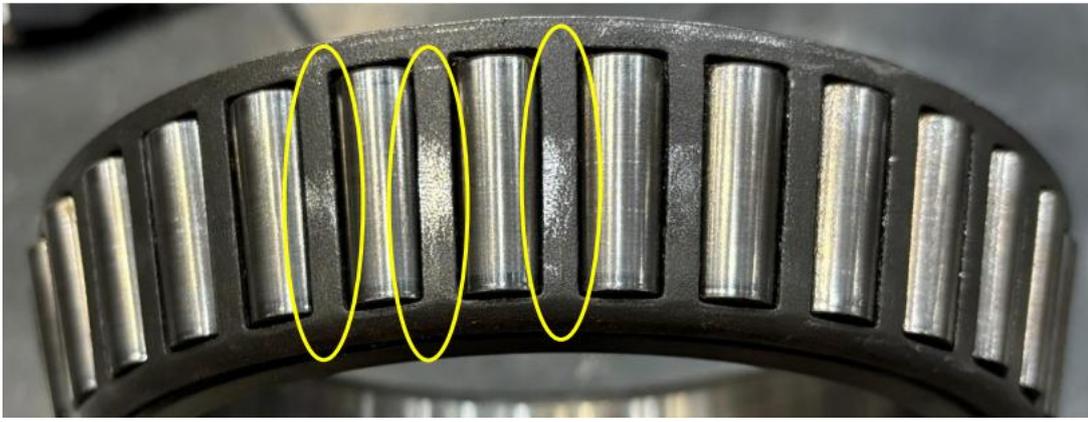
Figure 25: The inner contact marks

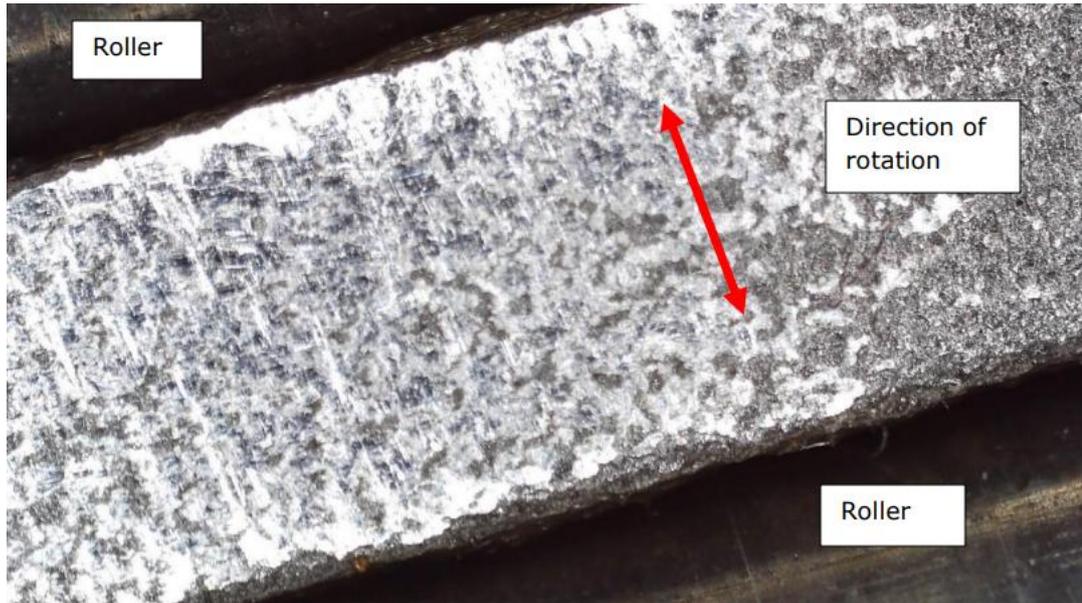
Figure 26: Roller with abrasion.

Roller large ends were in good condition with minimal scoring and no evidence of heat generation (Figure 26). This also indicated that lubrication was not suspected to have been deficient.

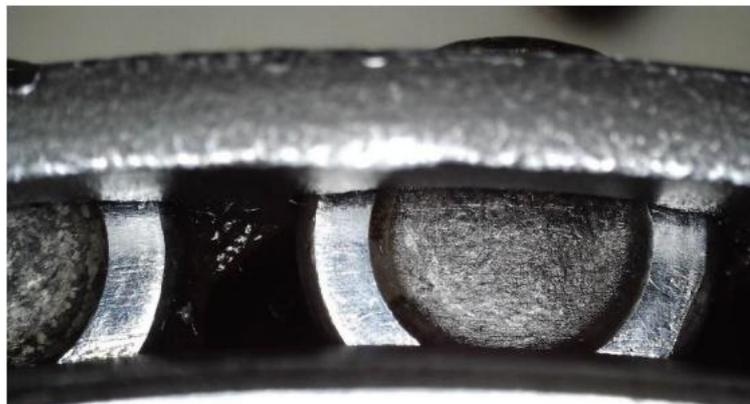
Figure 27: Roller ends with minimal scoring.

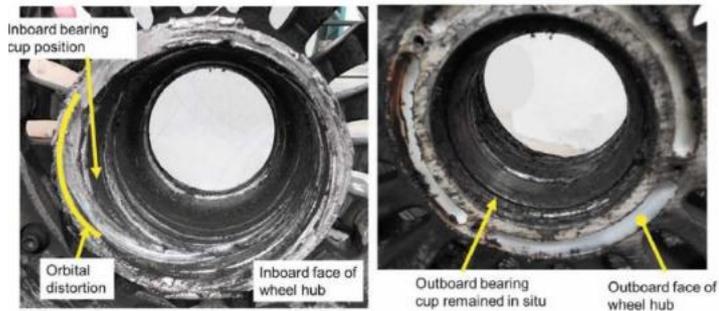
The investigation results revealed that the damage to the outboard wheel half (SNB-2272) could be attributed to the failure of the inboard wheel bearing assembly during operation. The failure of the inboard bearing assembly resulted in the failure of the inboard wheel hub bearing bore during operation.

Figures 28 and 29: Hub damage around the inboard and the outboard bearing cup area.
