LIMITED OCCURRENCE INVESTIGATION REPORT – FINAL

Reference Number	CA18/3/2/1461						
Classification	Serious Incident	Date	24 November 2024			Time	0746Z
Type of Operation	Private (Part 94)						
Location							
Place of Departure	Ballito Microlight Airfield, KwaZulu-Natal Province		Place of Intended Landing		Ballito Microlight Airfield, KwaZulu-Natal Province		
Place of Occurrence	During the climb after take-off from Ballito Microlight Airfield, Runway 18						
GPS Co-ordinates	Latitude	29°29'19.25" S	Longitude	31°10' 35.77" E		Elevation	230 feet
Aircraft Information							
Registration	ZU-BUI						
Make; Model; S/N	Solo Wings; Windlass Aquilla Trike (Serial Number: WA723)						
Damage to Aircraft	None		Total Aircraft Hours	1 454.2			
Pilot-in-command							
Licence Type	National Pilot Licence		Gender	Male		Age	27
Licence Valid	Yes	Total Hours	3 583.5		Total Hours on Type	3 144.5	
Total Hours 30 Days	50.0		Total Hours on Type Past 90 Days		50.0		
People On-board	1 + 1	Injuries	0	Fatalities	0	Other (on ground)	0

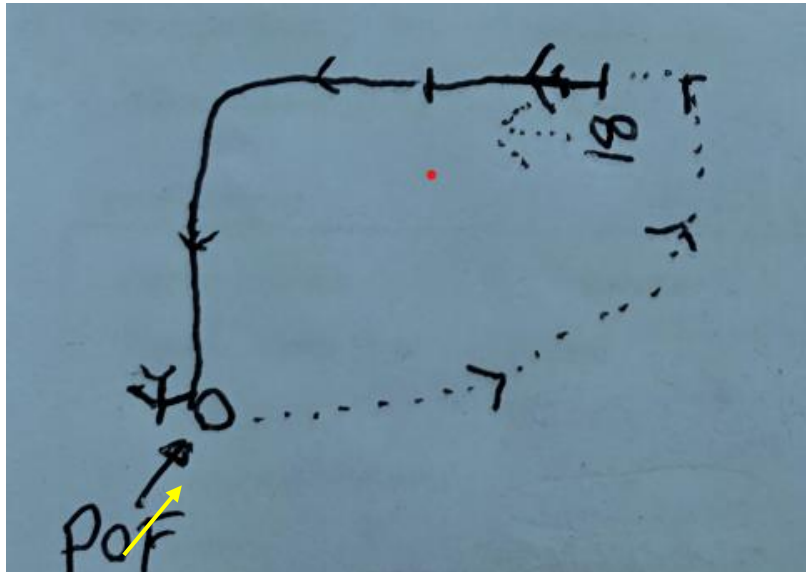
Figure 1: The pilot's sketch depicts the take-off direction and the point at which the exhaust outlet pipe-end part broke off after executing a left turn. (Source: Pilot)

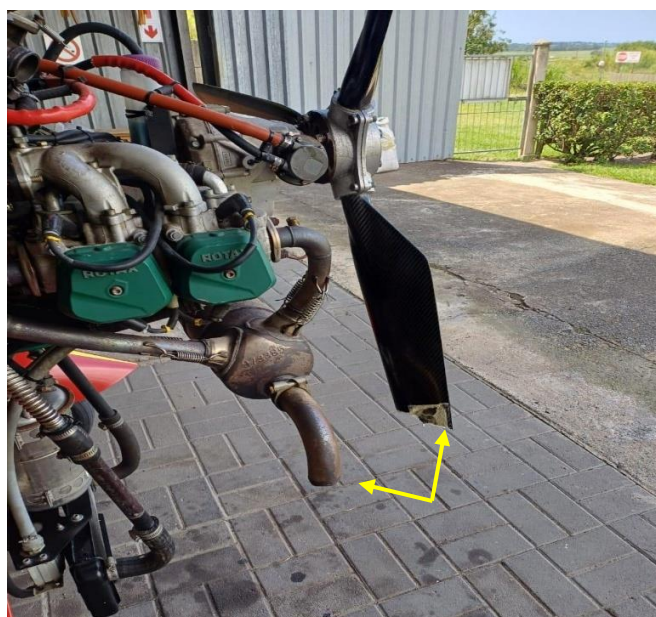
The Rotax engine exhaust pipe is manufactured from stainless steel and is made up of two parts that are welded together. The missing exhaust outlet pipe was not found. An engineer from the Rotax-approved agent in Germiston, Gauteng province, indicated that the exhaust pipe-end part broke off on the welded joint area after his assessments of the engine. There had been no other related failures of the Rotax exhaust system in the past; therefore, this was an isolated case. The engineer concluded that substandard welding on the exhaust outlet pipe led to its end part breaking off due to fatigue caused by vibration.

Figure 3: The yellow arrows show the remaining half of the exhaust pipe and the severed propeller blade.

2.7	It was found that substandard welding of the exhaust outlet pipe led to the end part breaking off due to fatigue caused by vibration.
Probable Cause(s)	
The aircraft experienced sever engine vibration as a result of the exhaust outlet pipe severing one of the propeller blades. The vibration dislodged the two carburettors which resulted in the engine stoppage due to fuel starvation.	
Contributing Factor(s)	
The exhaust outlet pipe broke off on the welded joint area due to undetected substandard welding. Consequently, the failed outlet pipe hit one of the propeller blades and the two carburettors dislodged which resulted in engine stoppage due to fuel starvation.	
Safety Action(s)	
None.
