**LIMITED OCCURRENCE INVESTIGATION REPORT – FINAL**

<b>Reference Number</b>	CA18/3/2/1462						
<b>Classification</b>	Serious Incident	<b>Date</b>	17 November 2024		<b>Time</b>	1642Z	
<b>Type of Operation</b>	Private (Part 94)						
<b>Location</b>							
Place of Departure	New Tempe Aerodrome (FATP), Free State Province		Place of Intended Landing	Adamsfontein Farm, Northern Cape Province			
Place of Occurrence	On Runway 10 at Adamsfontein Farm, 14nm west of Gariep Dam (FAHV) Aerodrome Northern Cape Province						
GPS Co-ordinates	Latitude	30° 34' 53"S	Longitude	25° 15' 36" E	Elevation	3974 ft	
<b>Aircraft Information</b>							
Registration	ZU-ITS						
Make; Model; S/N	Thatcher CX4 (Serial Number: 537)						
Damage to Aircraft	Minor			Total Aircraft Hours	5497		
<b>Pilot-in-command</b>							
Licence Type	National Pilot Licence (NPL)		Gender	Male		Age	77
Licence Valid	Yes	Total Hours	5497		Total Hours on Type	113.9	
Total Hours 30 Days	2.6		Total Flying on Type Past 90 Days	19.8

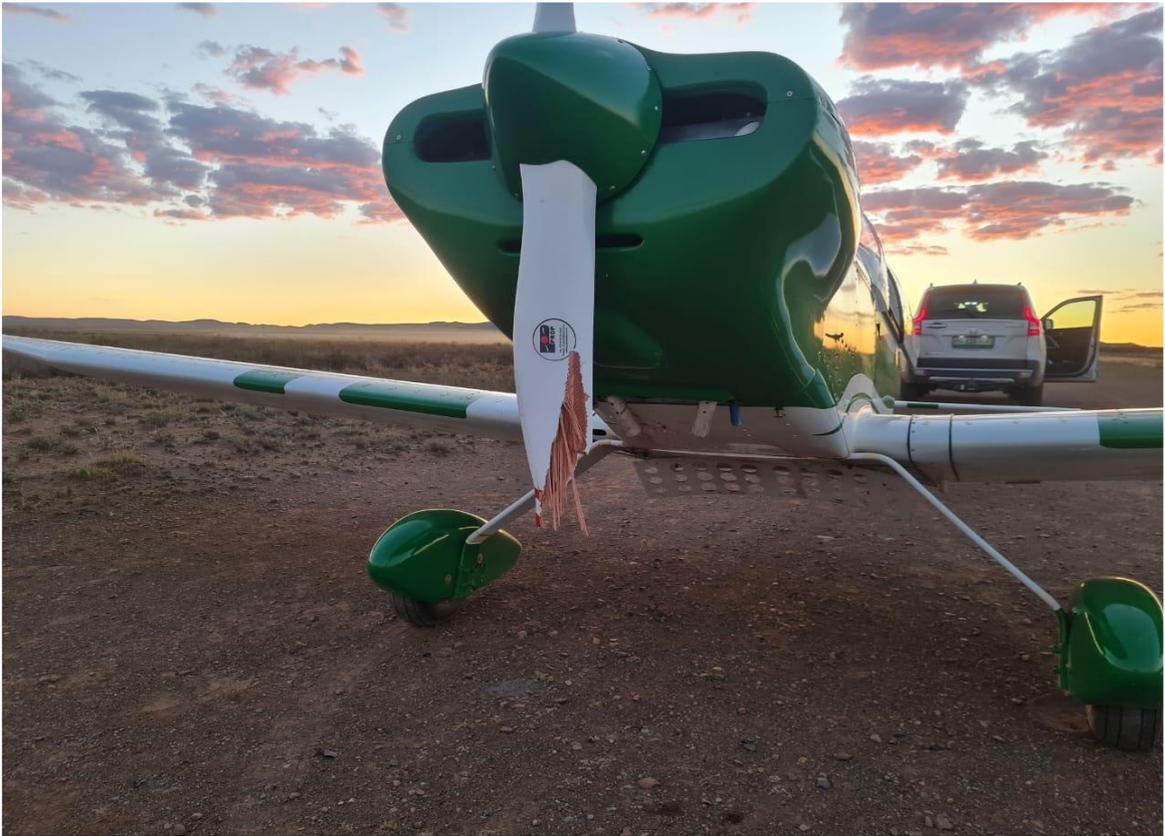
impacted the sheep which were fatally injured. The pilot was not injured during the serious incident; however, the aircraft sustained minor damage to the wooden propeller.

**Figure 1:** The aircraft with the damaged wooden propeller. (Source: Owner)

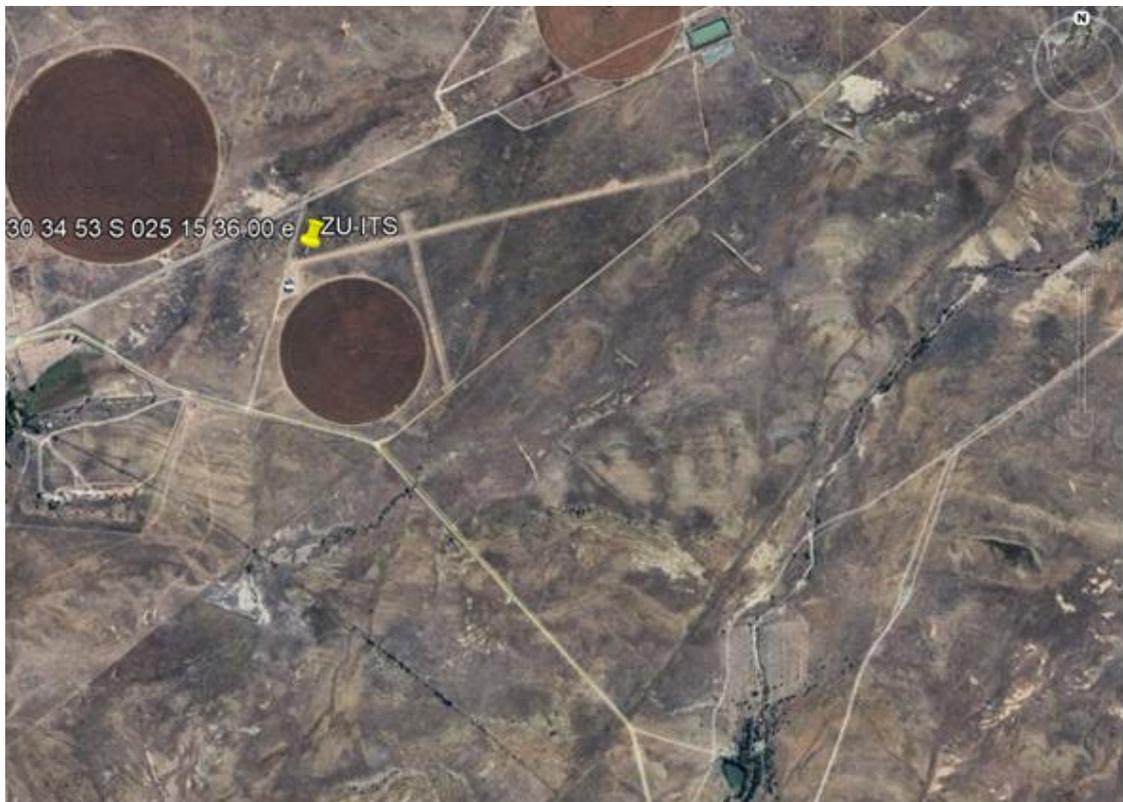
**Figure 2:** An overview of the accident site. (Source: Google Earth)

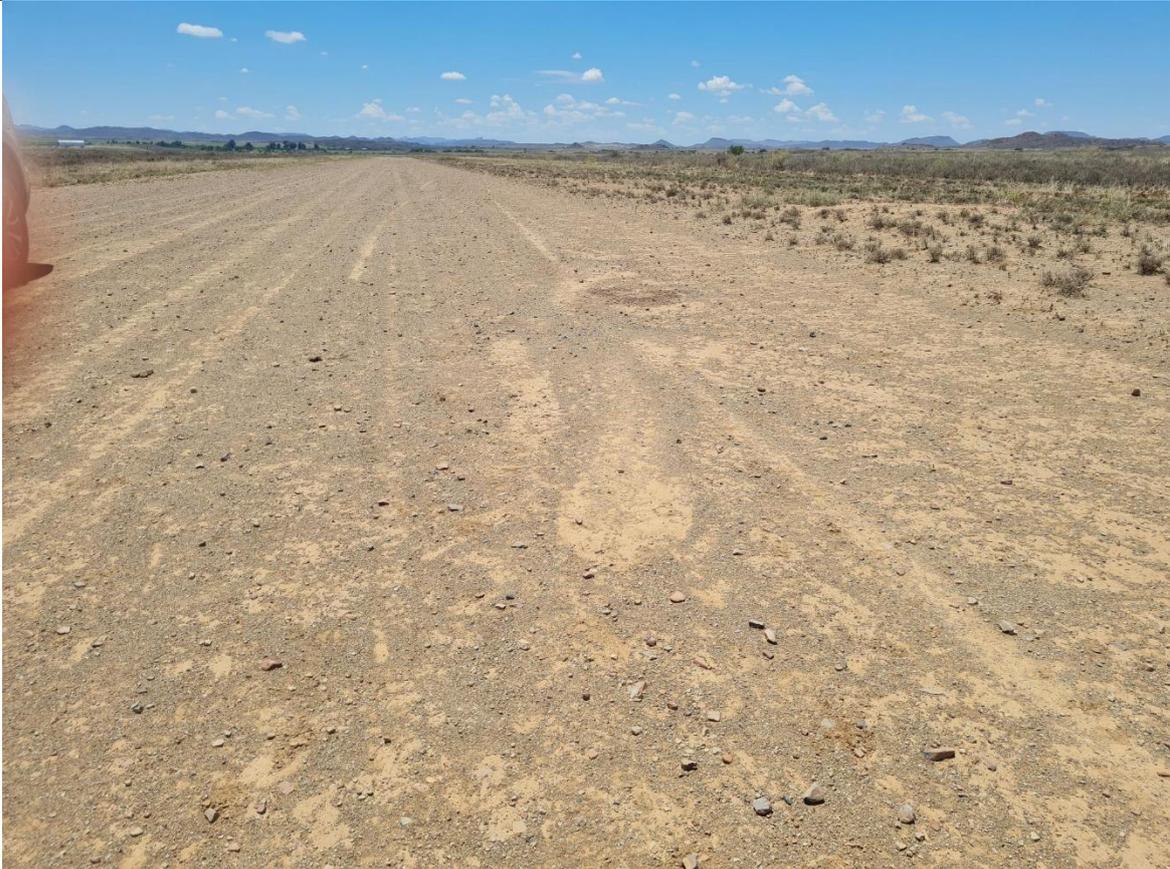
**Figure 3:** The farm's landing strip. (Source: Pilot)

2.6	On the pilot questionnaire, the pilot stated that he saw the sheep on the ground, which was obscured by grass, about 50m to the left of RWY 10 threshold, and he did not identify any sheep ahead of the flight path; therefore, he continued to land the aircraft. The three sheep that ran across the runway must have been hidden by the grass and only appeared after hearing the aircraft's engine. The aircraft was travelling too fast for the pilot to swerve (avoid impacting the sheep).
<b>Probable Cause(s)</b>	
During landing, three sheep ran across the runway and collided with the aircraft; the sheep were fatally injured.	
<b>Contributing Factor(s)</b>	
None.	
<b>Safety Action(s)</b>	
None.	
<b>Safety Message and/or Safety Recommendation/s</b>	
None.	
<b>About this Report</b>	
<p><i>The decision to conduct a limited investigation is based on factors including whether the cause is known and the evidence supporting the cause is clear, the level of safety benefit likely to be obtained from an investigation and that will determine the scope of an investigation. For this occurrence, a limited investigation has been conducted, and the Accident and Incident Investigations Division (AIID) has relied on the information submitted by the affected person/s and organisation/s to compile this limited report. The report has been compiled using information supplied in the initial notification, as well as from follow-up desk top enquiries to bring awareness of potential safety issues to the industry in respect of this occurrence, as well as possible safety action/s that the industry might want to consider in preventing a recurrence of a similar occurrence.</i></p> <p><i>All times given in this report are Co-ordinated Universal Time (UTC) and will be denoted by (Z). South African Standard Time is UTC plus 2 hours.</i></p>

The farm owner stated that pilots should notify him in advance prior to landing at the airstrip so that he can relocate the sheep to a safer grazing area.
