LIMITED OCCURRENCE INVESTIGATION REPORT – FINAL

Reference Number	CA18/3/2/1463					
Classification	Serious Incident	Date	3 December 2024	Time	1105Z	
Type of Operation	Commercial Airline Transport (Part 121)					
Location						
Place of Departure	Cape Town International Airport (FACT), Western Cape Province		Place of Intended Landing	Hoedspruit Airforce Base (FAHS), Limpopo Province		
Place of Occurrence	During landing on Runway 09 at Hoedspruit Airforce Base (FAHS)					
GPS Co-ordinates	Latitude	24° 22' 50.61" S	Longitude	031° 2' 40.43" E	Elevation	5510.4 ft
Aircraft Information						
Registration	ZS-YZB					
Make; Model; S/N	Embraer; ERJ 190-100 LR; (Serial Number: 19000666)					
Damage to Aircraft	Minor			Total Aircraft Hours	22 304.27	
Pilot-in-command						
Licence Type	Airline Transport Pilot Licence (ATPL)		Gender	Male	Age	41
Licence Type	Airline Transport Pilot Licence (ATPL)		Gender	Female	Age	37
Licence Valid	Yes	Total Hours	12419	Total Hours on Type	3 870

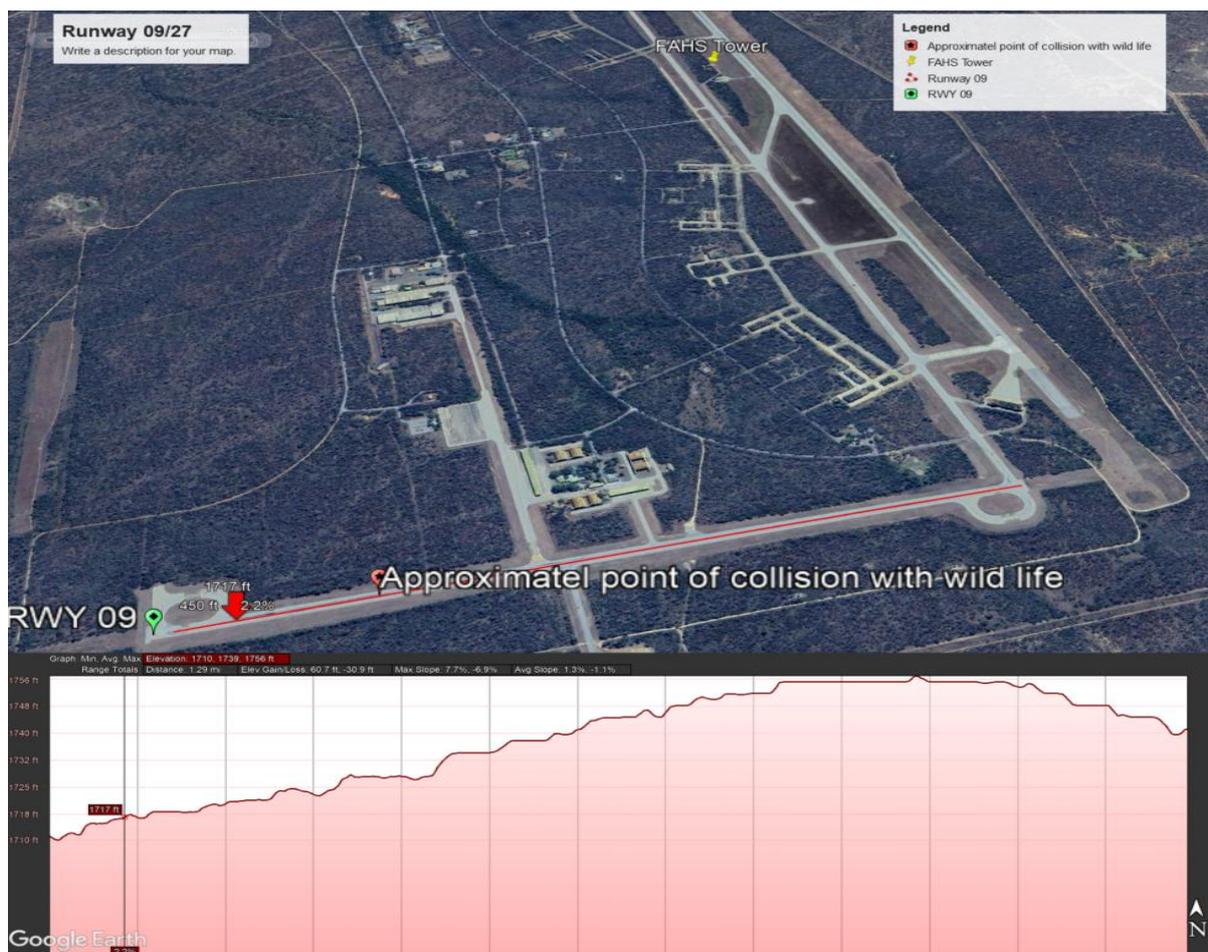
Figure 1: A view of the runway and the incident location. (Source: Google Earth Maps)

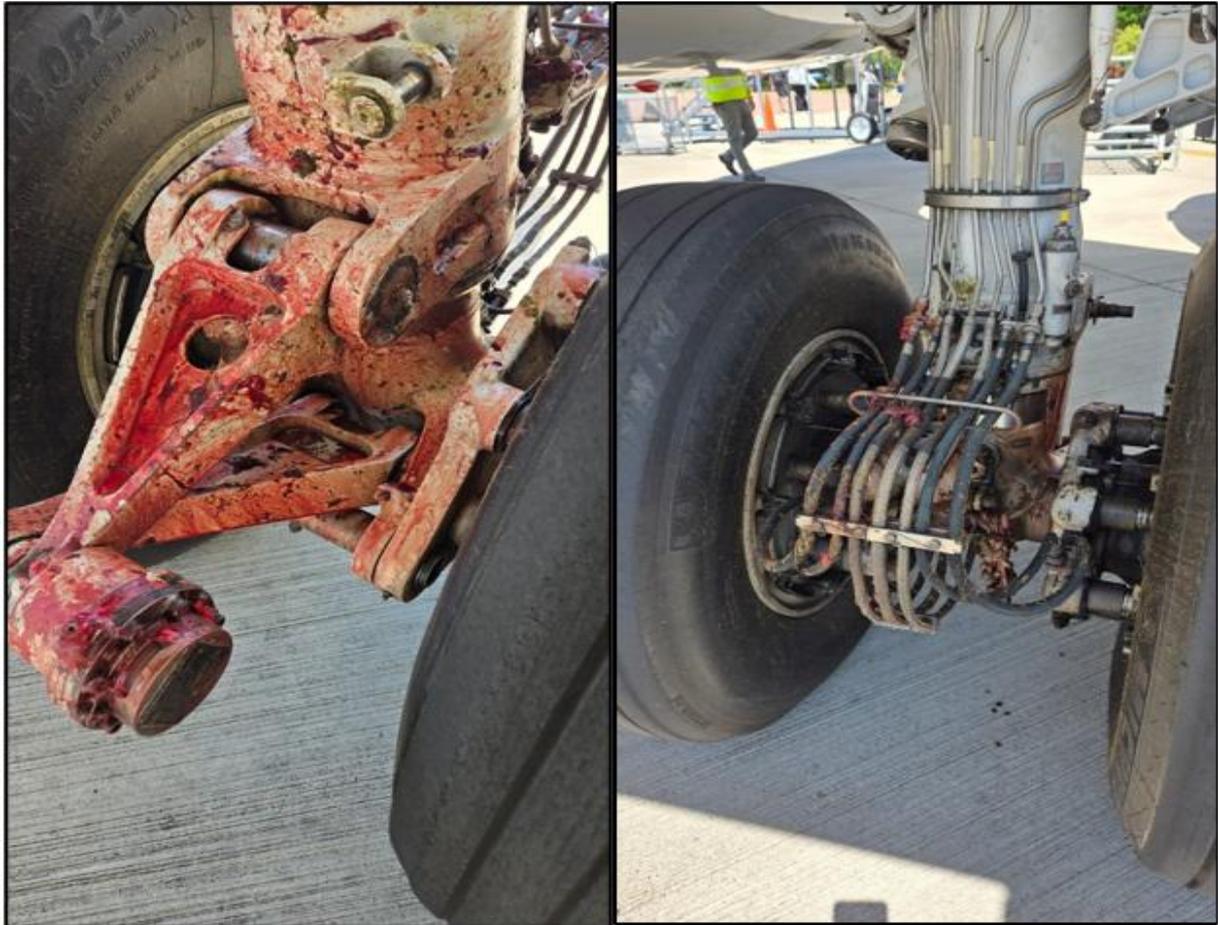
At 1104Z, the aircraft touched down on Runway (RWY) 09. During the landing roll whilst travelling at approximately 130 knots (kts), the CPT spotted a herd of impalas crossing the runway (from the left to the right of the runway). The CPT immediately disengaged the automatic braking system and applied maximum manual braking in an effort to stop the aircraft. However, the impalas stopped abruptly on the runway, facing the approaching aircraft. As the aircraft neared towards them, the herd fled to the right, however, the right main landing gear struck five impalas approximately 500 metres (m) from the touchdown point. The impact fatally injured the five impalas whilst the others ran and disappeared into the bush. The struck impala carcasses were found near the taxiway.

Figure 1: The left main landing gear that impacted the impalas. (Source: Operator)

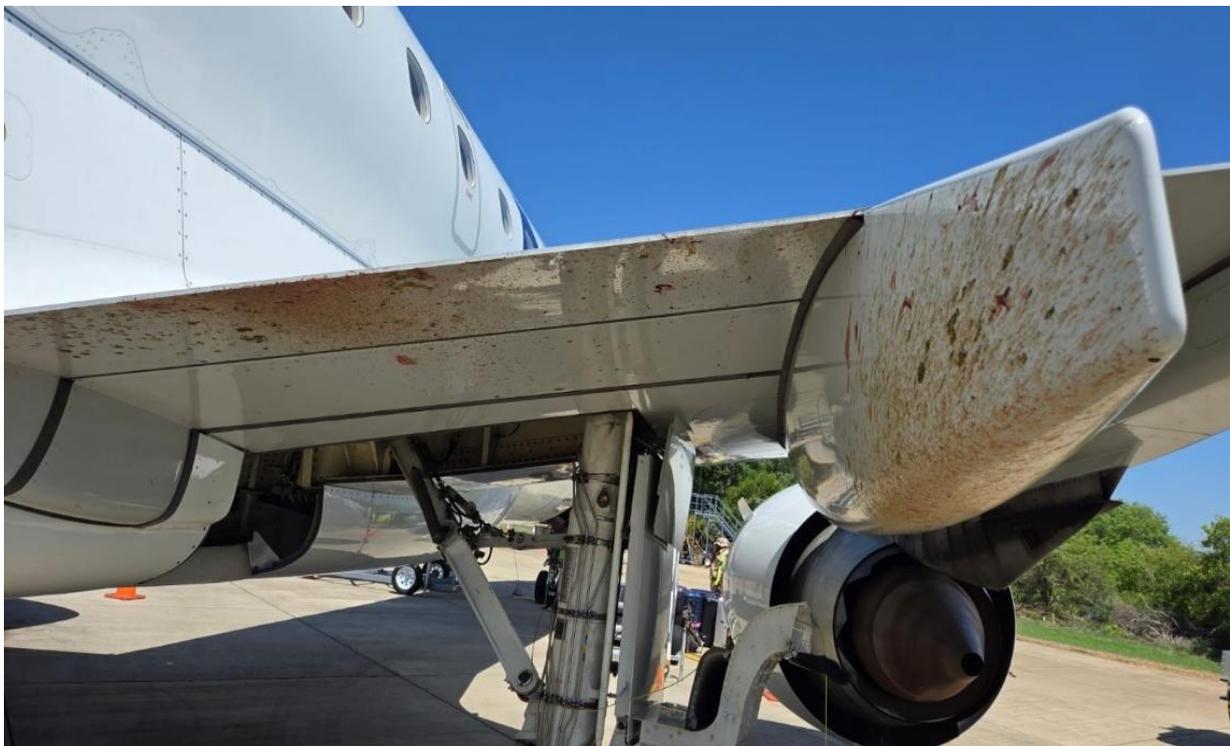
Figure 2: The right-wing inboard trailing edge after the serious incident. (Source: Operator)
