LIMITED OCCURRENCE INVESTIGATION REPORT – FINAL

Reference Number	CA18/3/2/1464						
Classification	Serious Incident	Date	29 December 2024		Time	1315Z	
Type of Operation	Private (Part 91)						
Location							
Place of Departure	Potchefstroom Aerodrome (FAPS), North West Province		Place of Intended Landing		Beaufort West (FABW) Aerodrome, Western Cape Province		
Place of Occurrence	Runway 26 at Beaufort West Aerodrome (FABW), Western Cape Province						
GPS Co-ordinates	Latitude	32° 18' 00.0" S	Longitude	022° 40' 00.0" E	Elevation	2 932 ft	
Aircraft Information							
Registration	ZS-JLP						
Make; Model; S/N	Piper Aircraft; PA28-180 (S/N:28-7505115)						
Damage to Aircraft	Minor			Total Aircraft Hours	5 867.46		
Pilot-in-command							
Licence Type	Private Pilot Licence (PPL)		Gender	Male		Age	66
Licence Valid	Yes	Total Hours	662.4		Total Hours on Type	23.67	
Total Hours 30 Days	1.8		Total Flying on Type Past 90 Days	5.7			
People On-board	1 + 1	Injuries	0	Fatalities	0	Other (on ground)	0

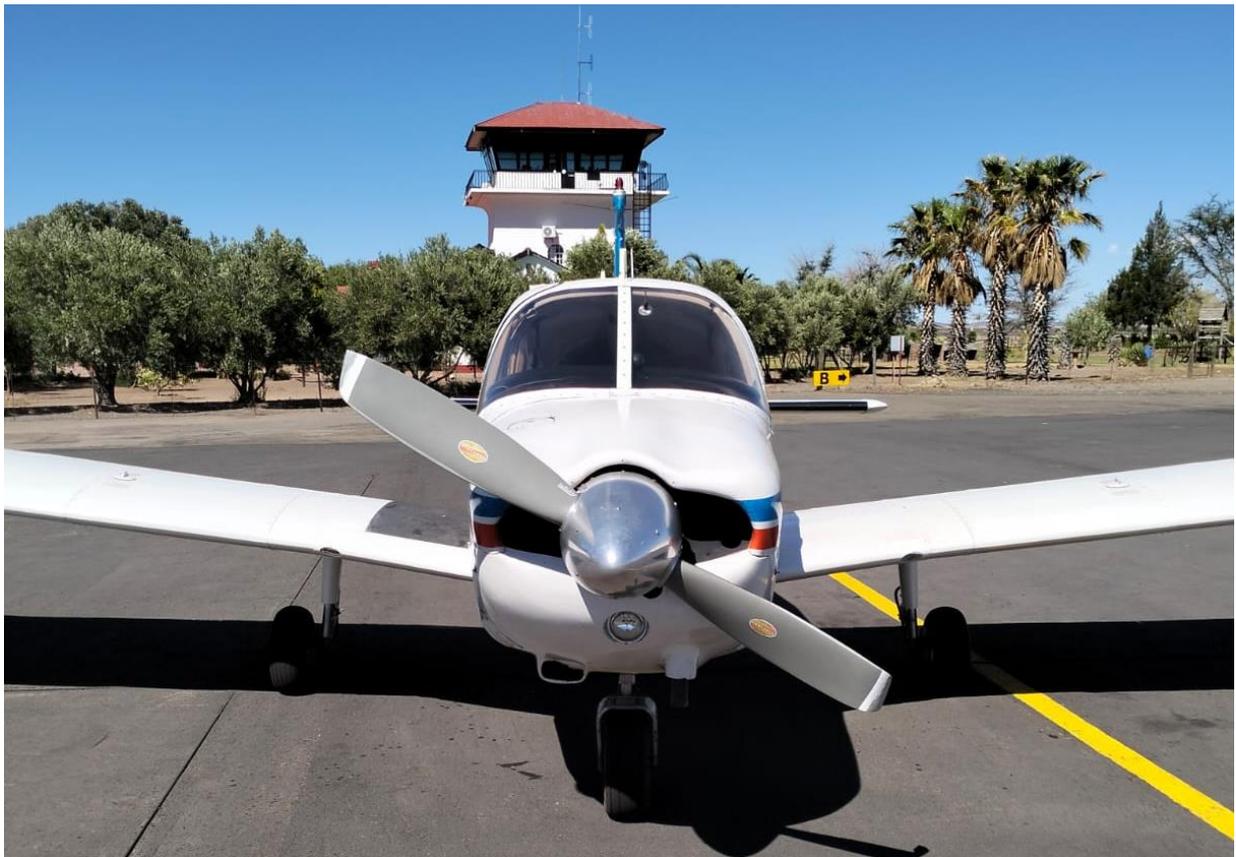
Figure 2: The aircraft after the serious incident. (Source: Pilot)

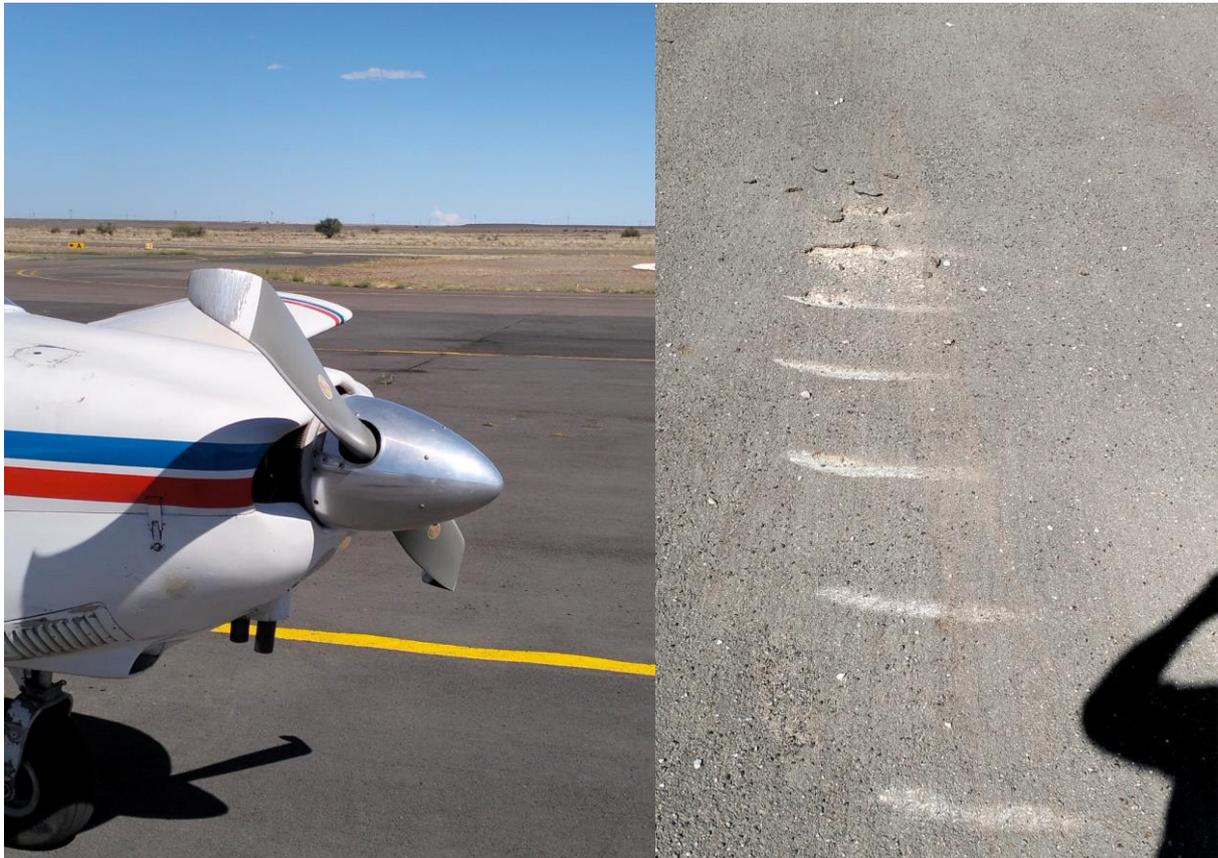
Figures 3 and 4: Damage to the propeller (left) and propeller marks on the runway (right). (Source: Pilot)

2.5 The aircraft approached at a speed of 81 MPH (70 kts) with 25° flaps setting instead of a speed of 112 MPH (97 kts) as recommended by the MOP. As a result, the aircraft touched down hard on the runway and it bounced, which led to the propeller damage.

Probable Cause(s)
The aircraft approached at a slow speed and it rapidly lost height, which led to a hard touchdown and a bounce, damaging the propeller.
Contributing Factor(s)
Incorrect configuration.
Safety Action(s)
None.
Safety Message and/or Safety Recommendation/s
None.
About this Report
<i>The decision to conduct a limited investigation is based on factors including whether the cause is known and the evidence supporting the cause is clear, the level of safety benefit likely to be obtained from an investigation and that will determine the scope of an investigation. For this occurrence, a limited investigation has been conducted, and the Accident and Incident Investigations Division (AIID) has relied on the information submitted by the affected person/s and organisation/s to compile this limited report. The report has been compiled using information supplied in the initial notification, as well as from follow-up desk top enquiries to bring awareness</i>
