LIMITED OCCURRENCE INVESTIGATION REPORT – FINAL

Reference Number		CA18/3/2/1465					
Classification	Serious Incident	Date	4 January 2025			Time	1010Z
Type of Operation	Training Part 141						
Location							
Place of Departure	Swellendam Airfield (FASX), Western Cape Province			Place of Intended Landing	Winelands Airfield (FAWN), Western Cape Province		
Place of Occurrence	Runway 05 at Winelands Airfield (FAWN)						
GPS Co-ordinates	Latitude	33° 46' 00.10" S	Longitude	018° 44' 00.00" E	Elevation	400 ft	
Aircraft Information							
Registration	ZS-JLO						
Make; Model; S/N	Piper PA-28-151; Cherokee Warrior (SN:28-7515179)						
Damage to Aircraft	Minor			Total Aircraft Hours	8007.3		
Pilot-in-command							
Licence Type	Private Pilot Licence		Gender	Male		Age	39
Licence Valid	Yes	Total Hours	150		Total Hours on Type	9.6	
Total Hours 30 Days	3.1		Total Flying on Type Past 90 Days			9.6	
People On-board	1+0	Injuries	0	Fatalities	0	Other (on ground)	0
What Happened

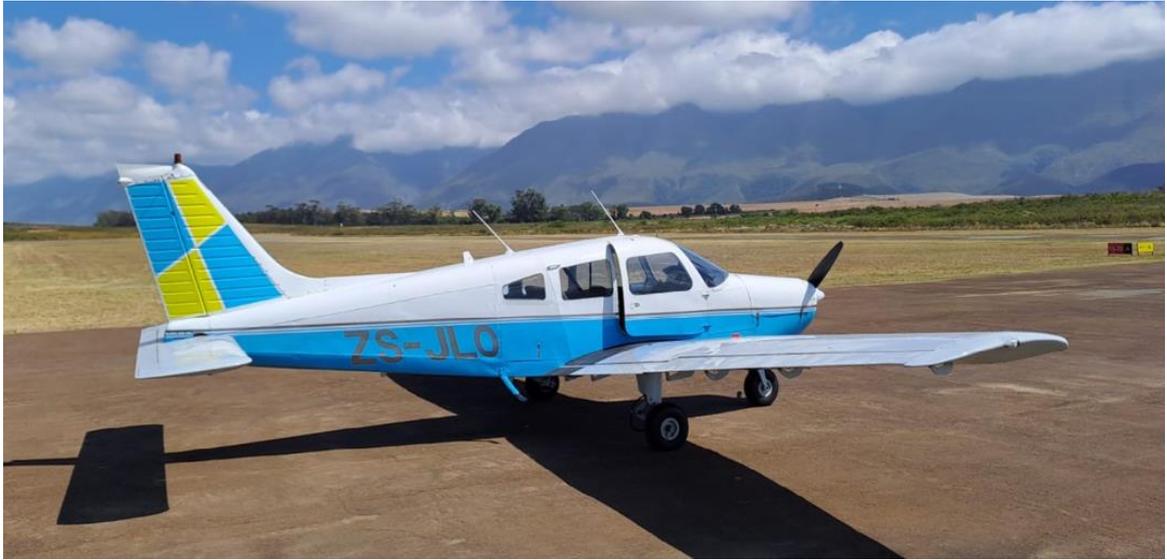
Figure 1: The aircraft after the incident. (Source: Operator)

6. The aircraft was maintained by the aircraft maintenance organisation (AMO) with an approved AMO Certificate that was issued on 2 March 2024 with an expiry date of 28 February 2025. The aircraft type was endorsed on the AMO's operational specifications.
7. During the third landing, the aircraft touched down hard and bounced due to loss of lift as a result of low speed on final approach. The pilot lost directional control, and the aircraft veered off to the left of the runway. Subsequently, the right-wing tip scraped the runway.

The aircraft's speed was slow at 40° flap settings on final approach which resulted in loss of lift and a hard landing, followed by a bounce and loss of directional control.

The pilot is encouraged to undergo additional training, particularly in crosswind landings and recovery after bounced landings to improve control in such situations.

Given the two-month break in flying, recurrent training should be emphasised to maintain proficiency in the new aircraft type. The pilot should consider additional practise in various wind conditions, including crosswinds, before undertaking complex landings.

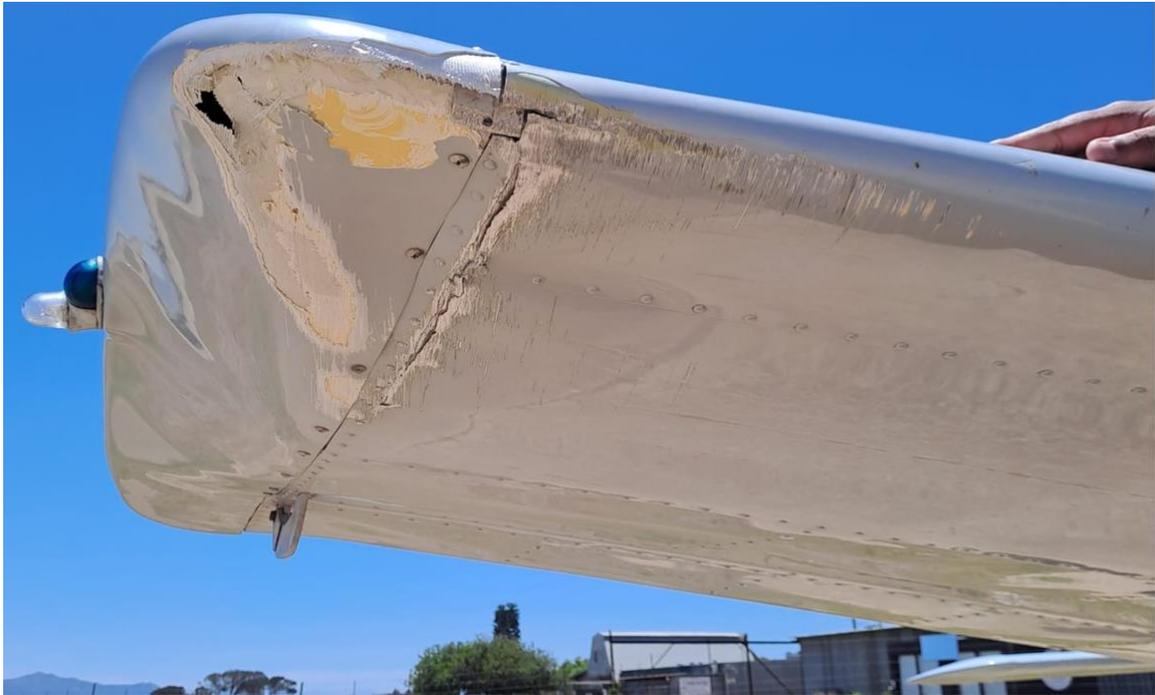
Figure 2: Damage on the right-wing tip fairing. (Source: Operator)

On the third final approach, the aircraft's speed was 65 kts at 40° flap setting. The speed was 2 kts above the manufacturer's recommended speed. It is likely that the pilot reduced the aircraft's speed to below the manufacturer's required speed of 63 kts with the flap set at 40°; this resulted in the aircraft losing lift and height and it touched down hard on the runway and bounced. The pilot lost directional control, and the aircraft veered off to the left of the runway. To recover, the aircraft rolled to the right and the right-wing tip scraped the runway surface.
