AIRCRAFT SERIOUS INCIDENT REPORT AND EXECUTIVE SUMMARY

Reference:		CA18/3/2/1466	
Aircraft Registration	ZS-PEA	Date of Incident	15 January 2025		Time of Incident	0929Z	
Type of Aircraft	Beechcraft King Air 200C	Type of Operation		Air Transport Operations (Part 135)			
Pilot-in-command Licence Type	Commercial Pilot Licence (CPL)	Age	42	Licence Valid	Yes		
Pilot-in-command Flying Experience	Total Flying Hours		1 307	Hours on Type	640		
Last Point of Departure	Chief David Stuurman International Airport (FAPE), Eastern Cape Province						
Next Point of Intended Landing	O.R. Tambo International Airport (FAOR), Gauteng Province						
Damage to Aircraft	None						
Location of the incident site with reference to easily defined geographical points (GPS readings if possible)							
Approximately 40 nautical miles (nm) north-east of FAPE at flight level (FL) 220 and at GPS co-ordinates 33°27'58.24"S 26° 7'16.78"E; elevation at 1 345 feet (ft)							
Meteorological Information	Surface wind: 200°/08; Visibility: 9 000m; Temperature: 17°C; Due Point: 15°C; Cloud cover: Scattered; Cloud base: 36 00ft; QNH: 1012hPa

Reference Number : CA18/3/2/1466
Occurrence Category : Serious Incident
Type of O

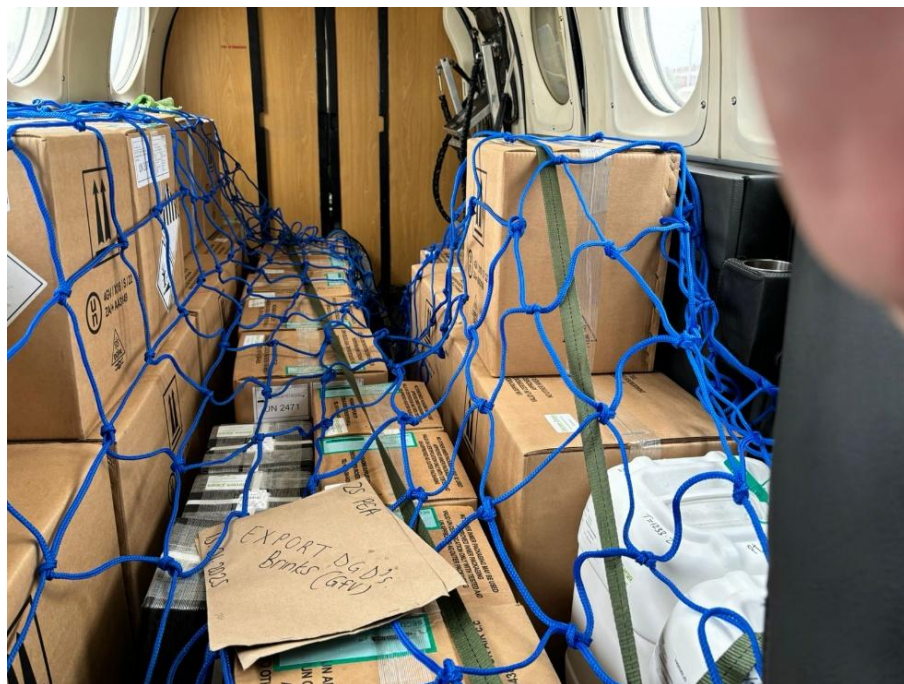
- 1.1.2. The shipper of the dangerous goods delivered the cargo to FAPE where he met with the flight courier (FC) who then inspected the powdered chemical packaged in boxes and liquid chemical stored in 25-litre (L) plastic containers. The FC also verified that the items carried in each box and the 25L containers were correctly captured on the notification to captain (NOTOC) documentation. *The NOTOC document that was reviewed by the investigators was not signed by the shipper and was submitted to the captain who also did not endorse it with his signature.* The FC and first officer (FO) loaded the cargo in the main cabin and secured it with a net. One of the boxes was segregated and placed in the lavatory because it contained a chemical that was deemed flammable. Once all the cargo was loaded, the crew climbed over the boxes to gain access to the cockpit as the aircraft floor space was taken up by cargo (see Figure 1).

Figure 1: The main cabin with the packed cargo. (Source: Shipper)

- 4.2.1. It is recommended that the operator marks the cargo load area in the cabin area and clearly indicate the walkway that should be left unoccupied. Moreover, the operator needs to define and implement proper storage space fit for purpose for the transportation of Dangerous Goods cargo that needs to be segregated from other cargo. The lavatory is not intended for this purpose.
- 4.2.2. It is recommended that the operator provides each crew member with additional personnel protection equipment (PPE) which is relevant to the type of Dangerous Goods transported. The sealed PPE bag should always be carried on board the aircraft in case of an emergency.

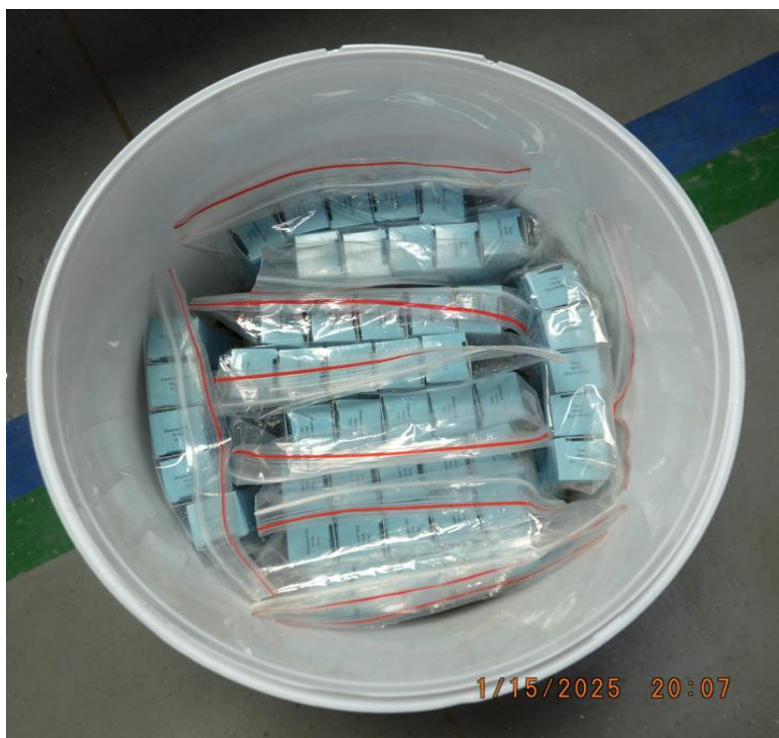
Figure 2: The packaged powdered chemical that was housed in boxes. (Source: Shipper)

1.16.1. The 25L plastic containers filled with a liquid chemical and boxes with powdered chemical were individually inspected after the serious incident, and were all found intact. There was no evidence of chemical spillage; and the origin of the unusual chemical smell could not be identified.
