LIMITED OCCURRENCE INVESTIGATION REPORT – FINAL

Reference Number	CA18/3/2/1467					
Classification	Serious Incident	Date	18 January 2025	Time	1420Z	
Type of Operation	Private (Part 91)					
Location						
Place of Departure	Swellendam Airfield (FASX), Western Cape Province		Place of Intended Landing	Cape Town International Airport (FACT), Western Cape Province		
Place of Occurrence	On a field in Stikland Hospital situated 5nm north of Cape Town International Airport (FACT)					
GPS Co-ordinates	Latitude	33° 53' 42.4" S	Longitude	018° 39' 25.8" E	Elevation	300 ft
Aircraft Information						
Registration	ZS-IDL					
Make; Model; S/N	Cessna; C150 (Serial Number: A1500144)					
Damage to Aircraft	None		Total Aircraft Hours	9478.45		
Pilot-in-command						
Licence Type	Private Pilot Licence (PPL)		Gender	Male		Age 21
Licence Valid	Yes	Total Hours	114.9		Total Hours on Type	74.2
Total Hours 30 Days	6.6		Total Flying on Type Past 90 Days	6.6		
People On-board	1+1	Injuries	0	Fatalities	0	Other (on ground) 0

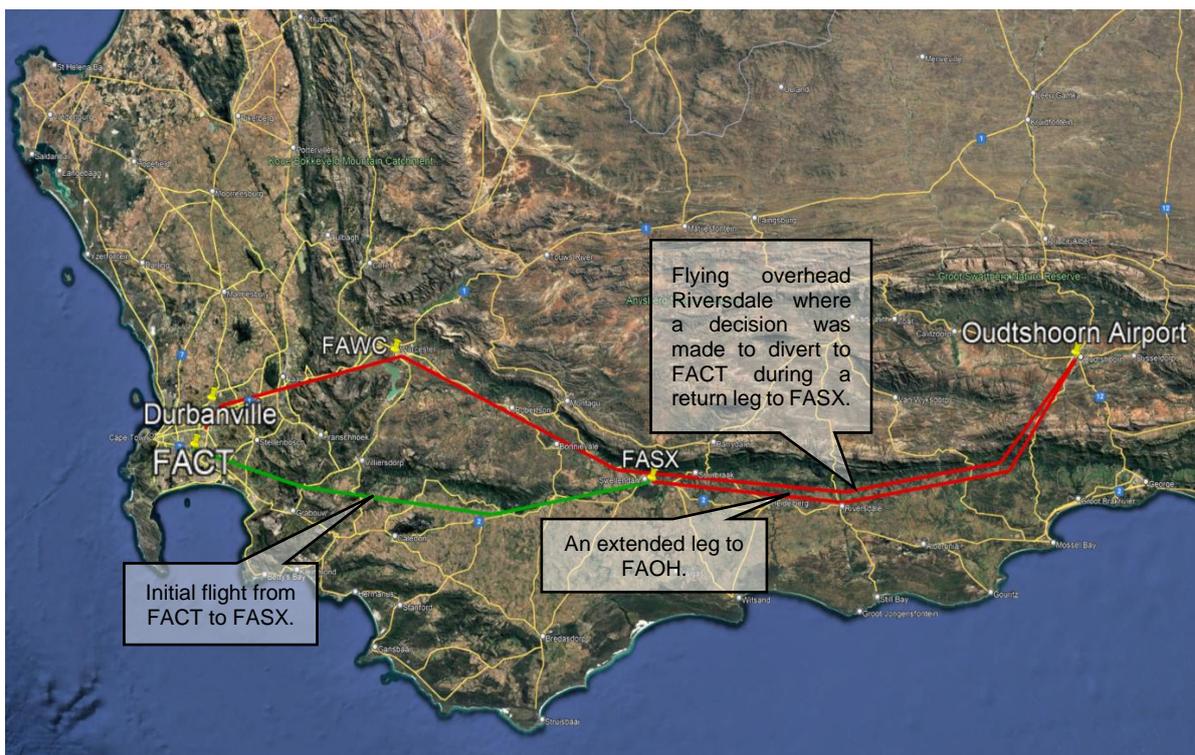
Figure 1: Plotted aircraft route. (Source: Google Earth Map)

In Figure 1, the green line represents the initial flight from FACT to FASX; the red line indicates the extended leg from FASX to FAOH after a new flight plan was filed. After reaching FAOH, the aircraft turned back toward FASX for a planned fuel uplift. However, whilst the aircraft was flying over Riversdale, the pilot diverted to FACT, bypassing the fuel stops along the route.

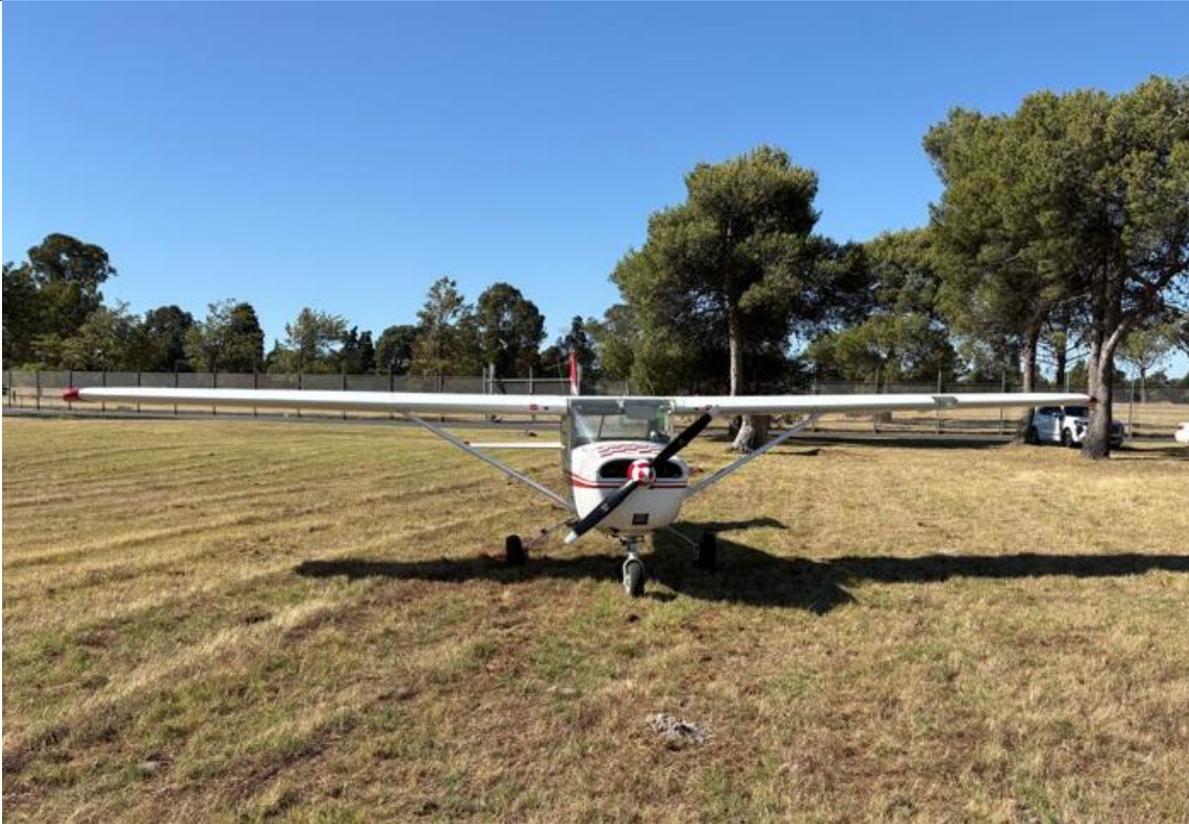
Figure 2: The aircraft after the forced landing. (Source: Pilot)

engine spluttered and lost power. The pilot checked the instruments, and the fuel gauges indicated empty with no fuel flow pressure. The pilot declared a MAYDAY to FACT tower and advised the air traffic control (ATC) personnel of the engine failure and his intention to perform a forced landing.

The pilot scanned the area for a suitable landing site. He then advised the ATC personnel that he had identified a field near the Stikland Industrial area. He committed to a forced landing and successfully brought the aircraft down on the field in Stikland Hospital. The pilot then communicated to the ATC personnel that the aircraft was safely on the ground. After landing, the pilot and the passenger evacuated the aircraft before the pilot contacted the chief flight instructor (CFI) from his flight school via a cellular phone. He also updated the ATC personnel via a cellular phone with the exact location, which was confirmed to be Stikland Psychiatric Hospital.

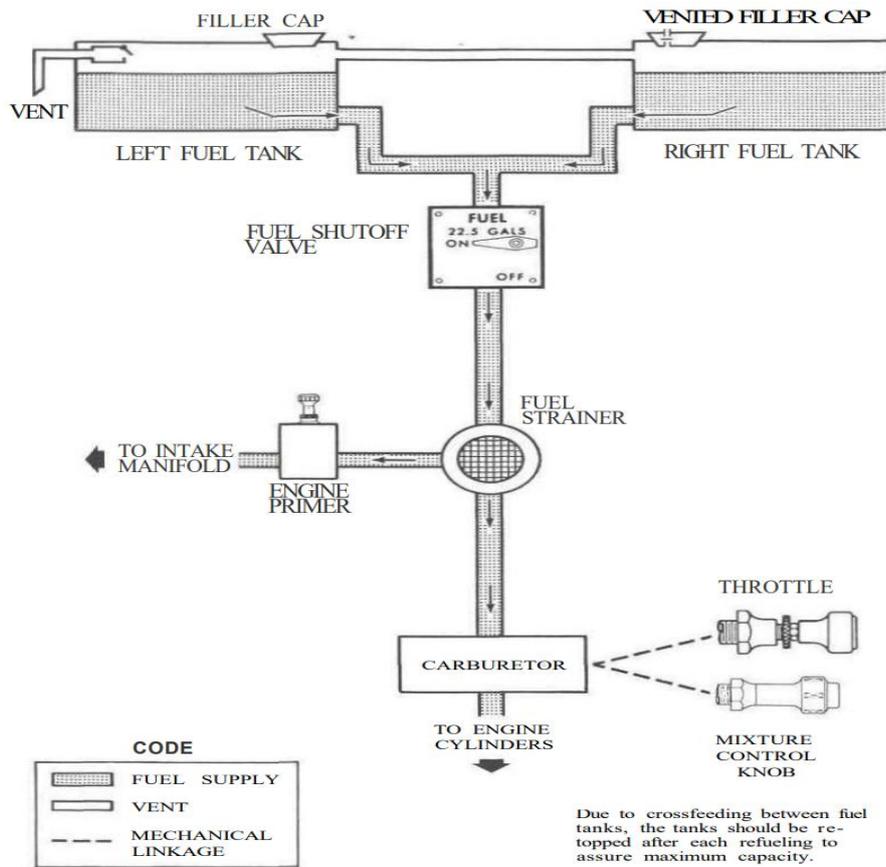
Diagram 1: Fuel system. (Source: POH)

Fuel system venting is essential to system operation. Blockage of the venting system will result in a decreasing fuel flow and eventual engine stoppage. Venting is accomplished by an interconnecting line from the right fuel tank to the left tank. The left tank is vented overboard through a vent line which is equipped with a check valve and protrudes from the bottom surface of the left wing near the wing strut attach point. The right fuel tank filler cap is also vented. Fuel quantity is measured by two float-type fuel quantity transmitters (one in each tank) and indicated by two electrically operated fuel quantity indicators on the lower left portion of the instrument panel. An empty tank is indicated by a red line and the letter E. When an indicator shows an empty tank, approximately 1.75 gallons remain in a standard tank as unusable fuel. The indicators cannot be relied upon for accurate readings during skids, slips, or unusual attitudes. The fuel system is equipped with drain valves to provide a means for the examination of fuel in the system for contamination and grade. The system should be examined before the first flight of every day and after each refuelling, by using the sampler cup provided to
