LIMITED OCCURRENCE INVESTIGATION REPORT – FINAL

Reference Number	CA18/3/2/1469						
Classification	Serious Incident	Date	1 February 2025	Time	0915Z		
Type of Operation	Private (Part 94)						
Location							
Place of Departure	Stellenbosch Airfield (FASH), Western Cape Province		Place of Intended Landing	Stellenbosch Airfield (FASH), Western Cape Province			
Place of Occurrence	On a field near Alfon Primary School, situated 17 nm north of Stellenbosch Airfield (FASH)						
GPS Co-ordinates	Latitude	33°34'39.30" S	Longitude	018°54'56.72" E	Elevation	260 ft	
Aircraft Information							
Registration	ZU-EJB						
Make; Model; S/N	Aeroprakt LTD; A-22 (Serial Number: 161)						
Damage to Aircraft	None			Total Aircraft Hours	2201.0		
Pilot-in-command							
Licence Type	Private Pilot Licence (PPL)		Gender	Male		Age	33
Licence Valid	Yes	Total Hours	130	Total Hours on Type	9		
Total Hours 30 Days	2.5		Total Flying on Type Past 90 Days	2.5			
People On-board	1+1	Injuries	0	Fatalities	0	Other (on the ground)	0

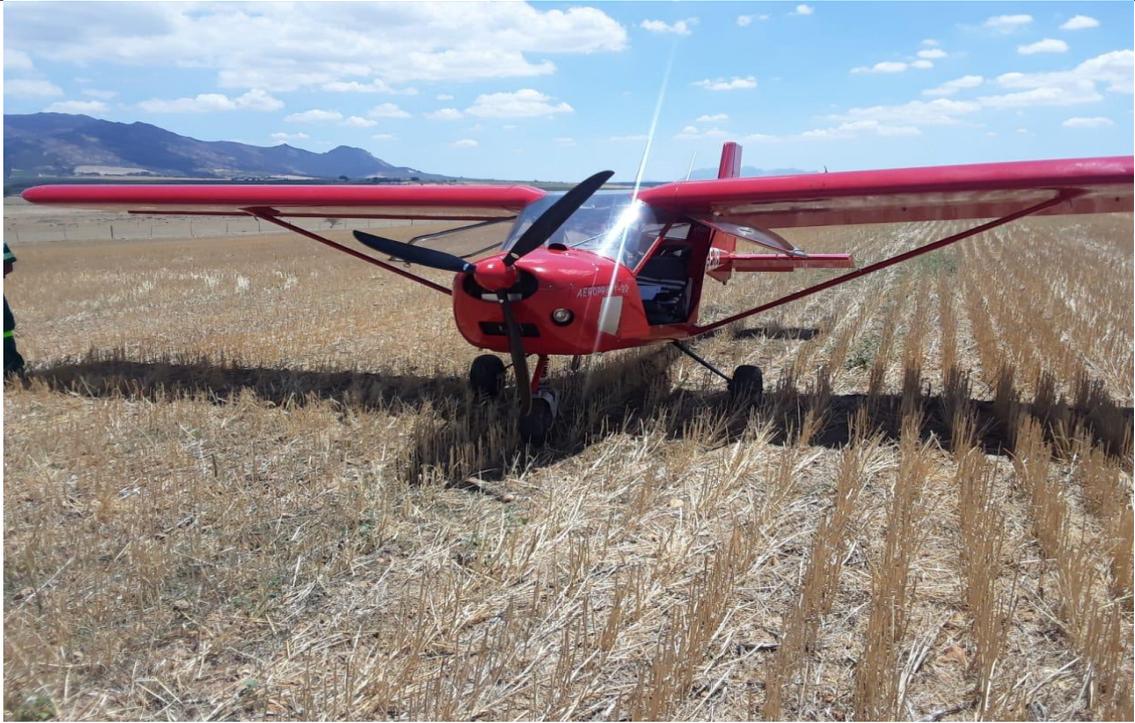
The pilot scanned and identified a suitable field on which to land ahead of the flight path. He maintained a stable glide profile and conducted a successful forced landing. The aircraft was not damaged. The pilot and the passenger were unharmed. Later on, a flight instructor from the Aviation Training Organisation (ATO) that hired out the aircraft started the engine without difficulty or anomalies found. The aircraft was recovered by an approved aircraft maintenance organisation (AMO).

Figure 2: The aircraft after it had come to a stop. (Operator)

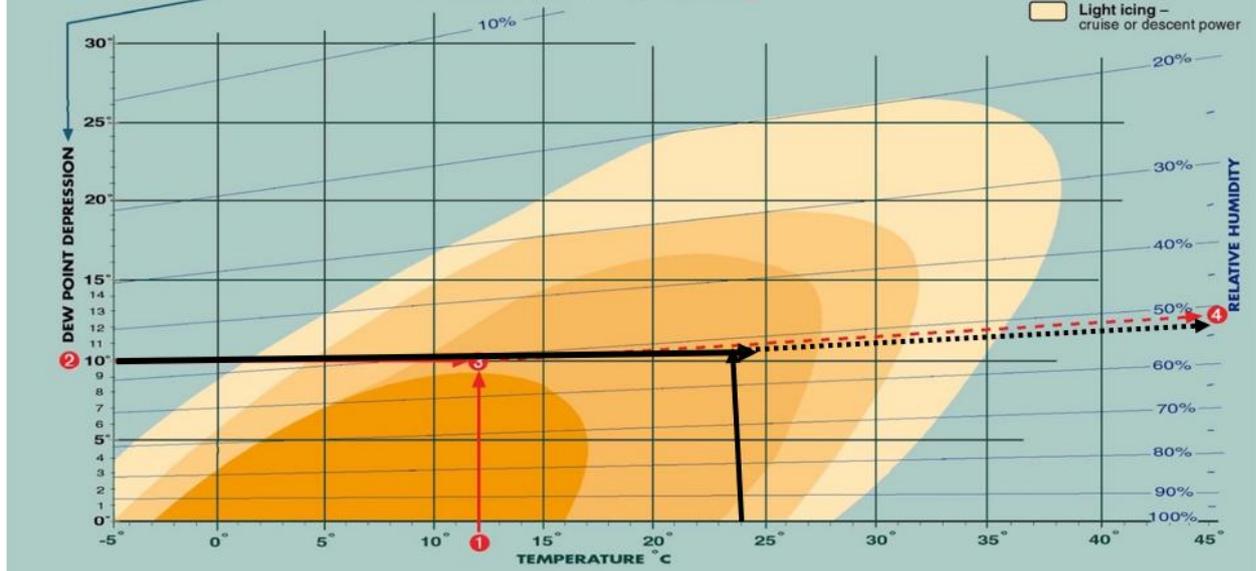
Figure 3: Carburetor Icing probability calculations.

The dew point depression of 10°C and a temperature of 24°C indicated a high chance of relative humidity at above 50% with serious icing during descent power settings.

7. During the flight, weather conditions were favourable with a temperature of 24°C and a dew point of 14°C. However, these conditions posed a significant risk of carburettor icing at certain power settings.
8. As the aircraft descended from 3500ft to 2800ft, the engine spluttered, followed by a complete shutdown which was due to carburettor icing. After the serious incident, the engine was restarted without difficulty, and no damage or system faults were found.

Weather conditions: High humidity levels increased the likelihood of serious carburettor icing during descent power settings, posing a significant hazard.

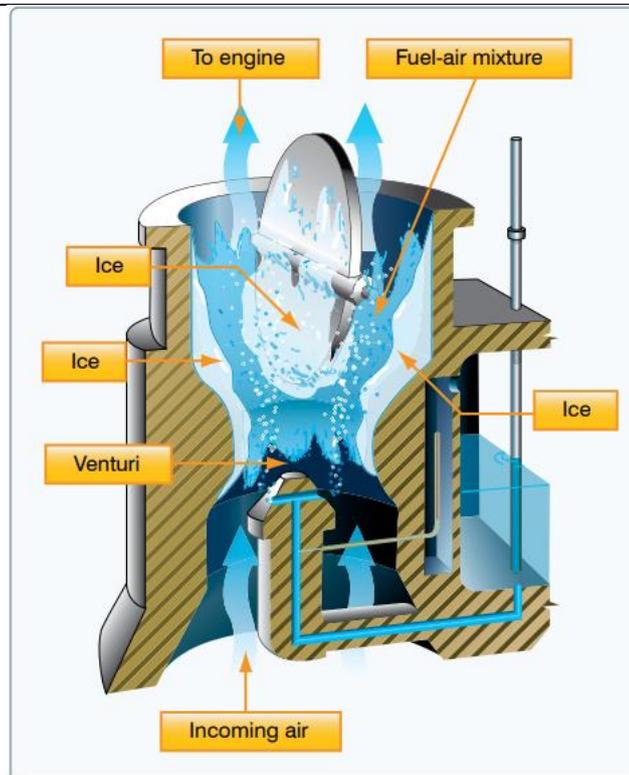
Carburettor ice occurs due to the effect of fuel vaporisation and the decrease in air pressure in the venturi, which causes a sharp temperature drop in the carburettor. If water vapour in the air condenses when the carburettor temperature is at or below freezing, ice may form on the internal surfaces of the carburettor, including the throttle valve. The reduced air pressure, as well as the vaporisation of fuel, contributes to the temperature decrease in the carburettor. Ice generally forms in the vicinity of the throttle valve and in the venturi throat. This restricts the flow of the fuel-air mixture and reduces power. If enough ice builds up, the engine may cease to operate. Carburettor ice is most likely to occur when temperatures are below 70 degrees Fahrenheit (°F) or 21 degrees Celsius (°C) and the relative humidity is above 80 percent. Due to the sudden cooling that takes place in the carburettor, icing can occur even in outside air temperatures as high as 100 °F (38 °C) and humidity as low as 50 percent.

Diagram 1: Illustration of the formation of carburettor icing.

Carburettor icing most likely occur at low power settings, such as during descent or approach, especially in humid conditions. Applying carburettor heat early can help prevent or clear the ice.
