AIRCRAFT SERIOUS INCIDENT REPORT AND EXECUTIVE SUMMARY

| | | | | Reference: | | CA18/3/2/1470 | |
| Aircraft Registration | ZS-LFW | Date of Incident | 08 February 2025 | | Time of Incident | 1420Z | |
| Type of Aircraft | Beechcraft Super King Air B200 | | Type of Operation | | Part 91 | | |

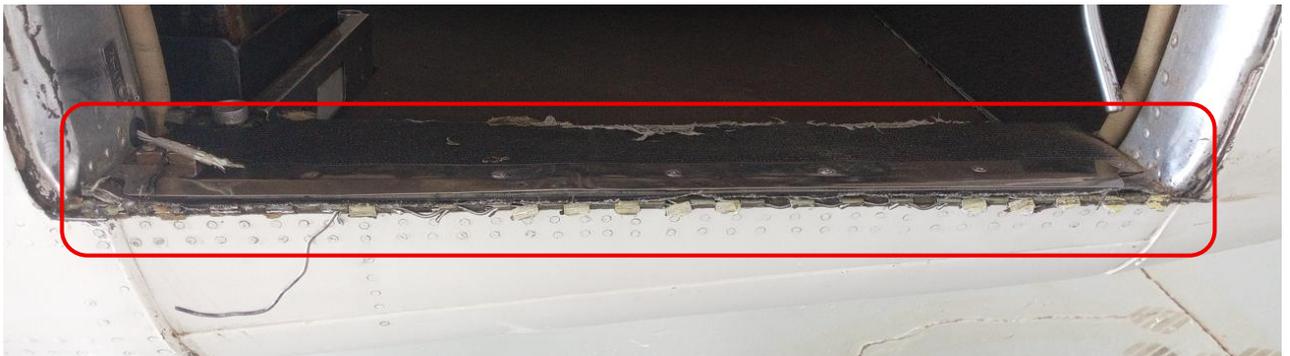
1.3.1. The aircraft sustained damage to the door attachment hardware and lower cabin door frame hinge attachment points; the cabin door was also severely damaged after it impacted the ground.

Figure 3: The damaged cabin door hinge and electrical harness.

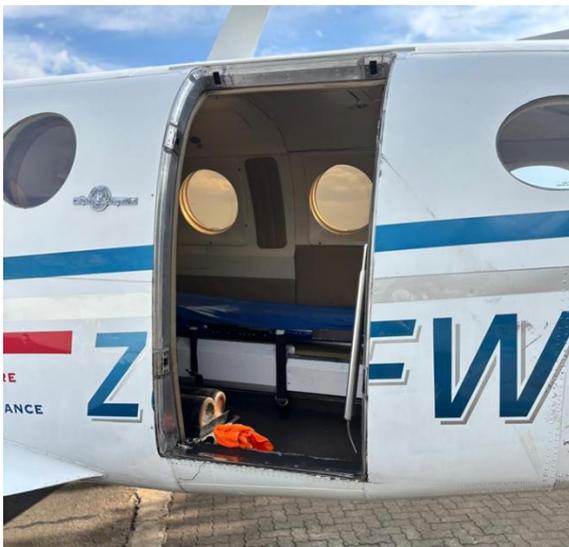
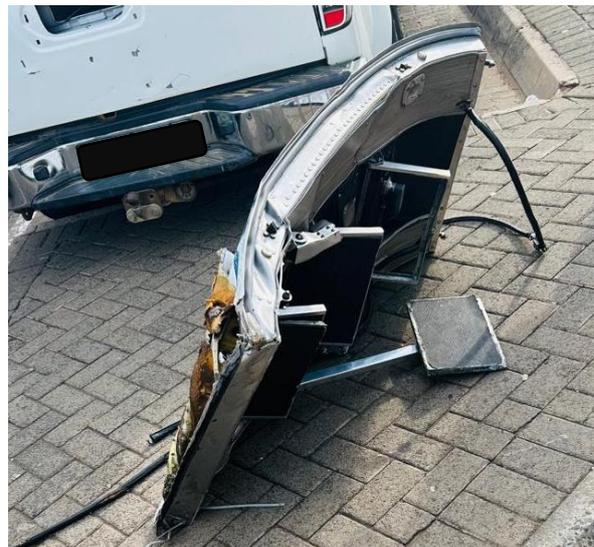
Figures 4 and 5: The aircraft without the cabin door (left), and the damaged door on the paved parking lot. (Source: Operator)

1.12.1. Whilst on approach for landing at FABL during the downwind leg for RWY 30, the cabin door opened and detached from the fuselage. It landed on a shopping mall parking lot and sustained substantial damage. No person was injured on the ground, and no property was damaged during the serious incident (see Figures 2 and 5).

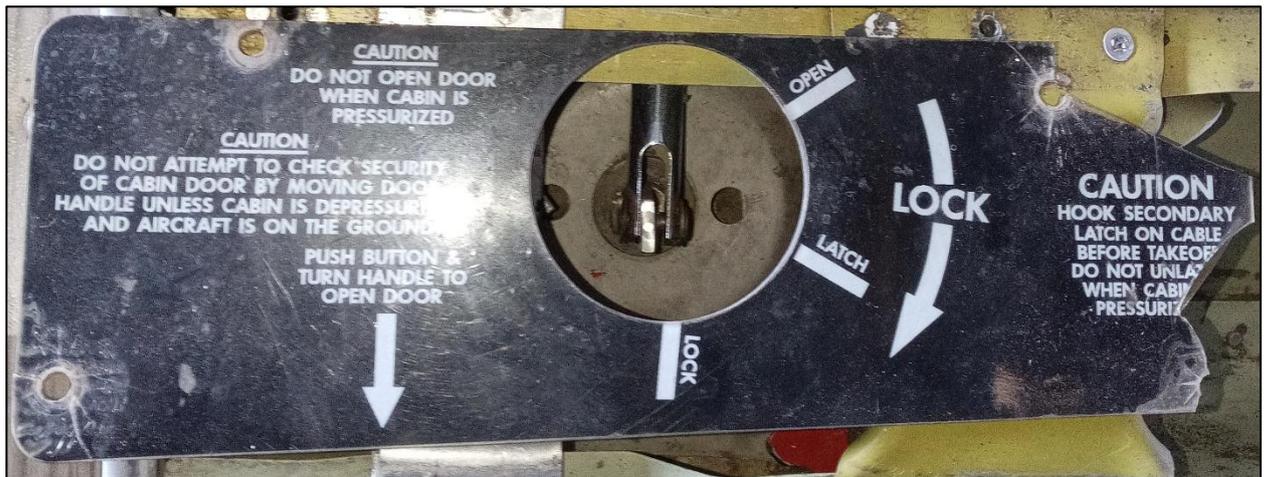
- 1.6.3. The cabin door has three distinct conditions, namely: Open, Latch and Lock as indicated on the internal door handle decal. In the Open condition, the lock safety aid and all latch pins and hooks are fully disengaged, and the door can be opened. In the Latch condition, all latch pins and hooks are positively engaged in the door frame, but the braze arm assembly lock safety aid is disengaged, and the door handle can be freely rotated. In the Lock condition, all latches and hooks are positively engaged in the door frame, the braze arm assembly safety aid lock is positively engaged, and the door handle cannot be rotated (see Figure 9).

Figure 9: The ZS-LFW cabin door interior door handle decal.

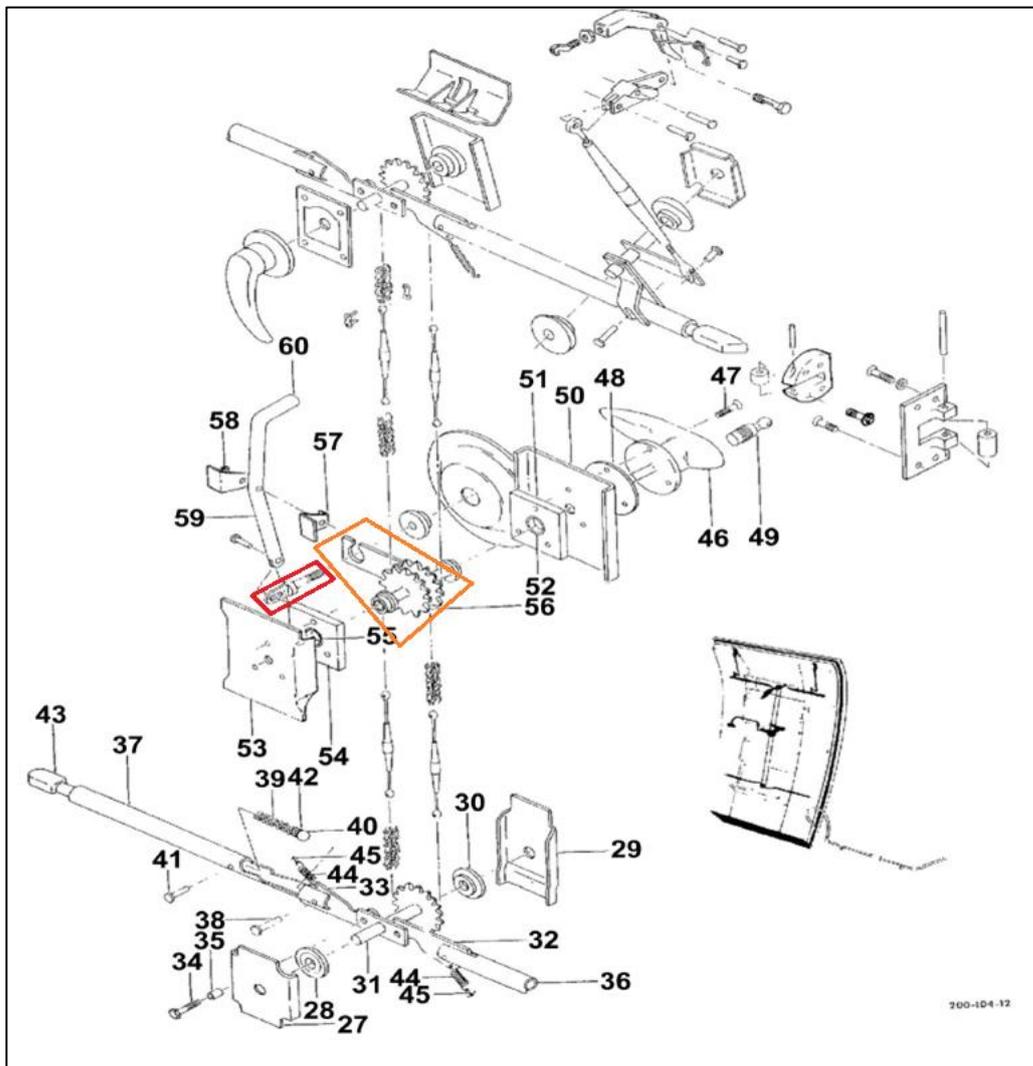
- 1.6.4. The cabin door locking mechanism has a built-in safety aid in the form of a braze assembly arm that engages a bolt to prevent the inadvertent rotation of the cabin door handle. The bolt is machined to have a wide diameter shank portion and a narrow diameter shank portion. This safety feature is deactivated by depressing a button adjacent to the cabin door handle, the action of pressing the button moves the bolt in an inboard direction, aligning the narrow diameter shank portion with the opening in the braze arm, thereby, allowing the braze arm to rotate free from the bolt. When the button is released, the bolt moves in an outboard direction and the wide diameter shank portion enters the braze arm opening and prevents it from being rotated (see Figure 10).

Figure 10: The bolt (in red) and braze arm assembly (in orange).

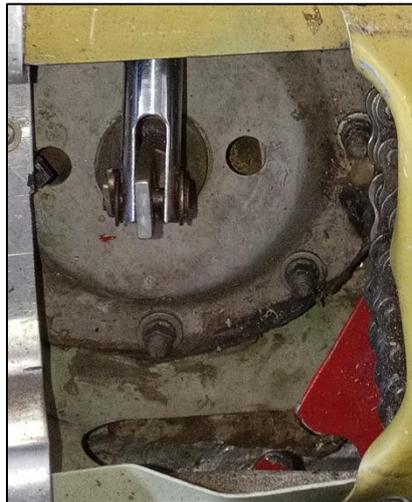
- The braze assembly arm was in the open position, not engage on the bolt (Figure 11).
- The upper forward and aft latch pins that engage in the door frame were partially extended and the lower forward and aft latch pins that engage in the door frame were fully extended (Figure 12).
- The latch hooks at the top of the door were partially extended (Figure 13).
- The interior and external handle (although impacted through the door skin) were still aligned and both were orientated in the latch (bias position) (Figures 13 and 14).

Figure 11: Braze arm assembly with engaged bolt.

- The braze arm assembly, having been found in the unlocked position, was likely the case that the door mechanism was not fully locked prior to the aircraft's departure. This is also supported by the position of the interior door handle being in the latch position. It is also likely that it was the microswitch actuated by the braze arm assembly that closed the circuit and caused the illumination of the cabin door light on the annunciator panel in the cockpit. It should be borne in mind that the potential of the impact of the cabin door with the ground to move the position of the door handles and latch pins could not be ruled out.

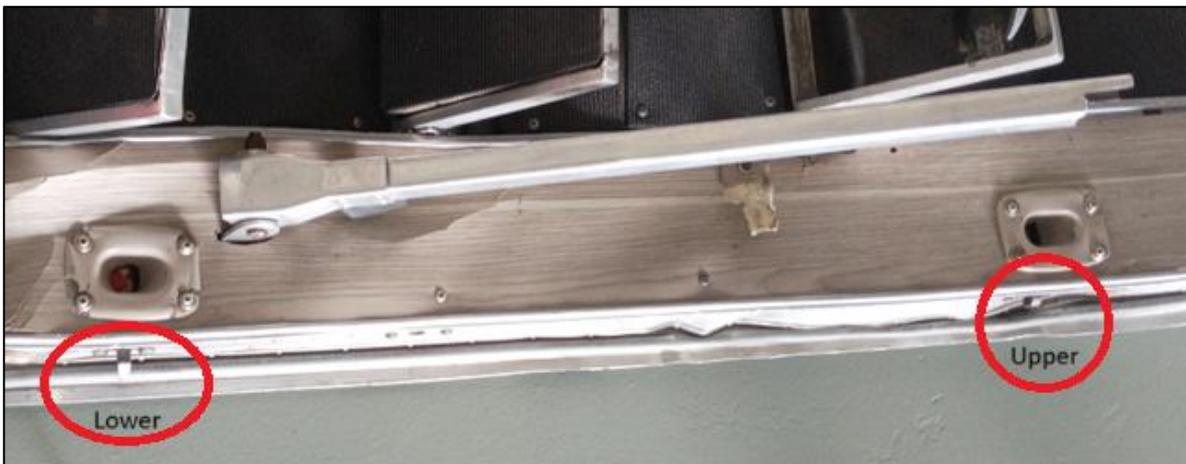
Figure 12: The fully extended lower latch pin (left red circle) and the partially extended upper latch pin (right red circle).

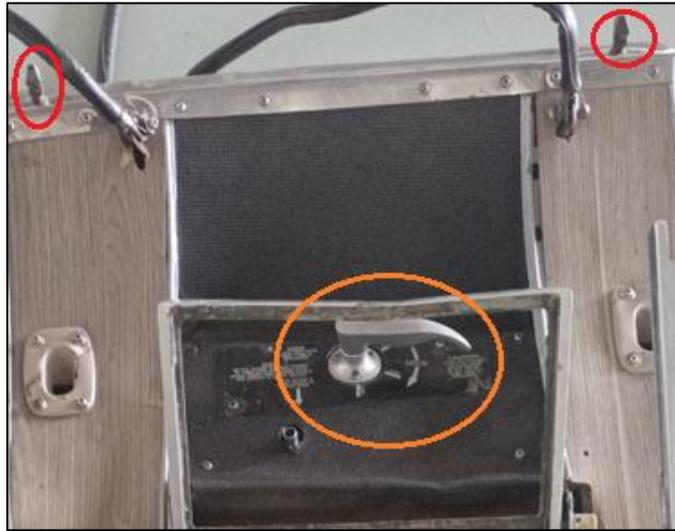
Figure 13: Partially extended top latch hooks (red circles), and the interior door handle biased to the latch position (orange circle).

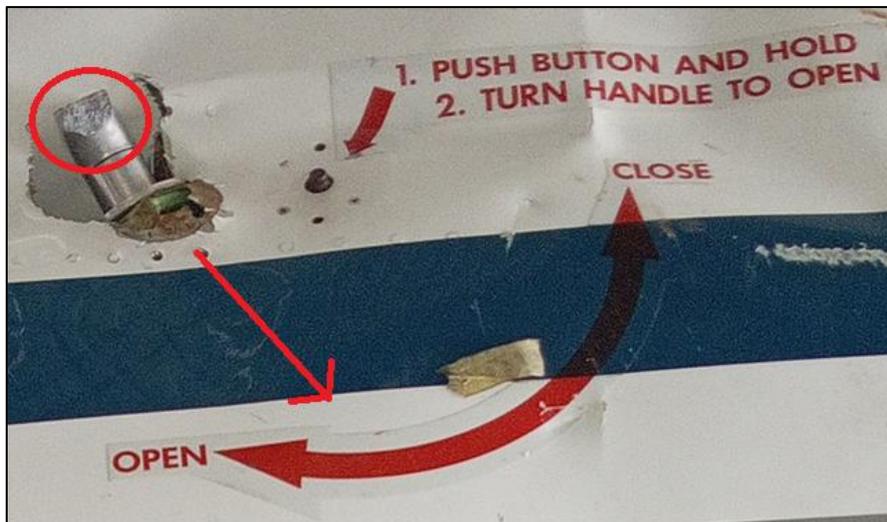
Figure 14: Exterior door handle position. The circle indicates the chipped handle piece, and the arrow indicates the approximate position the handle would point when placed back in position on the cabin door skin.

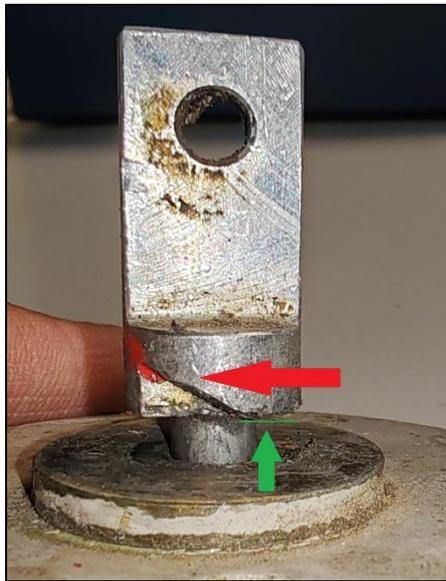
- 1.16.2. The closing of the door does not require depressing the button for the safety aid actuation as the bolt has a chamfered arc at the bottom that allows the braze arm assembly to slide up and around the bolt with noticeable force as it passes behind the wide diameter portion of the bolt, and produces a positive engagement feel and "click" when the locked position is reached as the bolt snaps back to its original position (see Figure 15).

Figure 15: Chamfered arc on bolt indicated by the red arrow; the green arrow and line indicate the flat surface behind the wide diameter portion of the bolt that is passed before positive locking around the wide diameter portion of the bolt.

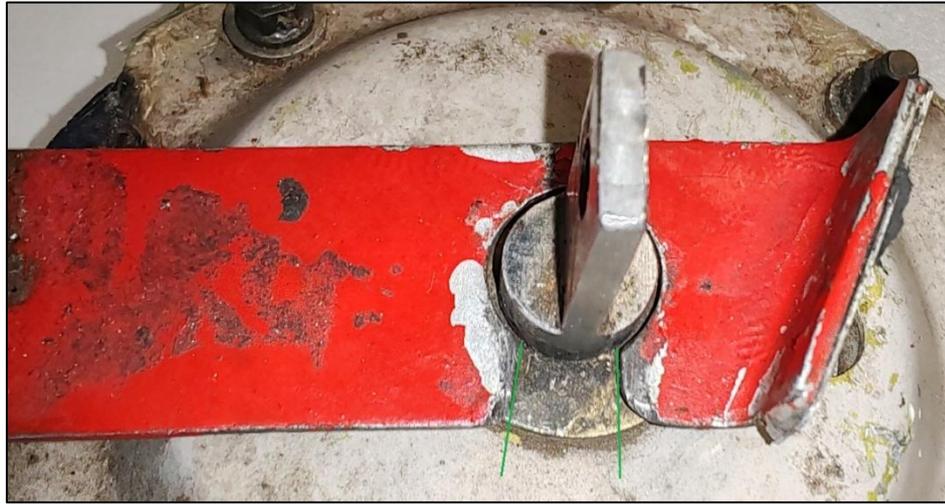
- 1.16.3. The braze arm assembly and bolt that form the door lock mechanism were removed from the cabin door to facilitate a check of the interference fit of the two components when in locked position. It was found that the interference fit was serviceable as the braze arm assembly could not be moved past the bolt without first depressing the bolt into the bellows. The braze arm assembly and bolt had no damage or deformation that would suggest the braze arm was forced past the bolt into a disengaged position (see Figure 16).

Figure 16: Braze arm assembly engaged around the bolt with positive interference as shown with green lines, and no damage beyond normal wear.

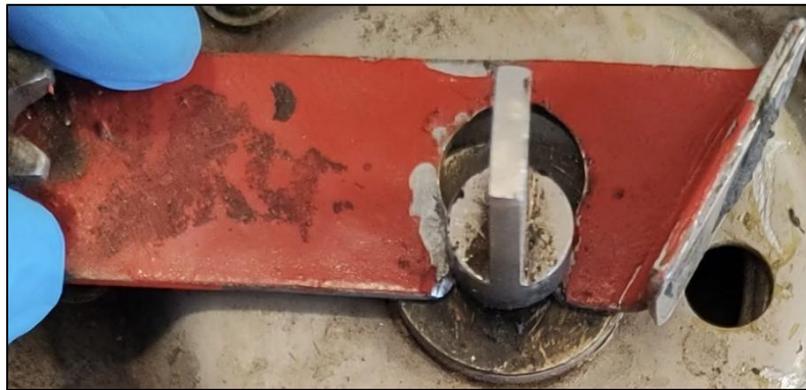
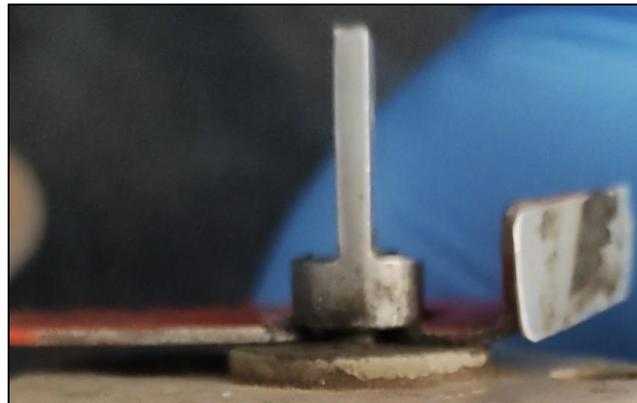
1.16.4. When testing the action of the braze arm assembly engaging the diaphragm bolt during the closing action, it was found that the potential for the braze arm assembly to remain wedged behind the wide diameter portion of the bolt of the lock mechanism and the bellows face plate flange exist without fully engaging around the shank in a locked position during the closing of the cabin door as depressing the button to move the bolt is not required during the closing action. The friction of the surface of the braze arm between the bolt and the bellows face plate flange produces a feeling of secure engagement. The braze arm would, however, not be secured in this condition and could easily disengage due to the chamfered arc on the bolt (see Figures 17 and 18).

Figures 17 and 18: The braze arm wedged behind wide diameter portion of shank and bellows face plate flange.
