**LIMITED OCCURRENCE INVESTIGATION REPORT – FINAL**

<b>Reference Number</b>	CA18/3/2/1472					
<b>Classification</b>	Serious Incident	<b>Date</b>	11 March 2025	<b>Time</b>	1218Z	
<b>Type of Operation</b>	Training (Part 141)					
<b>Location</b>						
<b>Place of Departure</b>	Virginia Aerodrome (FAVG) Durban, KwaZulu-Natal Province		<b>Place of Intended Landing</b>	Virginia Aerodrome (FAVG) Durban, KwaZulu-Natal Province		
<b>Place of Occurrence</b>	Tinley Manor Beach in Zinkwazi, KwaZulu-Natal Province					
<b>GPS Co-ordinates</b>	<b>Latitude</b>	S29°26'28.05"	<b>Longitude</b>	E31°17'31.8"	<b>Elevation</b>	7 feet
<b>Aircraft Information</b>						
<b>Registration</b>	ZU-STA					
<b>Make; Model; S/N</b>	Sling II (Serial Number: 242)					
<b>Damage to Aircraft</b>	None		<b>Total Aircraft Hours</b>	3 459.3		
<b>Pilot-in-command</b>						
<b>Licence Type</b>	Airline Transport Pilot Licence (ATPL)		<b>Gender</b>	Female		<b>Age</b> 33
<b>Licence Valid</b>	Yes	<b>Total Hours</b>	2 051.5		<b>Total Hours on Type</b>	525.8

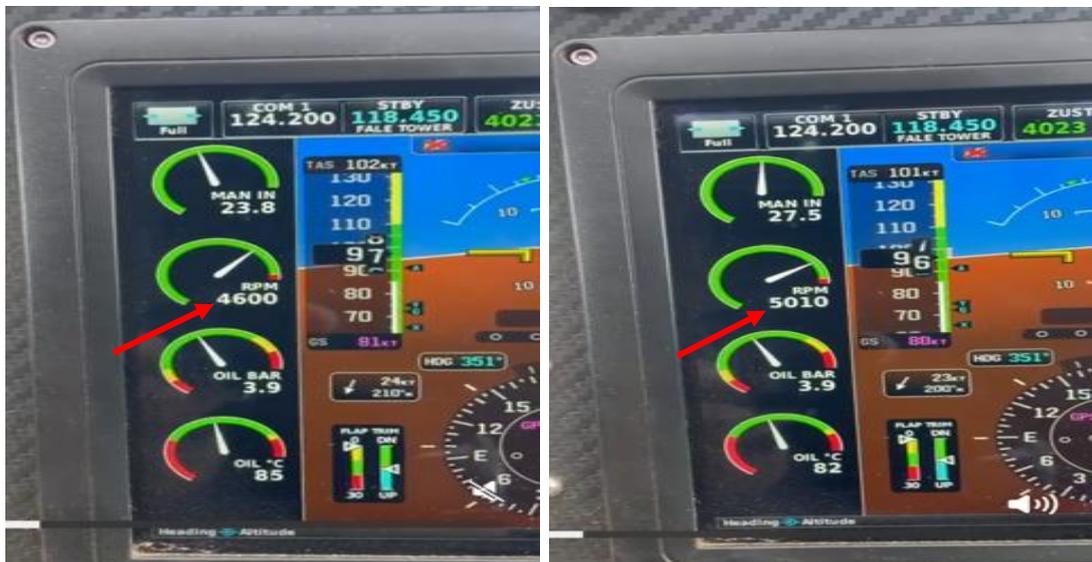
The crew had planned to be airborne for two hours, as well as route along the coast. The FI was the pilot flying (PF) at the start of the flight. The FI stated that she started the engine and allowed it to warm up until all indications were in the green arch. Thereafter, she broadcasted their intentions to FAVG tower on frequency 120.60-Megahertz (MHz). After a few minutes, she taxied the aircraft to the threshold of Runway 23. At approximately 1118Z, the FI advanced the throttle to 4 830 revolutions per minute (RPM) and commenced with the take-off run. The aircraft rotated and climbed to 2 200 feet (ft). They flew along the coast at an air speed of 94 knots (kts). Later, the crew switched roles during which the pilot (who was receiving training) became the PF as required by the exercises that they were conducting. After being airborne for about an hour whilst in the vicinity of Tinley Manor Beach, approximately 49 kilometres (km) north-east of FAVG, the crew felt a vibration that was emanating from the engine. At that time, the engine revolutions per minute (RPM) that showed on the EFIS screen were fluctuating between 4 600RPM and 5 010RPM; the pair had not moved (manoeuvred) the power lever.

**Figures 1 and 2:** The red arrow on the EFIS screen shows the engine power at 4 600RPM (left picture). The red arrow on the same screen shows the engine power at 5 010RPM (right picture).  
(Source: video footage taken by the FI)

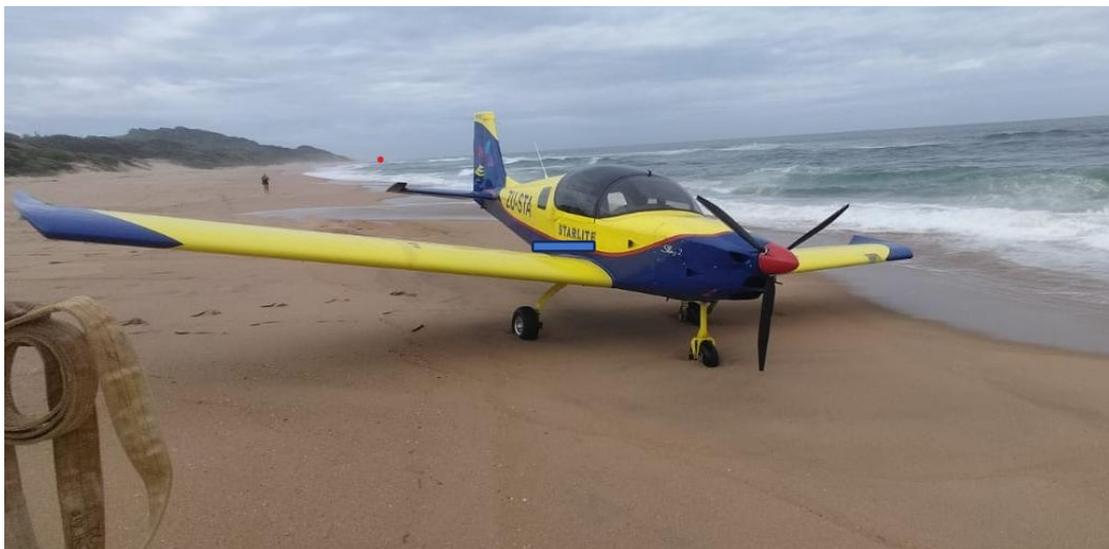
assistance. Around 1218Z, the FI performed a successful forced landing on Tinley Manor Beach in Zinkwazi. When the aircraft came to a stop, the FI turned off the master switch. The crew unbuckled their safety harnesses and disembarked from the aircraft. The aircraft was not damaged and the crew was not injured.

**Figure 4:** The aircraft as it came to rest on the beach. (Source: FI)

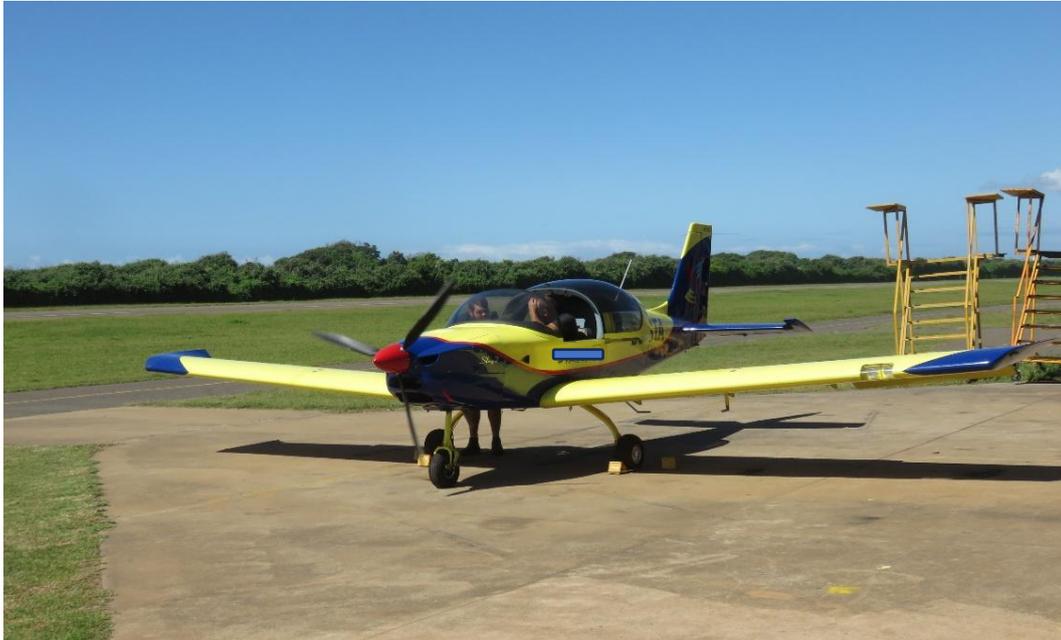
The aircraft, which was parked on the apron, was refuelled with Avgas 100LL from a bowser; each tank was refuelled with 50L. One of the engineers boarded the aircraft to perform the engine ground run as the investigator observed. The engine started immediately and was allowed to warm up until the temperature and pressures were within the normal operating range. The throttle was advanced to maximum RPM, and no anomalies were noted.

**Figure 5:** The aircraft on the apron during the engine run.

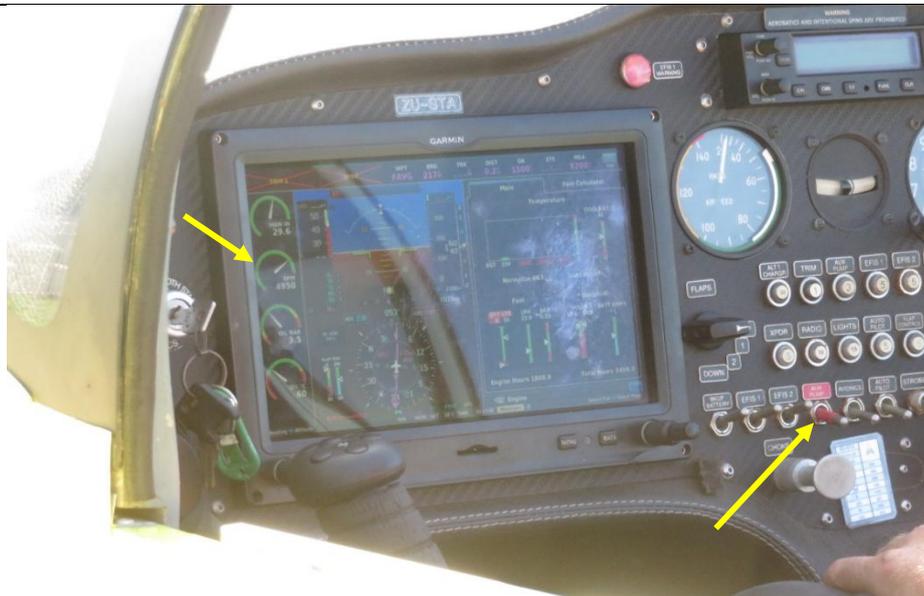
**Figure 6:** The engine RPM indication (left side yellow arrow) on the EFIS screen shows 4 950 and the auxiliary (AUX) fuel pump switch (right side yellow arrow) in the middle console is in the OFF (down) position.

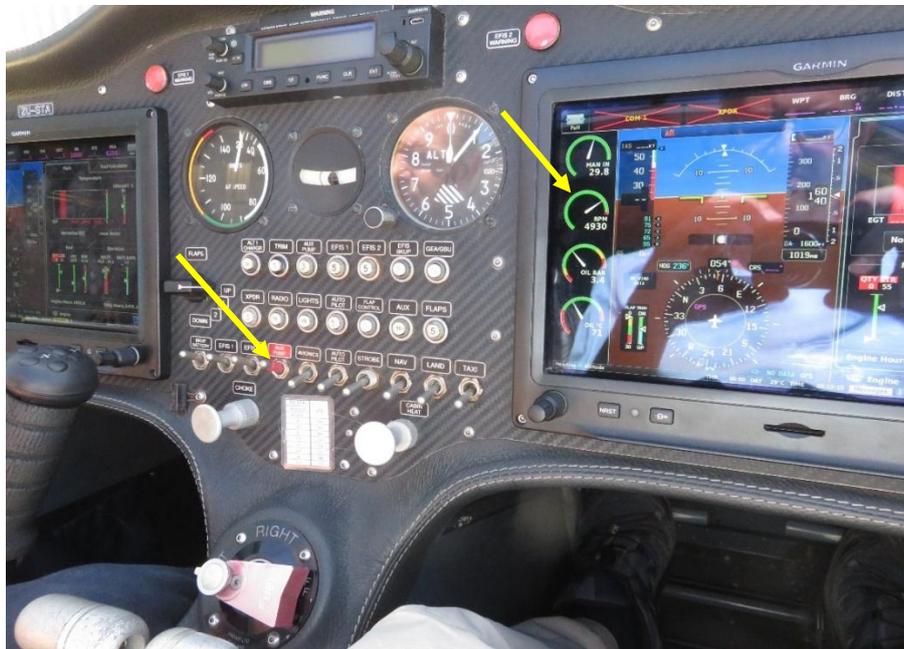
The engine was shut down and restarted after it was allowed to cool down. The throttle was advanced to maximum power; the RPM remained constant when fuel tanks were changed, and the AUX pump was switched ON and OFF and no changes were observed in engine performance and fuel flow. Moreover, there was no engine vibration.

**Figure 7:** The right EFIS screen shows the engine RPM at 4 930 with the AUX pump in the ON (up) position and with the left fuel tank selected.

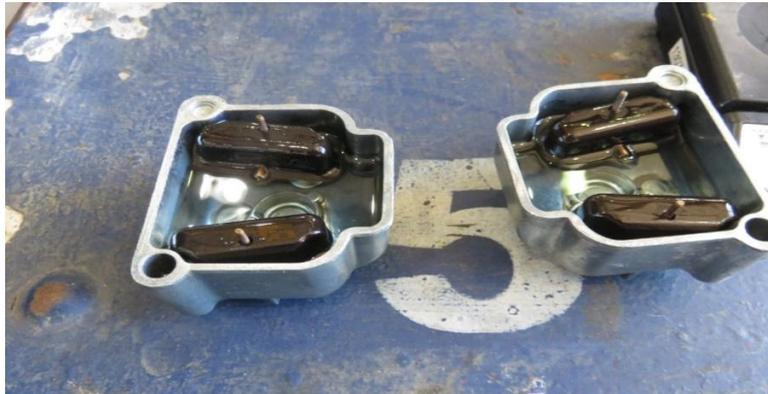
The carburettor bowls on both sides were removed after the engine ground run. They both contained Avgas 100LL fuel that was free of contamination. The floats in each of the bowls were removed and

weighed, and they were found to be within limits in accordance with (IAW) the maintenance manual (mm). In conclusion, post-serious incident examination of the engine did not reveal any anomalies that would have precluded operation of the engine prior to the occurrence.

**Figure 8:** The carburettor bowls after being removed from the engine.
