LIMITED OCCURRENCE INVESTIGATION REPORT

Reference Number	CA18/3/2/1473						
Classification	Serious Incident	Date	29 March 2025		Time	0910Z	
Type of Operation	Private (Part 91)						
Location							
Place of Departure	Virginia Aerodrome (FAVG), KwaZulu-Natal Province		Place of Intended Landing	Virginia Aerodrome (FAVG), KwaZulu-Natal Province			
Place of Occurrence	On the beach shoreline near Beachwood Mangroves Nature Reserve						
GPS Co-ordinates	Latitude	29°48'00.00" S	Longitude	031°02'00.00" E	Elevation	20 ft	
Aircraft Information							
Registration	ZS-SBC						
Make; Model; S/N	Cessna 152 (Serial Number: 15280336)						
Damage to Aircraft	None			Total Aircraft Hours	9915.4		
Pilot-in-command							
Licence Type	Private Pilot Licence (PPL)		Gender	Male		Age	19
Licence Valid	Yes	Total Hours	77.0		Total Hours on Type	77.0	
Total Hours 30 Days	14.3		Total Flying on Type Past 90 Days	32.6			
People On-board	1+1	Injuries	0	Fatalities	0	Other (on ground)	0

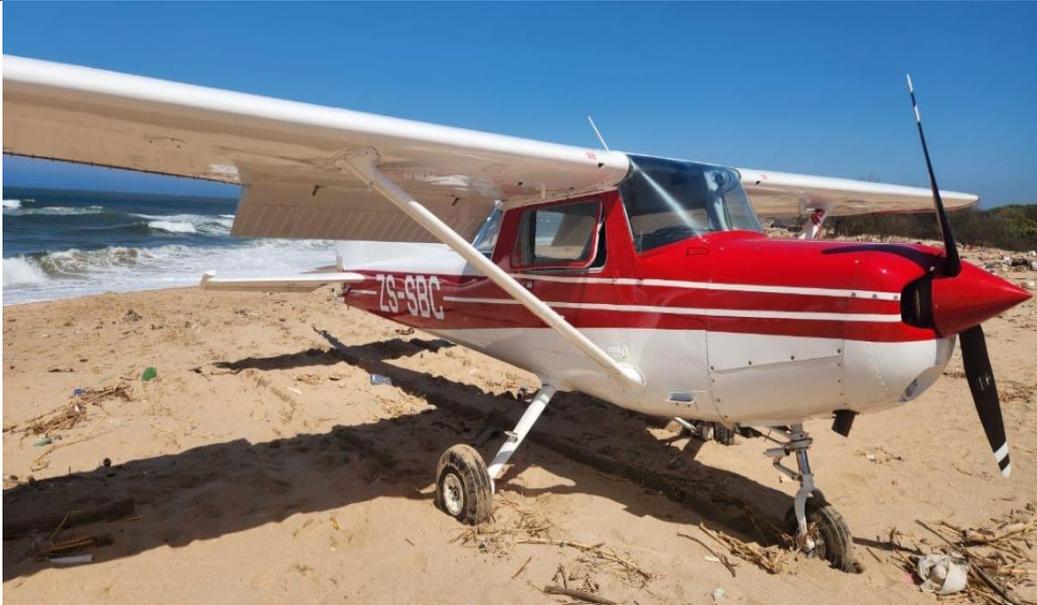
Therefore, the passenger contacted FAVG control tower on very high frequency (VHF) 120.60-Megahertz (MHZ) to inform them of their situation. As the aircraft was rapidly losing height, the pilot selected the flaps to 30 degrees and executed a successful forced landing on the beach shoreline near Beachwood Mangroves Nature Reserve. After the aircraft had stopped, the pilot switched off the master switch and turned off the fuel selector valve. Both occupants vacated the aircraft. No person was injured; the aircraft was also not damaged.

Figure 2: The aircraft after it had stopped. (Source: Safety Officer)

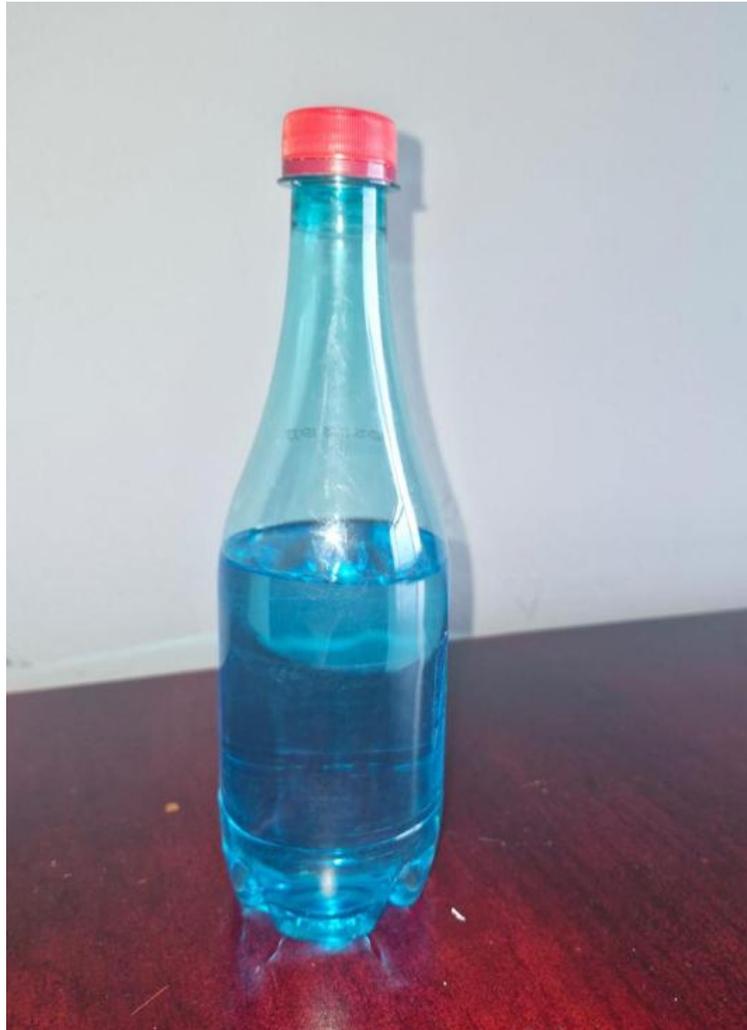
Figure 3: The amount of fuel drained from both aircraft tanks after the incident.

The aircraft was intact with no evidence of a fuel leak or contamination.

On 28 March 2025, the aircraft was uplifted with 33 litres (8.7 US Gallons) of fuel which was recorded in the flight folio. At the time of departure on 29 March 2025, the aircraft had insufficient fuel on-board to complete the full duration of the planned navigational flight.

Probable Cause(s)
Engine failure due to fuel exhaustion.
Contributing Factor(s)
None.
Safety Action(s)
The operator should ensure adherence to fuel policy when leasing aircraft to pilots. Pilots who lease aircraft to build hours are likely to upload the minimum required fuel for their trip to contain costs associated with flying.
