AIRCRAFT SERIOUS INCIDENT REPORT AND EXECUTIVE SUMMARY

Reference:		CA18/3/2/1474	
Aircraft Registration	ZU-JHF	Date of Incident	5 April 2025		Time of Incident	0908Z	
Type of Aircraft	Jabiru J430			Type of Operation	Private (Part 94)		
Pilot-in-command Licence Type	Private Pilot Licence		Age	49	Licence Valid	Yes	
Pilot-in-command Flying Experience	Total Flying Hours			986.3	Hours on Type	353.0	
Last Point of Departure	Heuningberg Farm, Western Cape Province						
Next Point of Intended Landing	Morningstar Aerodrome, Western Cape Province						
Damage to Aircraft	Minor						
Location of the incident site with reference to easily defined geographical points (GPS readings if possible)							
Ploughed field near Riebeek-Kasteel Town (GPS position: 33°24'55.95" South 018°51'26.79" East)							
Meteorological Information	Surface wind: 045°/10kt; temperature: 25°C; dew point: 10°C; visibility: CAVOK						
Number of People On-board	1+1	Number of People Injured	0	Number of People Killed	0	Other (On Ground)	0

Probable Cause/s and/or Contributory Factors							
<p>The pilot executed a forced landing on a ploughed field after engine failure; as a result, the aircraft sustained minor damage. I

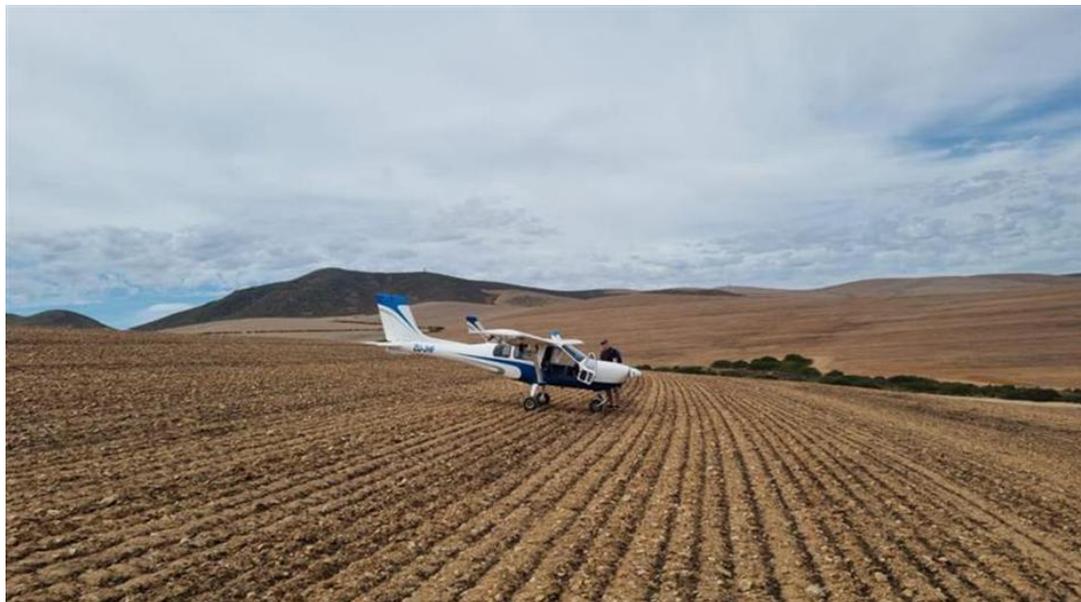
1.12.2 The aircraft sustained minor damage to the undercarriage due to an uneven terrain.

Figure 2: The aircraft on the cultivated wheat field. (Source: Pilot)

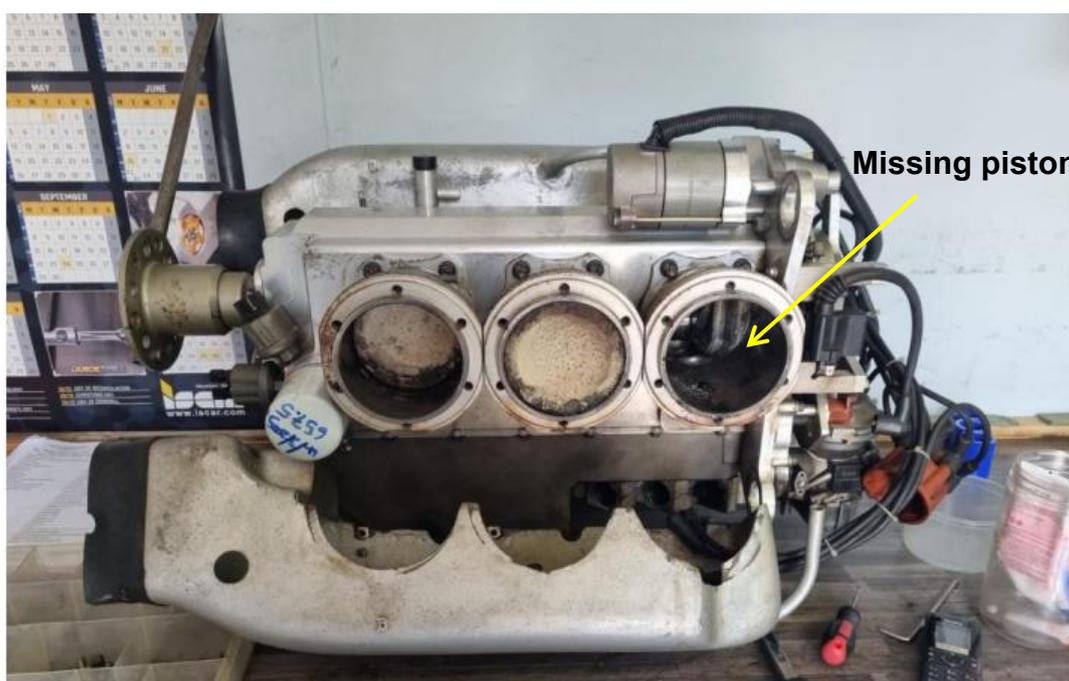
1. The piston from the Number cylinder 6 was missing, and there was debris that had scattered throughout the barrel.
2. The inlet valve head of the Number 6 cylinder was found separated from the valve stem.
3. The connecting rod (Conrod) of the Number 6 cylinder was found bent; the gudgeon pin was still attached.
4. Fragments of the piston and piston rings were located inside the engine, which further contributed to internal damage.

Figure 3: The Number 6 cylinder barrel with an absent piston.

The failure of the Number 6 cylinder piston could be attributed to exposure of high EGT temperatures (overheating) which, over an undetermined period, deteriorated the material integrity of the component and caused the piston to cease in the cylinder barrel. There might have been other factors that could have contributed to the failure, which were discussed in the technical report supplied by the manufacturer, and which could have resulted in additional hardware damage and, ultimately, causing the engine to fail.

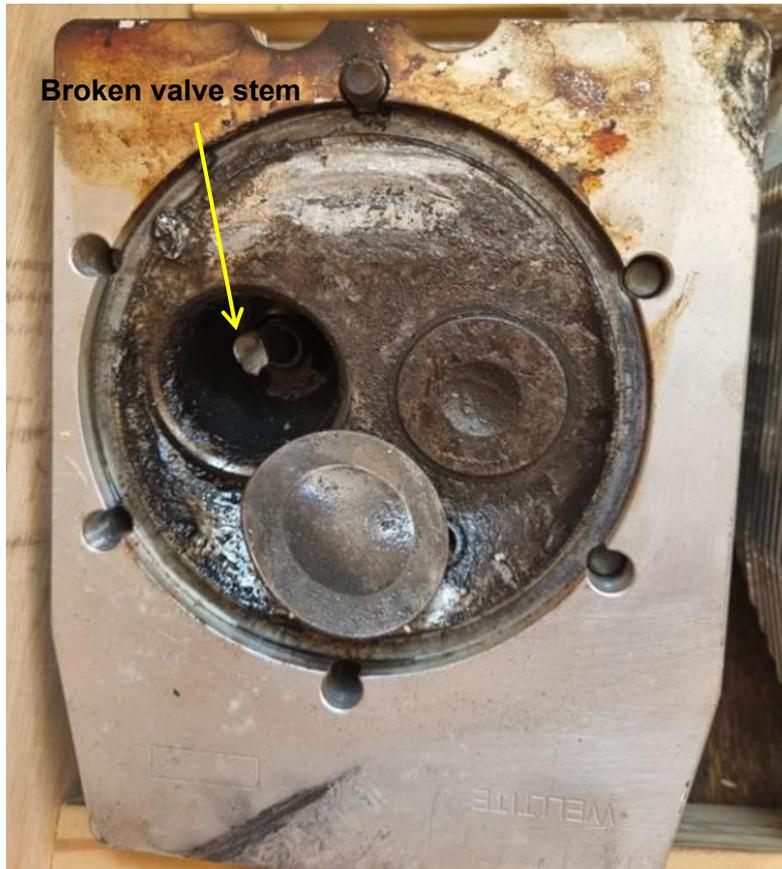
Figure 4: The Number 6 inlet valve head separated from the valve stem.

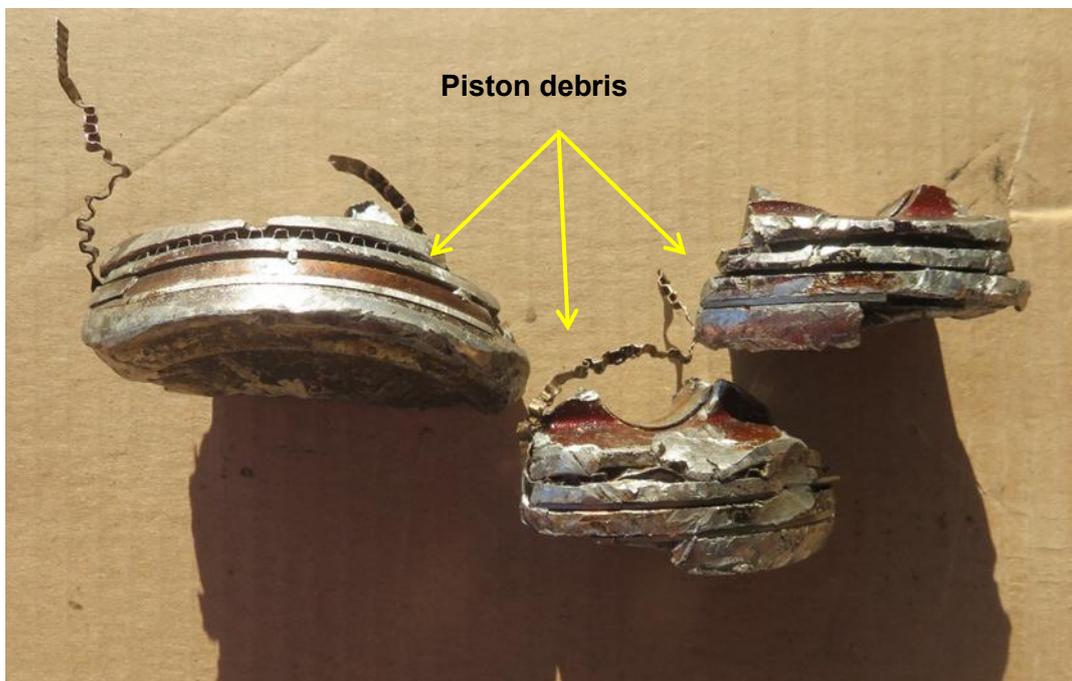
Figure 5: The debris found in the piston (viewed from the side).

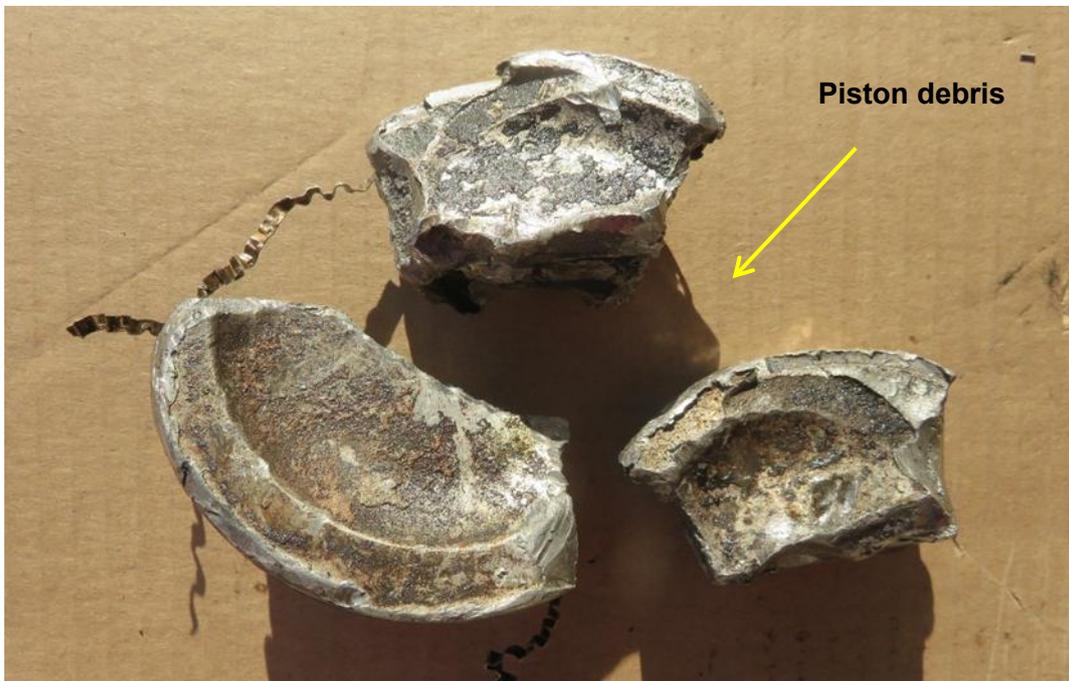
Figure 6: The debris found in the piston (viewed from the top).

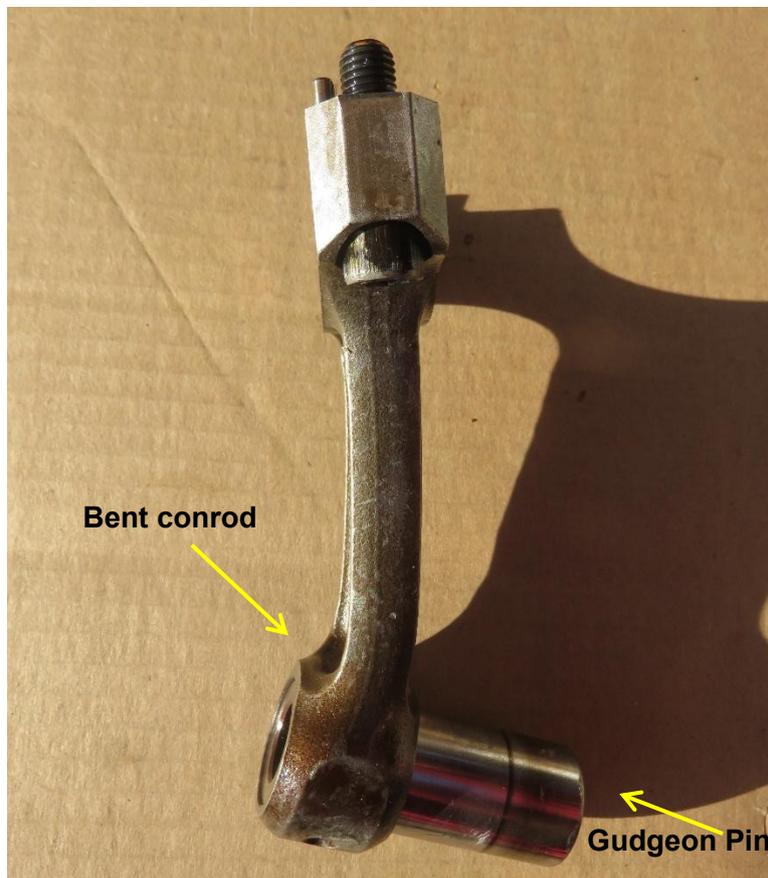
Figure 7: The bent conrod with gudgeon pin still attached.

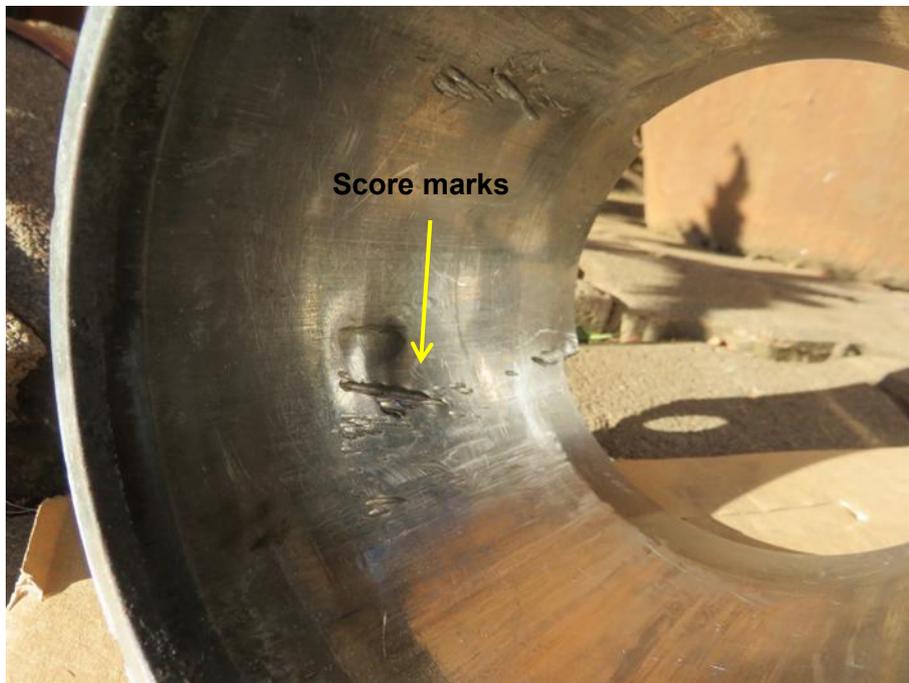
Figure 8: Score markings inside the Number 6 barrel.

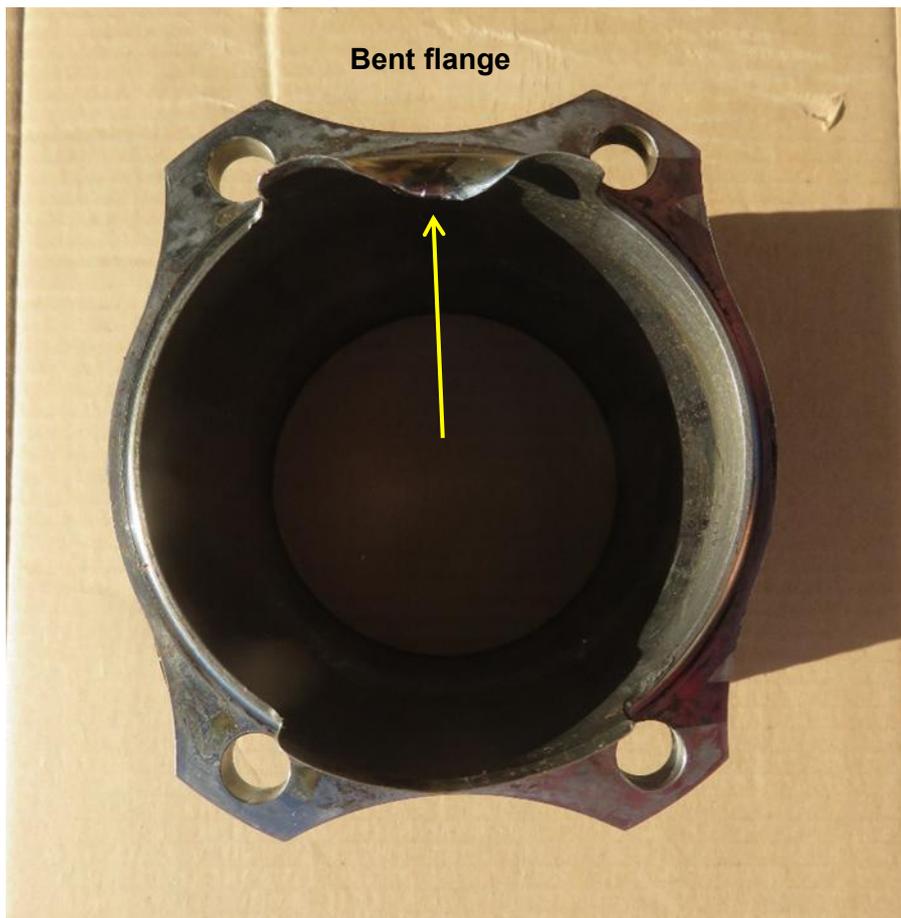
Figure 9: The Number 6 barrel with the flange bent on one end.

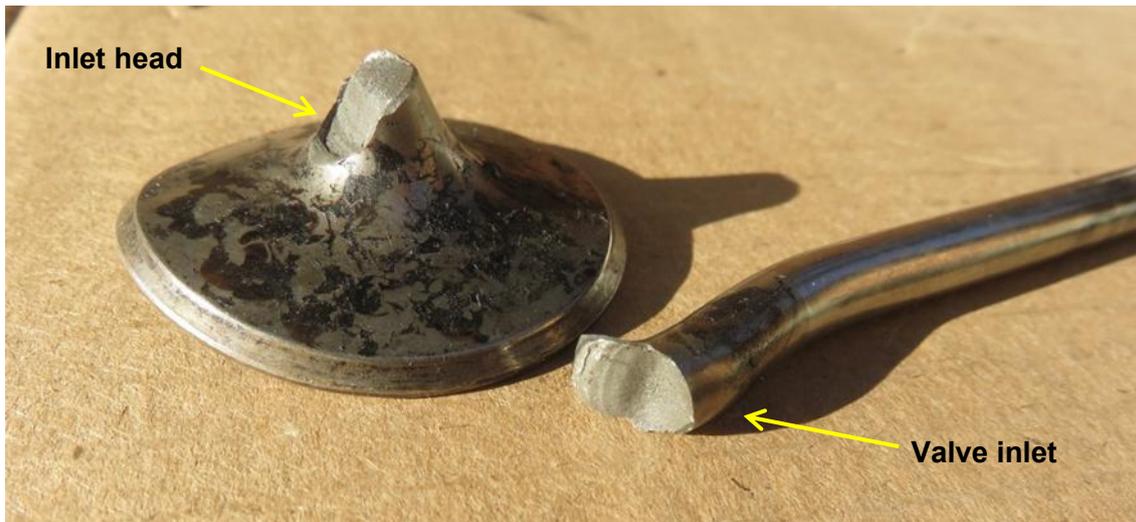
Figure 10: The fractured inlet valve head and the bent valve stem.

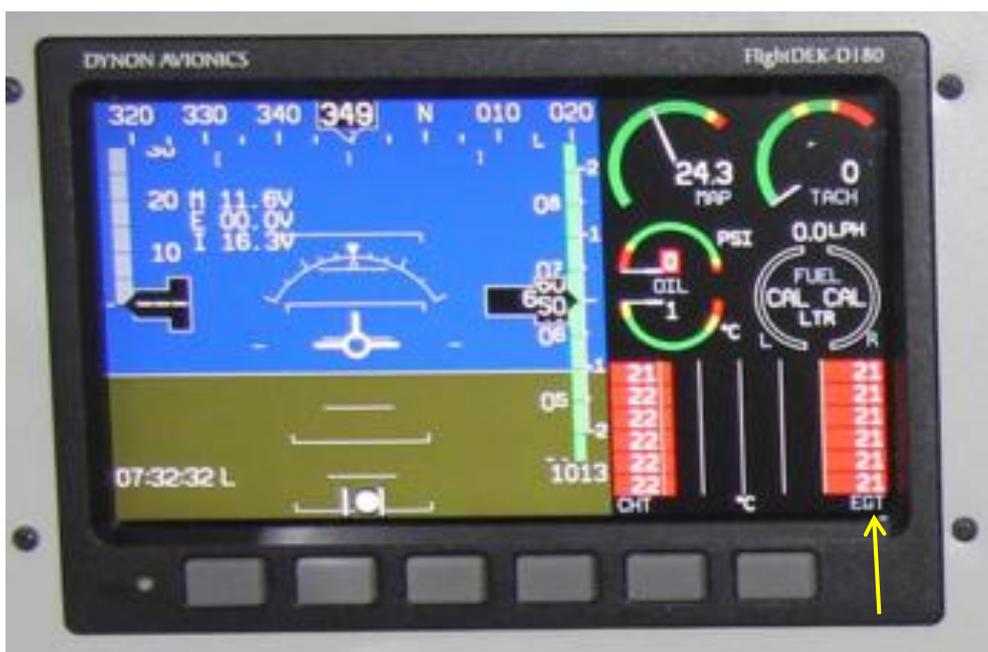
The aircraft owner disclosed that the EGT for the Number 6 cylinder frequently exceeded 800°C, whilst the maximum allowable EGT specified in the Jabiru Engine Maintenance Manual for the Generation 3 engine is 740°C.

Figure 14: Engine parameters are shown on the right, with the EGT temperature indicated by the yellow arrow.
