LIMITED OCCURRENCE INVESTIGATION REPORT – DRAFT

Reference Number	CA18/3/2/1475						
Classification	Serious Incident	Date	27 April 2025			Time	0558Z
Type of Operation	Training (Part 141)						
Location							
Place of Departure	Cape Winelands Aerodrome (FAWN), Western Cape Province			Place of Intended Landing	Cape Winelands Aerodrome (FAWN), Western Cape Province		
Place of Occurrence	On a farmland, approximately 3 nautical miles (nm) north-east of Cape Winelands Aerodrome						
GPS Co-ordinates	Latitude	33° 45' 34.05" S	Longitude	018° 44' 49.07" E	Elevation	308.4ft	
Aircraft Information							
Registration	ZS-FWR						
Make; Model; S/N	Piper; PA-28-140 Cherokee (Serial Number: 28-25326)						
Damage to Aircraft	None			Total Aircraft Hours	12 730.63		
Pilot-in-command							
Licence Type	Commercial Pilot Licence (CPL)		Gender	Male		Age	28
Licence Valid	Yes	Total Hours	513.7		Total Hours on Type	420.3	
Total Hours 30 Days	57.7		Total Flying on Type Past 90 Days	82.7

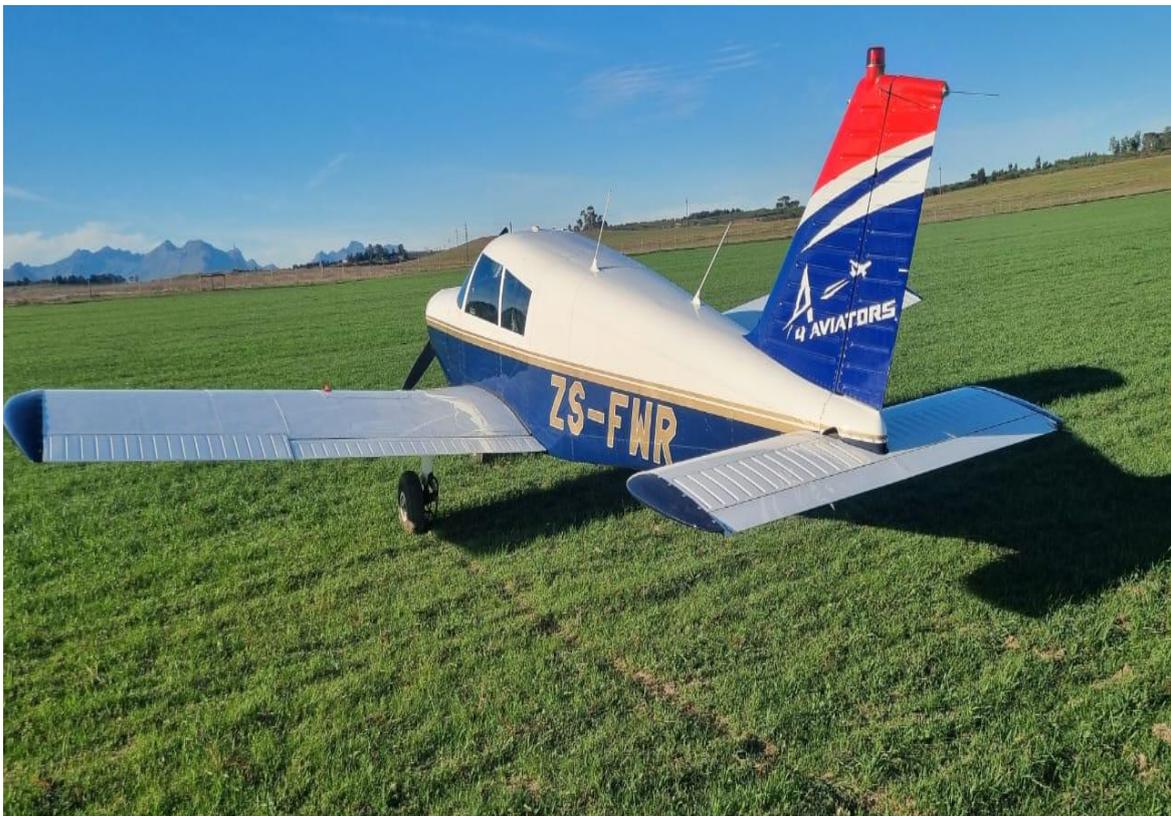
Figure 2: The aircraft came to rest on the farmland. (Source: ATO)

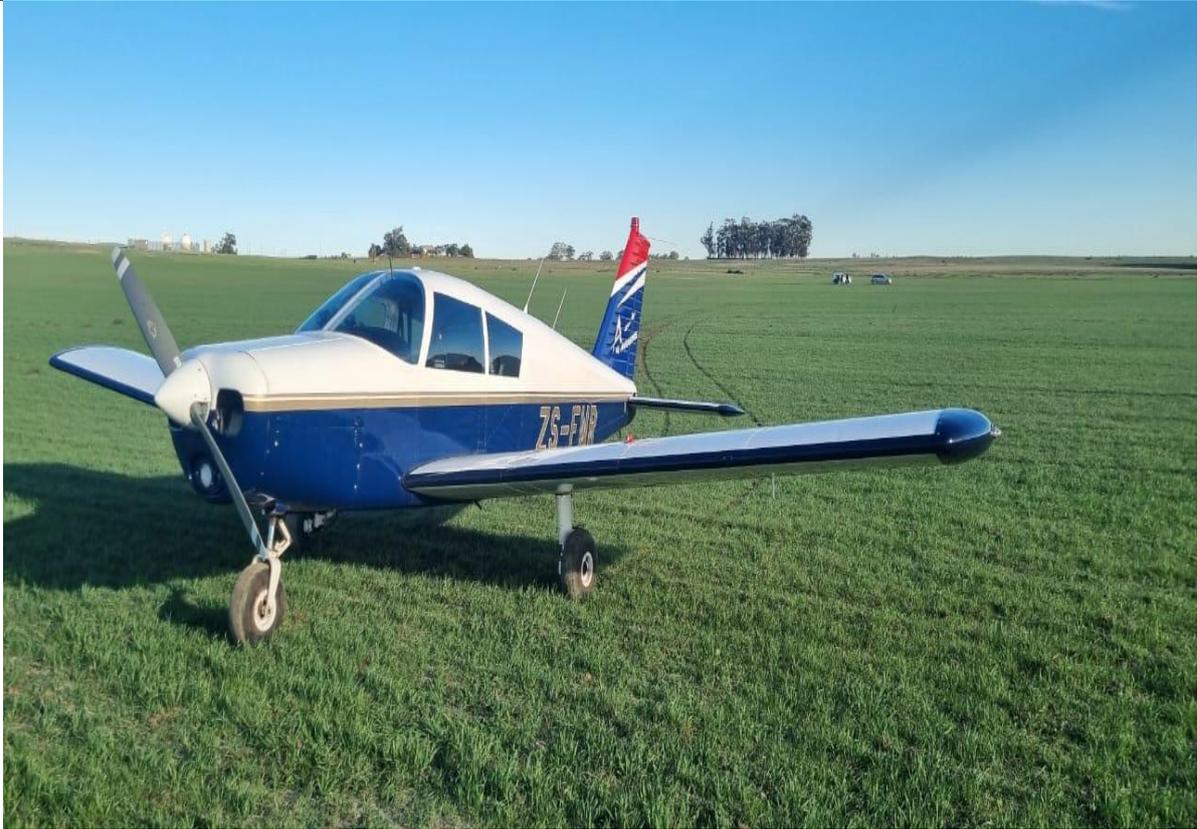
Figure 3: The track marks that were made by the aircraft before it stopped. (Source: ATO)

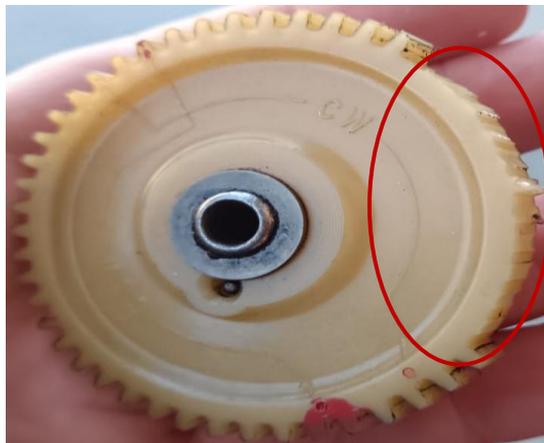
An aircraft maintenance organisation (AMO) that was approved by the South African Civil Aviation Authority (SACAA) inspected the failed right-side magneto. The AMO determined that a broken distributor gear within the magneto (Figure 4) was the root cause of the failure. This internal mechanical failure rendered the magneto inoperative and was the direct cause of the engine malfunction during the flight.

Figure 4: The magneto distributor gear. The red oval shows the broken distributor gear. (Source: AMO)

The mechanical failure of the right magneto due to the breakdown of the distributor gear caused the engine to misfire and lose power.

As part of the rectification process, the AMO performed a 500-hour/4-year inspection on both magnetos in line with the applicable maintenance schedules and airworthiness requirements (Figures 5 and 6). The magnetos were deemed serviceable, and a Certificate of Release to Service for both magnetos was issued on 30 April 2025.
