LIMITED OCCURRENCE INVESTIGATION REPORT – FINAL

Reference Number	CA18/3/2/1476					
Classification	Serious Incident	Date	26 April 2025		Time	1110Z
Type of Operation	Private (Part 91)					
Location						
Place of Departure	Virginia Aerodrome (FAVG), KwaZulu-Natal Province		Place of Intended Landing	King Phalo Aerodrome (FAEL), Eastern Cape Province		
Place of Occurrence	King Phalo Aerodrome Runway 11					
GPS Co-ordinates	Latitude	33° 02'11.43" S	Longitude	027° 49'07.44" E	Elevation	404 ft
Aircraft Information						
Registration	ZU-STG					
Make; Model; S/N	Sling 2 (Serial Number: 294)					
Damage to Aircraft	Minor		Total Aircraft Hours	2116.7		
Pilot-in-command						
Licence Type	Private Pilot Licence (PPL)		Gender	Female		Age 24
Licence Valid	Yes		Total Hours	117		Total Hours on Type 22.5
Total Hours 30 Days	4		Total Flying on Type Past 90 Days	4		
People On-board	1+0		Injuries	0		Fatalities 0
						Other (on ground) 0
What Happened						
<p>On Saturday, 26 April 2025, a pilot on-board a Sling 2 aircraft with registration ZU-STG took off from Virginia Aerodrome (FAVG) in KwaZulu-Natal province to King Phalo Aerodrome (FAEL) in Eastern Cape province. The flight was conducted under

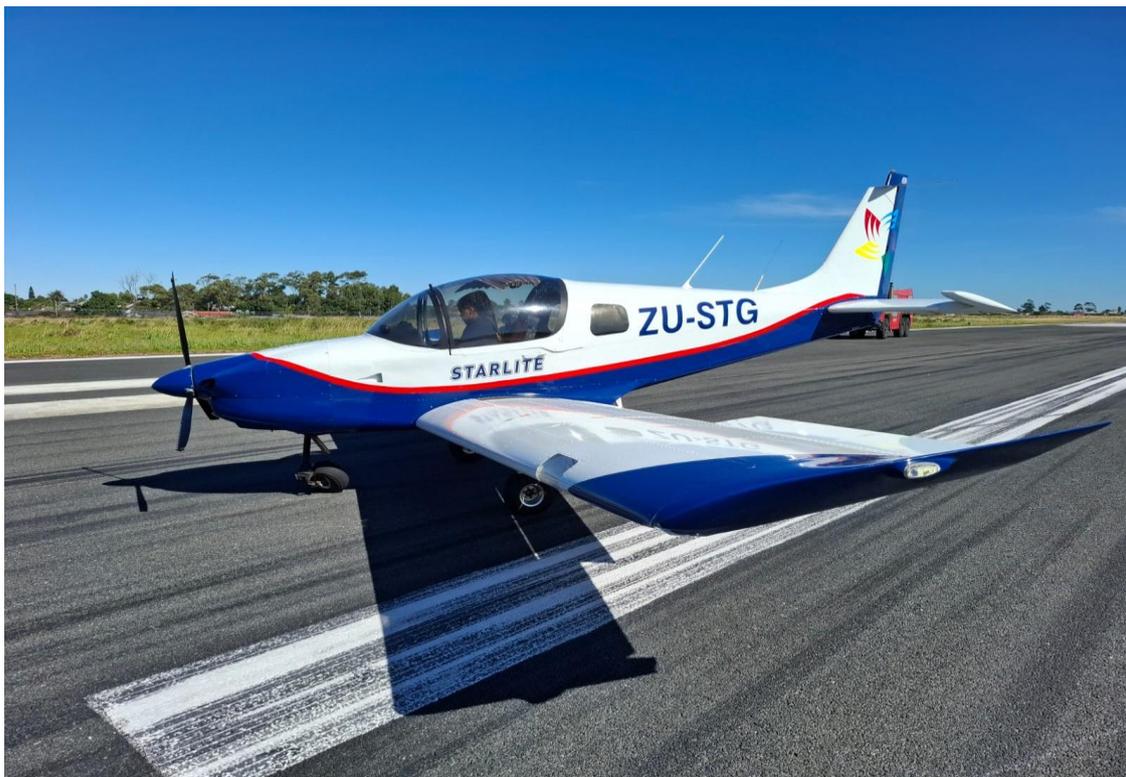
Figure 1: The aircraft as it came to a full stop. (Source: Operator)

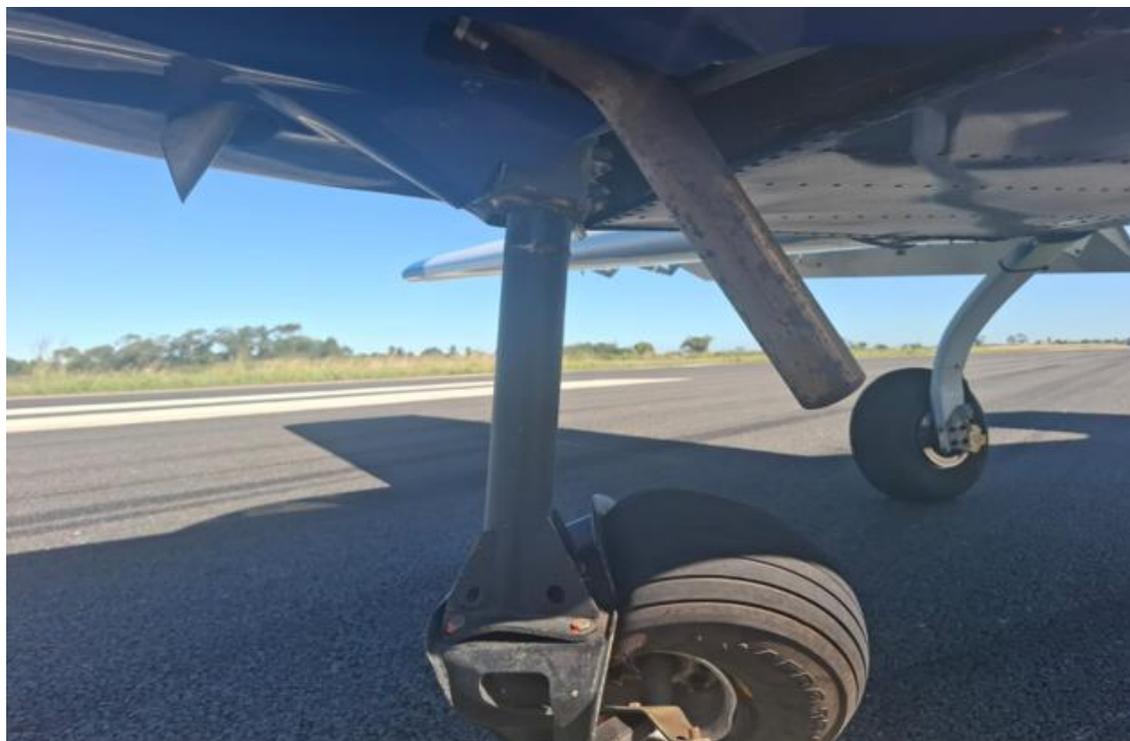
minor damage to the lower nose landing gear wheel support bracket, which bent to the right; the propeller tips; and the left-wing tip. The pilot was not injured.

Figure 2: Damage to the nose landing gear wheel support bracket.

11. Improper power management resulted in an increased rate of descent and multiple bounces after landing; the aircraft sustained damage to the propeller, nose landing gear wheel bracket and left-wing tip.
Probable Cause(s)
Improper power management resulted in an increased rate of descent and multiple bounces after landing.
Contributing Factor(s)
<ul style="list-style-type: none"> • The pilot's limited experience on the type. • Unfamiliarity with the destination aerodrome. • Deviation from the recommended approach speed as defined in the POH • Increased workload due to an extended downwind leg.
Safety Action(s)
None.
Safety Message
The approved training organisation (ATO) should introduce staged solo approvals for pilots accumulating hours towards their commercial pilot licences, starting with dual instruction or remote supervision for flights to unfamiliar aerodromes. Each flight should be followed by a structured debrief to review the pilot's approach, landing, speed control and decision-making.

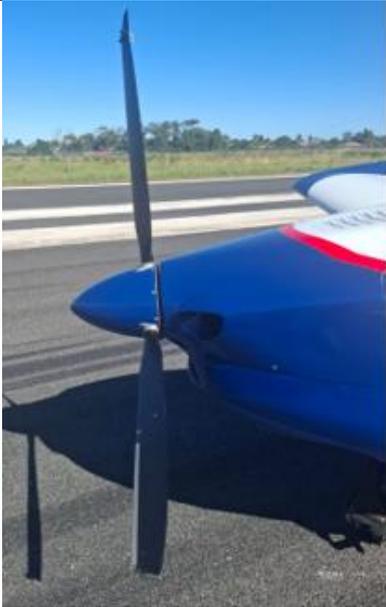
Figure 3: Damage to the propeller.

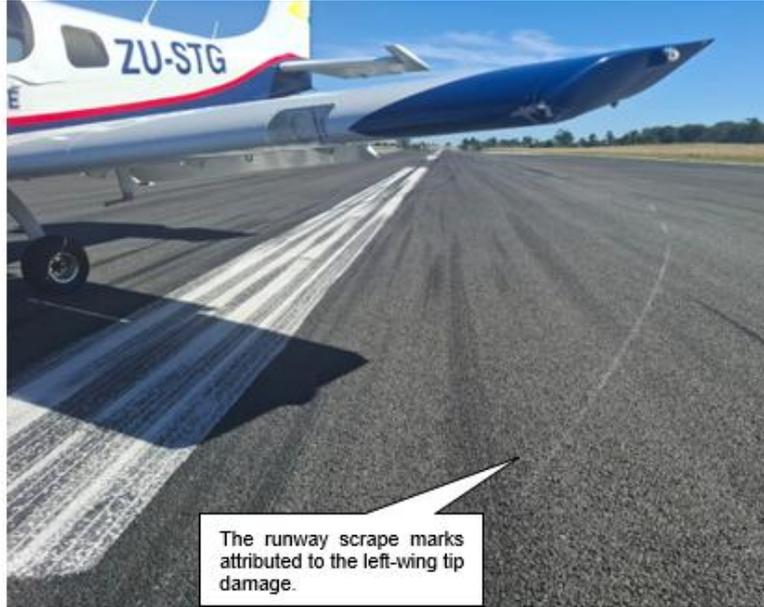
The runway scrape marks attributed to the left-wing tip damage.

Figure 4: Damage to the left-wing tip.
