LIMITED OCCURRENCE INVESTIGATION REPORT – FINAL

Reference Number	CA18/3/2/1478						
Classification	Serious Incident	Date	14 May 2025		Time	0942Z	
Type of Operation	Private (Part 94)						
Location							
Place of Departure	Wings Park Airfield, East London, Eastern Cape Province		Place of Intended Landing		Wings Park Airfield, East London, Eastern Cape Province		
Place of Occurrence	Wings Park Airfield in East London, Eastern Cape Province						
GPS Co-ordinates	Latitude	32°49'.17" S	Longitude	27°50'.18" E	Elevation	1 276ft	
Aircraft Information							
Registration	ZU-FVZ						
Make; Model; S/N	Jabiru Aircraft; J170 (Serial Number: 20)						
Damage to Aircraft	Minor		Total Aircraft Hours	472.5			
Pilot-in-command							
Licence Type	National Pilot Licence (NPL)		Gender	Male		Age	69
Licence Valid	Yes	Total Hours	1369.2		Total Hours on Type	30.2	
Total Hours 30 Days	12		Total Flying on Type Past 90 Days	23.6			
People On-board	1+1	Injuries	0	Fatalities	0	Other (on the ground)	0

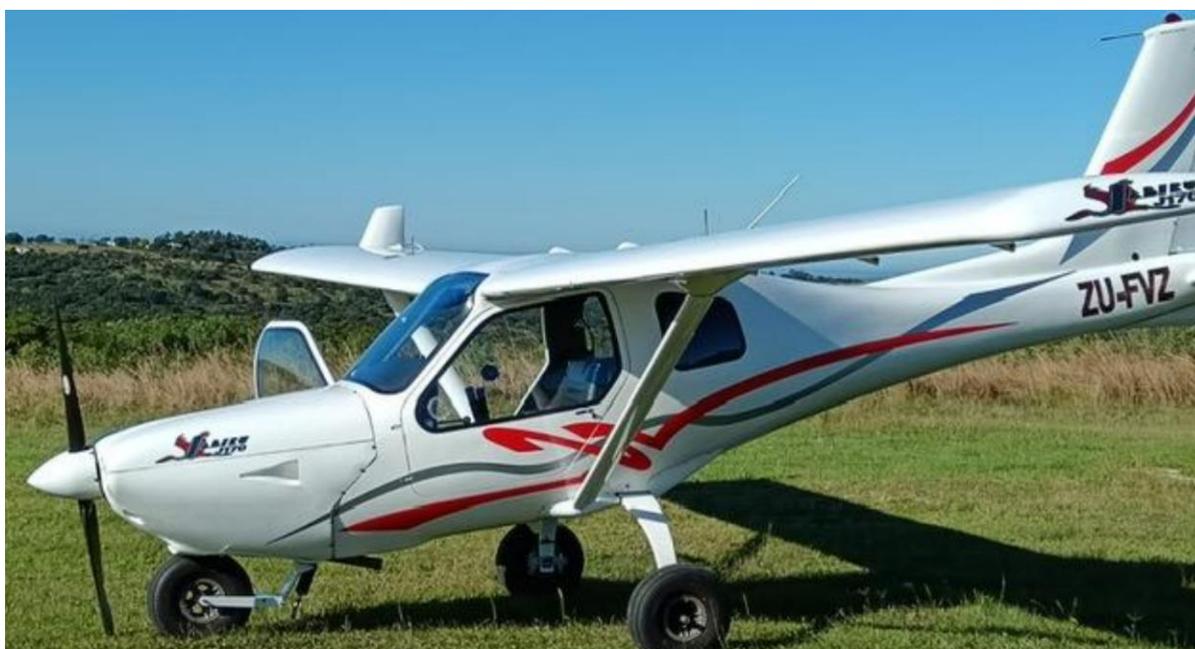
The aircraft sustained minor damage to the propeller and nose gear. No person was injured.

Figure 2: The aircraft at the serious incident site. (Source: Pilot)

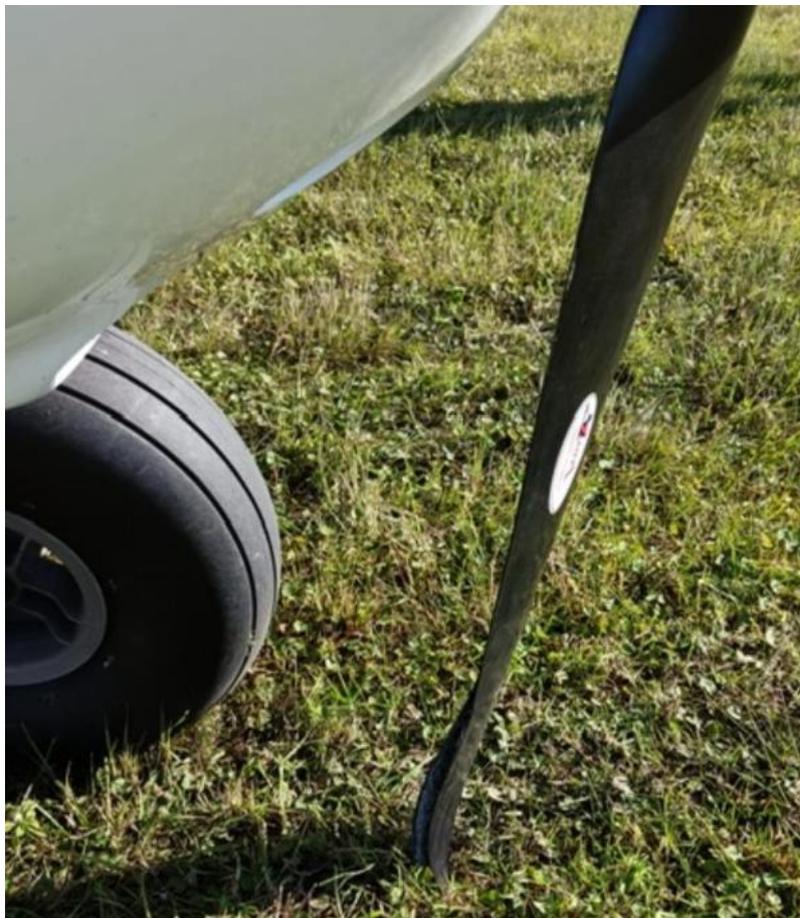
On the same day, 14 May 2025, the approved person (AP) recovered the aircraft to the South African Civil Aviation Authority-approved facility at Wings Park Airfield in East London. The AP reported that he inspected the engine for damage and found no anomalies. However, upon inspection of the propeller blades, he found that one of the blades was damaged (see Figure 3). He also noted that the bolt connecting the lower suspension shaft to the nose wheel yoke of the nose landing gear (NLG) was missing (see Figure 4), which caused the NLG to collapse. The AP searched the runway for the missing bolt but was unable to locate it.

Figure 3: The damaged propeller blade. (Source: Pilot)

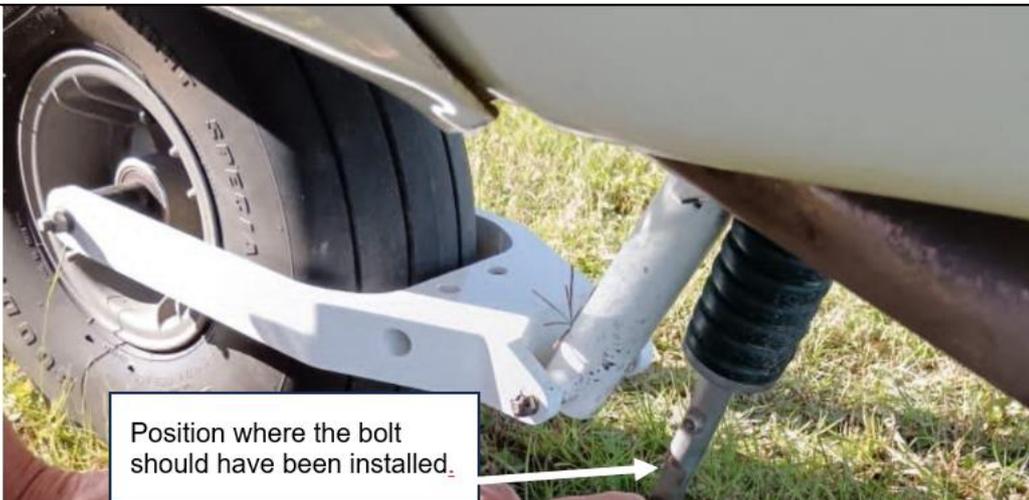
Figure 4: The lower suspension with the missing bolt. (Source: Pilot)

The collapse of the nose landing gear was due to the detachment of the bolt that secured the lower suspension shaft to the yoke of the nose landing gear assembly. The absence of the securing bolt rendered the suspension assembly ineffective to transmit loads which led to the nose landing gear collapse during taxi.

<p>7. The nose landing gear collapsed due to the detachment of the bolt that secured the lower suspension shaft to the yoke of the nose landing gear assembly.</p> <p>8. The absence of the bolt and nut compromised the structural integrity of the nose landing gear assembly which resulted in its failure.</p> <p>9. The Jabiru Pilot's Operating Handbook requires the inspection of the landing gear bolts during the pre-flight inspection.</p>
<p>Probable Cause</p> <p>The nose landing gear collapsed due to the detachment of the bolt that secured the lower suspension shaft to the yoke of the nose landing gear assembly. The loss of the bolt led to a structural failure of the nose gear which resulted in its collapse during taxi.</p>
<p>Contributing Factors</p> <p>None.</p>
<p>Safety Action(s)</p> <p>None.</p>
<p>Safety Message and/or Safety Recommendation/s</p> <p>None.</p>
<p>About this Report</p> <p><i>The decision to conduct a limited investigation is based on factors including whether the cause is known and the evidence supporting the cause is clear, the level of safety benefit likely to be obtained from an investigation and that will determine the scope of an investigation. For this occurrence, a limited investigation has been conducted, and the Accident and Incident Investigations Division (AIID) has relied on the information submitted by the affected person/s and organisation/s to compile this limited report. The report has been compiled using information supplied in the initial notification, as well as from follow-up desk top enquiries to bring awareness of potential safety issues to the industry in respect of this occurrence, as well as possible safety action/s that the industry might want to consider in preventing a recurrence of a similar occurrence.</i></p> <p><i>All times given in this report are Co-ordinated Universal Time (UTC) and will be denoted by (Z). South African Standard Time is UTC plus 2 hours.</i></p>

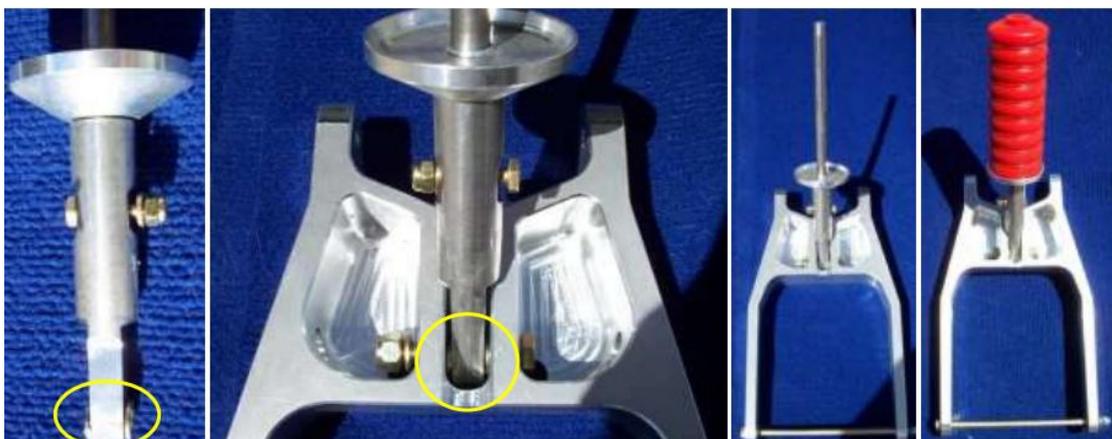
Figure 5: The yellow circles indicate the bolt connecting the lower suspension shaft to the yoke of the nose landing gear.

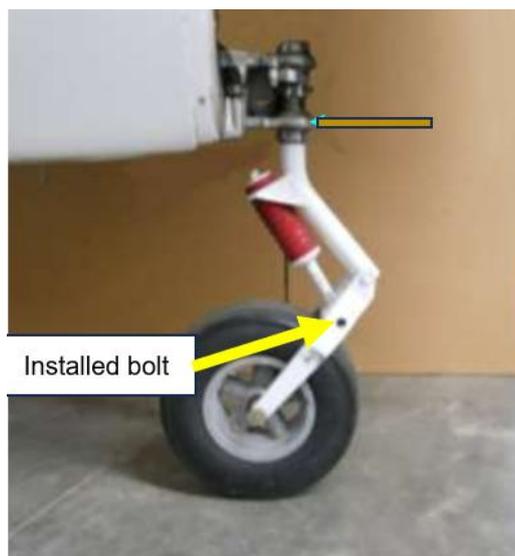
Figure 6: The lower suspension with the installed bolt. (Source: Jabiru J160/170 Constructors Manual)
