LIMITED OCCURRENCE INVESTIGATION REPORT – FINAL

Reference Number	CA18/3/2/1480						
Classification	Serious Incident	Date	23 May 2025		Time	1301Z	
Type of Operation	Training (Part 141)						
Location							
Place of Departure	George Airport (FAGG), Western Cape Province		Place of Intended Landing	Port Alfred Airport (FAPA), Eastern Cape Province			
Place of Occurrence	On a field, 6 nautical miles (nm) south-west of Port Alfred Airport (FAPA), Eastern Cape Province						
GPS Co-ordinates	Latitude	33°35'36.52" S	Longitude	026°45'46.85" E	Elevation	423 feet	
Aircraft Information							
Registration	ZS-FGU						
Make; Model; S/N	Piper; PA-28-140 Cherokee (Serial Number: 28-24070)						
Damage to Aircraft	Minor		Total Aircraft Hours	9 444.4			
Pilot-in-command							
Licence Type	Student Pilot Licence Integrated Course (SPLIC)		Gender	Male		Age	30
Licence Valid	Yes	Total Hours	136.4		Total Hours on Type	21.2	
Total Hours 30 Days	4.6		Total Flying on Type Past 90 Days	15.0

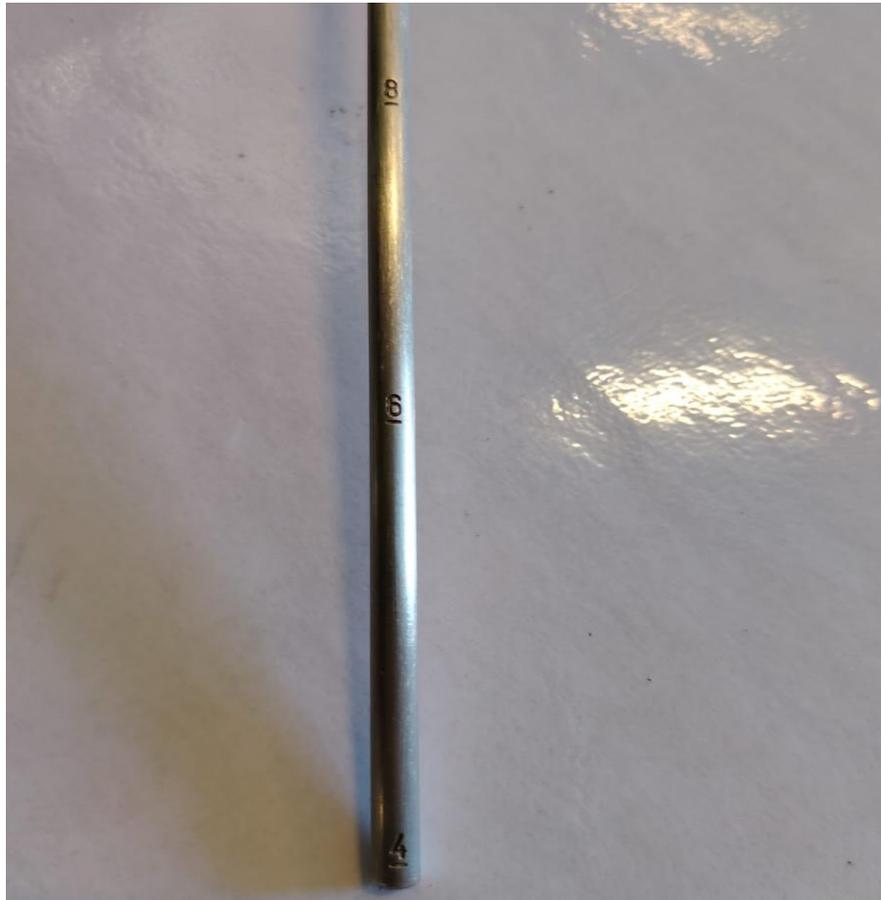
Figure 2: An engine oil dipstick shows oils level marked in quarts. (Source: POH)

2. The SP was aware that the engine was consuming above average oil. However, during the post-flight inspection prior to departure from FAGG, the SP failed to add oil to bring the level to eight quarts, which was the adequate amount required for safe engine operation.
3. The SP did not divert to any alternate aerodromes en route despite being available. The SP continued with the flight to FAPA after the AME, with whom he was communicating, advised him to do so.

10. The engine oil dipstick has a maximum level of eight quarts (see Figure 2).
11. Two quarts of engine oil were added before the SP departed from FAGG.

The engine oil level—maximum 8 quarts—must be verified during the pre-flight inspection.

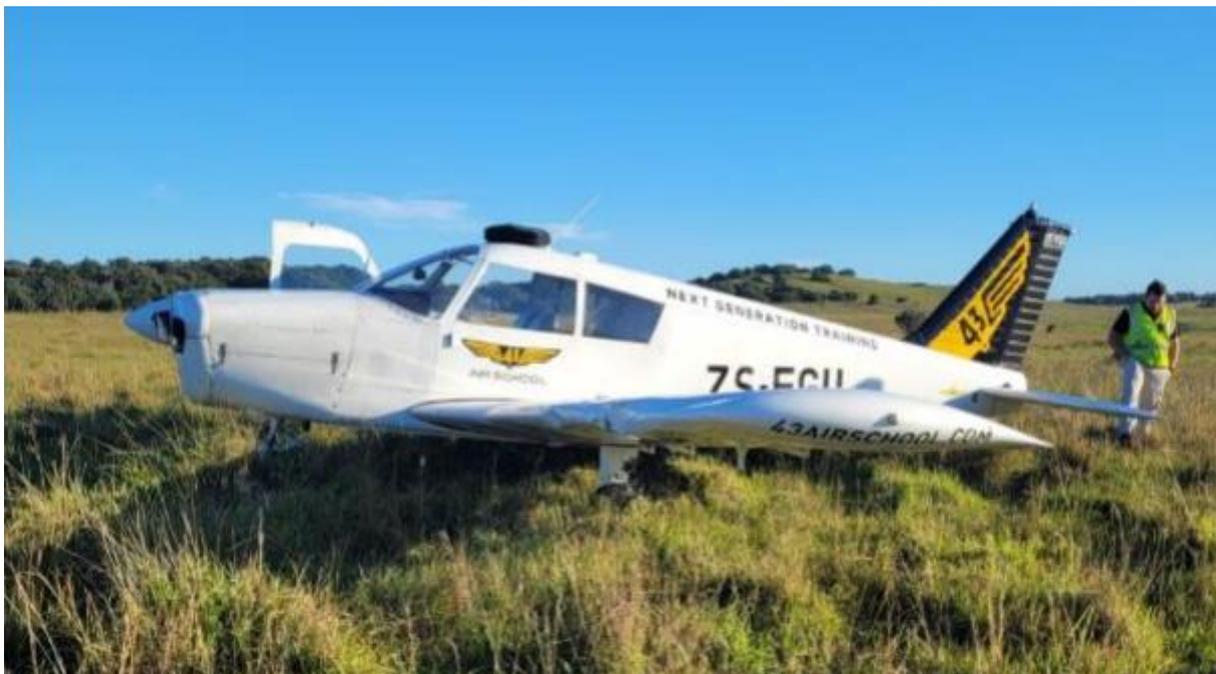
However, the engine ran rough approximately 3 miles north-east of Kenton-on-Sea, followed by a vibration and power loss. The SP then declared a MAYDAY on frequency 122.0-Megahertz (MHz) and provided his position and intentions before he attempted to restart the engine, which was unsuccessful. At this stage, there was smoke and a burning smell in the aircraft. The SP executed a forced landing on a field. The aircraft sustained minor damage; the SP was not injured during the serious incident.

Figure 4: The aircraft at the serious incident site. (Source: Pilot)

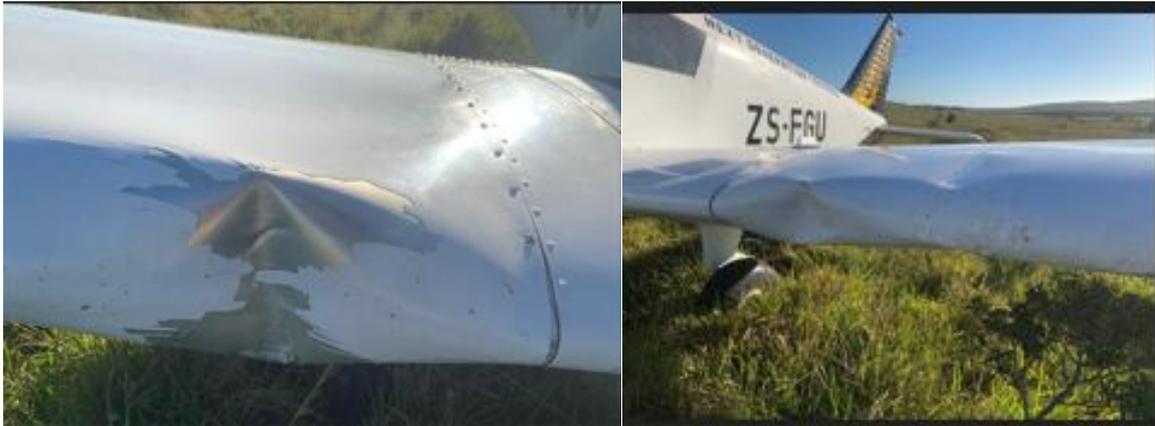
- On Monday, 26 May 2025, a detailed inspection of the aircraft was conducted. Both wings leading edges were damaged (see Figures 5 and 6).

Figures 5 and 6: Damaged to the right and left wings, respectively. (Source: Pilot)

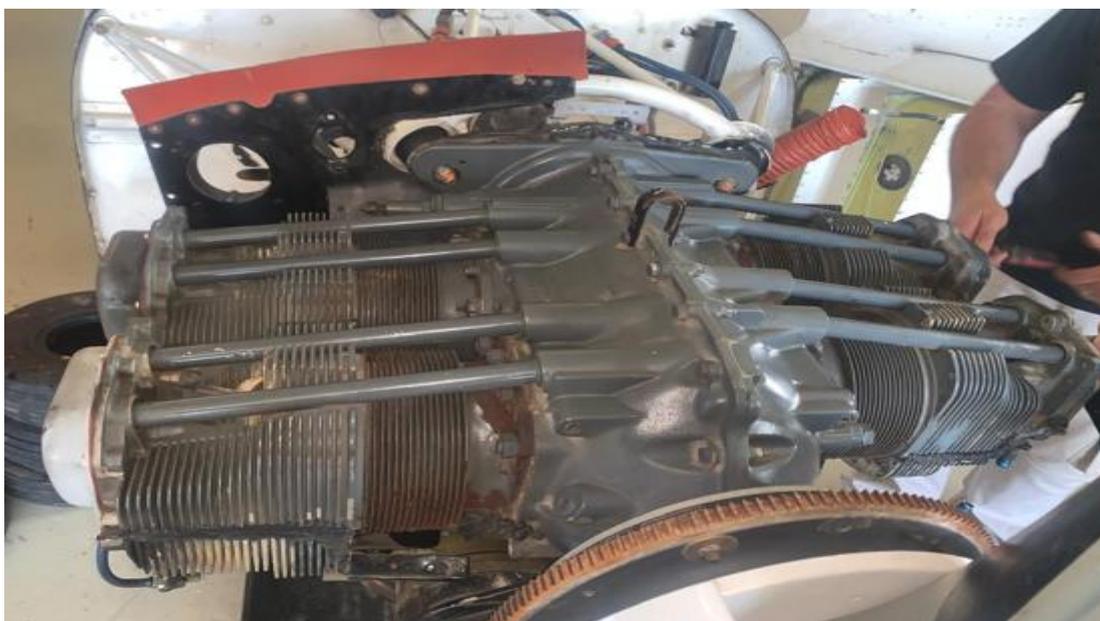
- *Upon initial inspection, the connecting rod (conrod) of Cylinder 1 was found to have punctured the crank case.*
- *External impact marks were observed above the pushrod tubes of Cylinder 4.*
- *Following a complete engine teardown, it was determined that Conrod 4 journal showed clear signs of oil starvation and appeared to have failed first, forcefully striking the engine block and creating a hole into the sump.*
- *Conrod 1 likely failed subsequently, adding to the mechanical damage.*
- *The oil pump was removed and opened, revealing a significant quantity of metal filings that had entered the pump cavity.*
- *The contamination restricted the supply of oil to the engine.*

Figure 7: The engine before teardown inspection. (Source: Pilot)

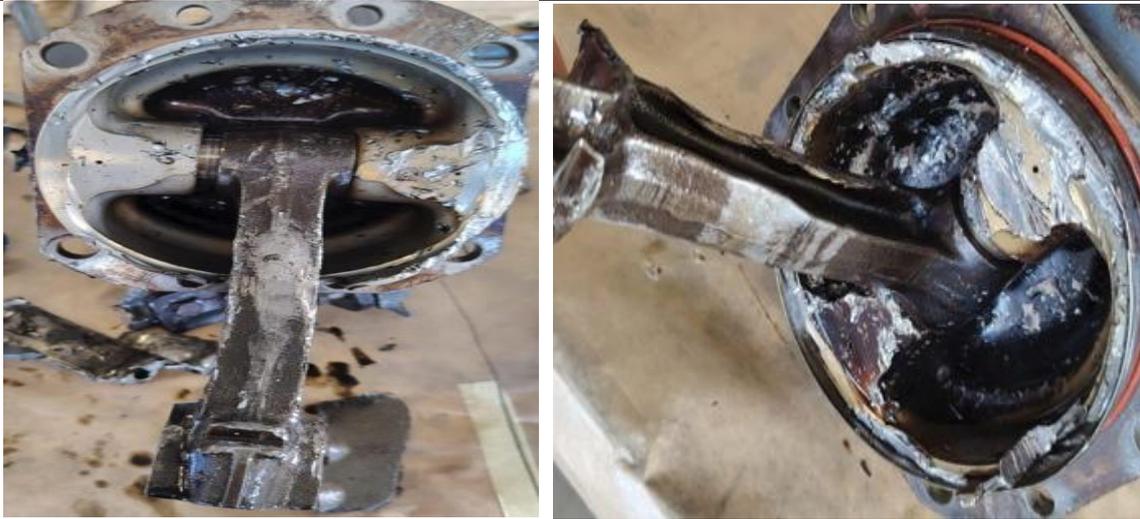
Figures 8 and 9: Connecting rods 1 and 2 (conrods). (Source: AMO)

4 failed first, breaching the engine oil sump. Conrod 1 failed subsequently, contributing further to the catastrophic engine damage.

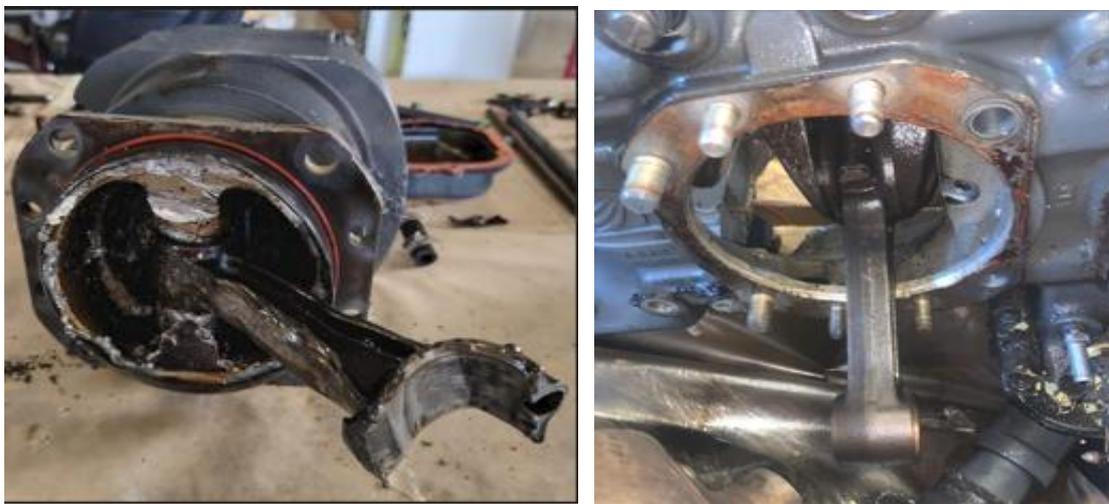
Figures 10 and 11: Connecting rods 3 and 4 (conrods). (Source: AMO)

The engine failure was caused by progressive oil starvation, compounded by an inoperative oil pump due to metallic debris contamination. Evidence from the teardown inspection indicated that Conrod
