**LIMITED OCCURRENCE INVESTIGATION REPORT – FINAL**

<b>Reference Number</b>	CA18/3/2/1481						
<b>Classification</b>	Serious Incident	<b>Date</b>	10 April 2025		<b>Time</b>	0900Z	
<b>Type of Operation</b>	Commercial (ZS-YAE Part 121 and ZS-PPG Part 135)						
<b>Location</b>							
<b>Place of Departure</b>	ZS-PPG - Skukuza Airport (FASZ), Mpumalanga Province		<b>Place of Intended Landing</b>		ZS-PPG - Lanseria International Airport (FALA), Gauteng Province		
	ZS-YAE – O.R. Tambo International Airport (FAOR), Gauteng Province				ZS-YAE - Skukuza Airport (FASZ), Mpumalanga Province		
<b>Place of Occurrence</b>	At Skukuza Airport (FASZ), Mpumalanga Province						
<b>GPS Co-ordinates</b>	<b>Latitude</b>	S32°37'30.0"	<b>Longitude</b>	E18°56'17.0"	<b>Elevation</b>	1 040 feet	
<b>Aircraft Information</b>							
<b>Registration</b>	ZS-PPG and ZS-YAE						
<b>Make; Model; S/N</b>	Beechcraft; King Air B200 (Serial Number: BB-1562) Embraer; ERJ-190 (Serial Number: 19000456)

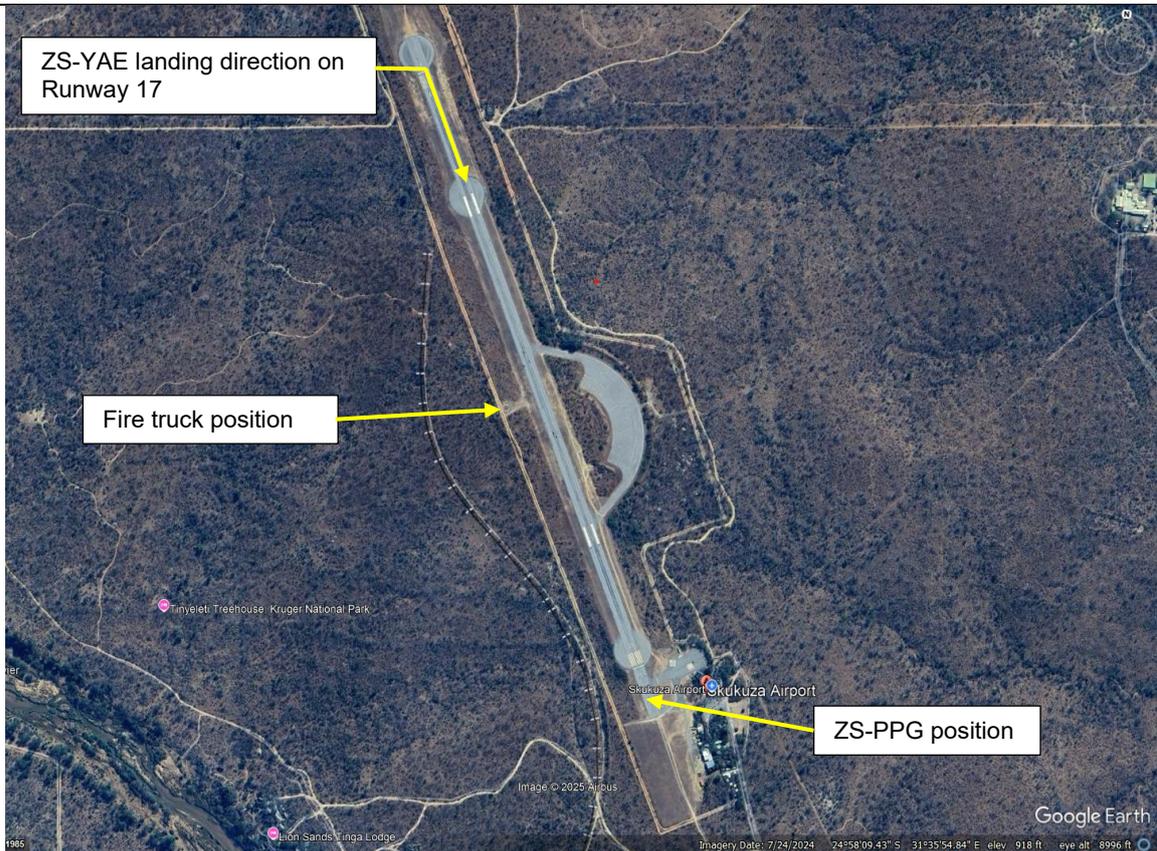
An eyewitness at FASZ reported that he was inside an ambulance that was parked midway Runway 17 on the side; the eyewitness watched the ZS-YAE as it approached. The eyewitness further stated that the ZS-PPG stopped at the threshold of Runway 35 without broadcasting on VHF 125.25-MHz to check for possible traffic inbound FASZ. Upon witnessing the above scenarios, the eyewitness used a two-way radio installed in the ambulance to instruct traffic on the ground to hold their positions. The ZS-PPG was then observed reversing onto the holding point of Runway 35. None of the aircraft was damaged during the serious incident, and no person was injured.

**Figure 1:** Aerial view of FASZ, the landing direction of ZS-YAE, the approximate position of the fire ambulance and the ZS-PPG position. (Source: Google Earth)

The available information indicated that the ZS-PPG crew decided to return to FALA earlier than previously planned. The crew notified Lowveld Information about their early departure but omitted to inform FASZ ground ops. Later, the crew started the engines and taxied the aircraft towards the threshold of Runway 35. They checked the surrounding vicinity for approaching traffic but did not detect the Embraer ERJ-190 (ZS-YAE) aircraft that was approaching Runway 17. The eyewitness who was inside an ambulance that was parked midway Runway 17 observed both aircraft and, thus, used a two-way radio installed in the ambulance to broadcast on VHF125.25-MHz that traffic on the ground maintain their position until ZS-YAE has landed. The eyewitness observed ZS-PPG reversing onto the holding point of Runway 35 to stay clear of the landing path of ZS-YAE. The ZS-YAE landed safely on Runway 17. After a few seconds, the ZS-YAE exited the runway and proceeded to Charlie
