LIMITED OCCURRENCE INVESTIGATION REPORT – FINAL

Reference Number	CA18/3/2/1482						
Classification	Serious Incident	Date	21 May 2025			Time	0515Z
Type of Operation	Private (Part 91)						
Location							
Place of Departure	Newcastle Airfield (FANC), KwaZulu-Natal Province			Place of Intended Landing	New Tempe Airfield (FATP), Free State Province		
Place of Occurrence	Approximately 6 nautical miles south-west of Chelmsford Nature Reserve						
GPS Co-ordinates	Latitude	28° 04' 57.3" S	Longitude	029° 45' 37.6" E	Elevation	4 219 ft	
Aircraft Information							
Registration	ZS-FXT						
Make; Model; S/N	Cessna; Cardinal C177B (Serial Number: 177-01400)						
Damage to Aircraft	None			Total Aircraft Hours	3 553.99		
Pilot-in-command							
Licence Type	Private Pilot Licence (PPL)			Gender	Male		Age 38
Licence Valid	Yes	Total Hours	126.32		Total Hours on Type	123.62	
Total Hours 30 Days	5.43			Total Flying on Type Past 90 Days	7.97		
People On-board	1+1	Injuries	0	Fatalities	0	Other (on ground)	0

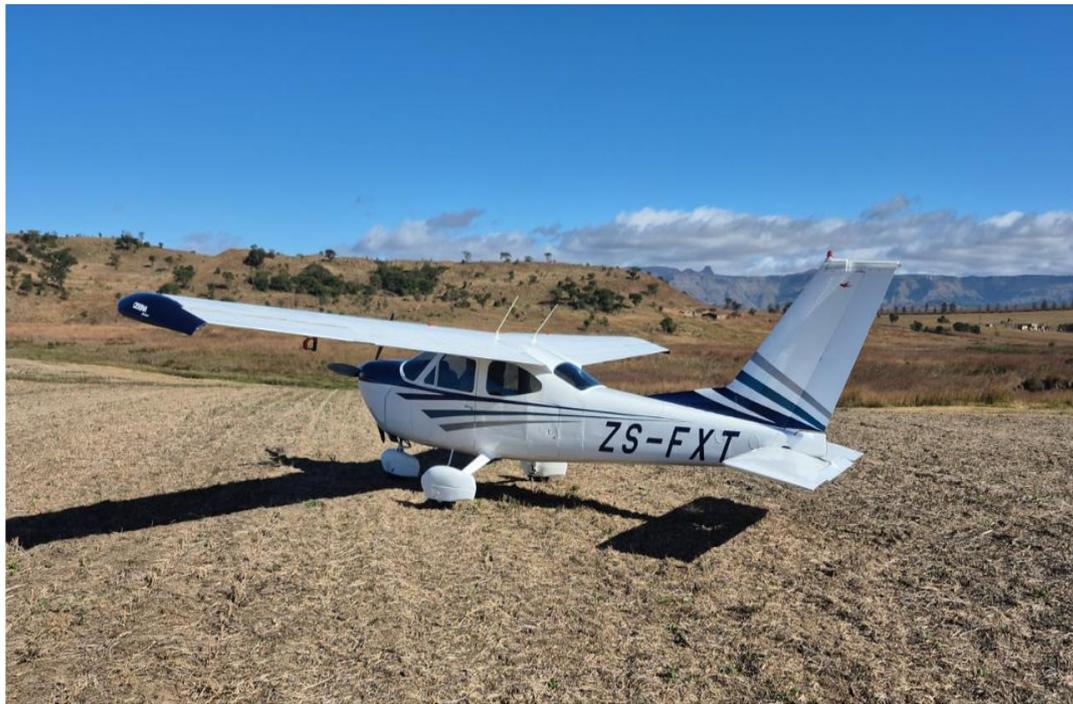
Figure 2: The aircraft post-serious incident. (Source: Operator)

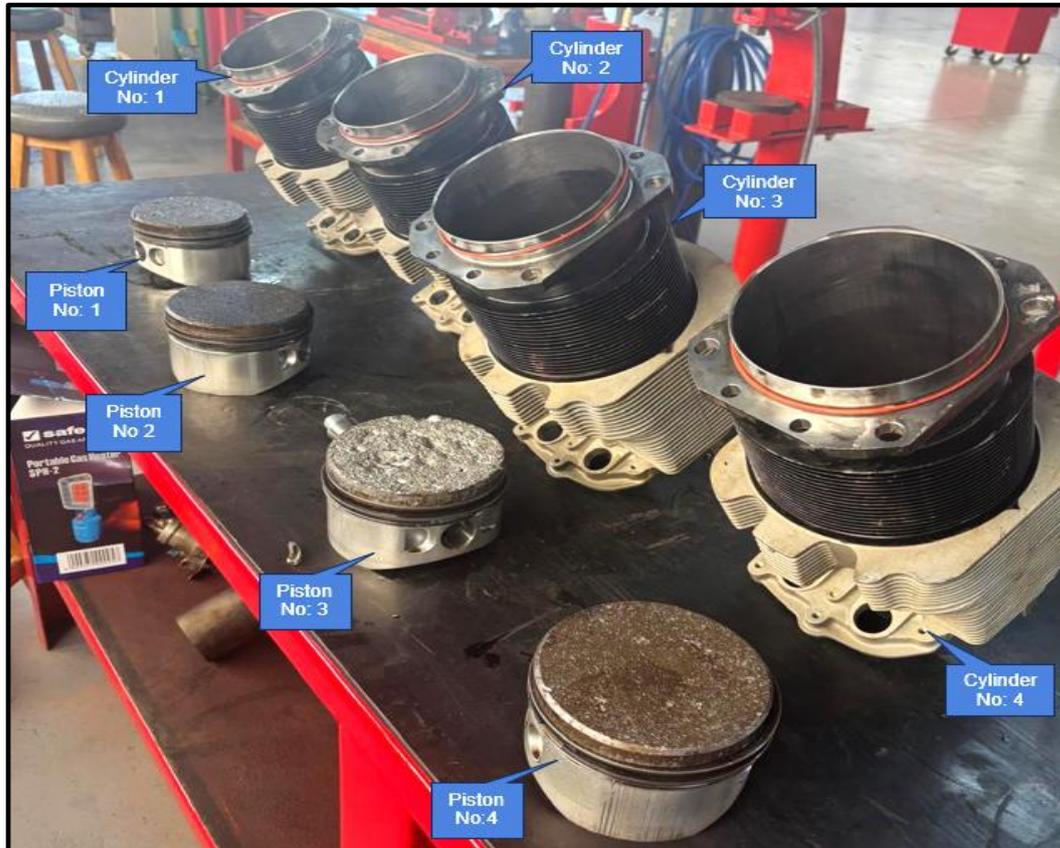
A Lycoming O-360 A1F6 engine with serial number L-14516-36 and with 3 571.41 hours was recovered to an approved AMO for further investigation. A teardown inspection was conducted on 28 May 2025. Figure 3 shows the cylinders and pistons after the engine was dismantled.

Figure 3: The damaged engine pistons. (Source: AMO)

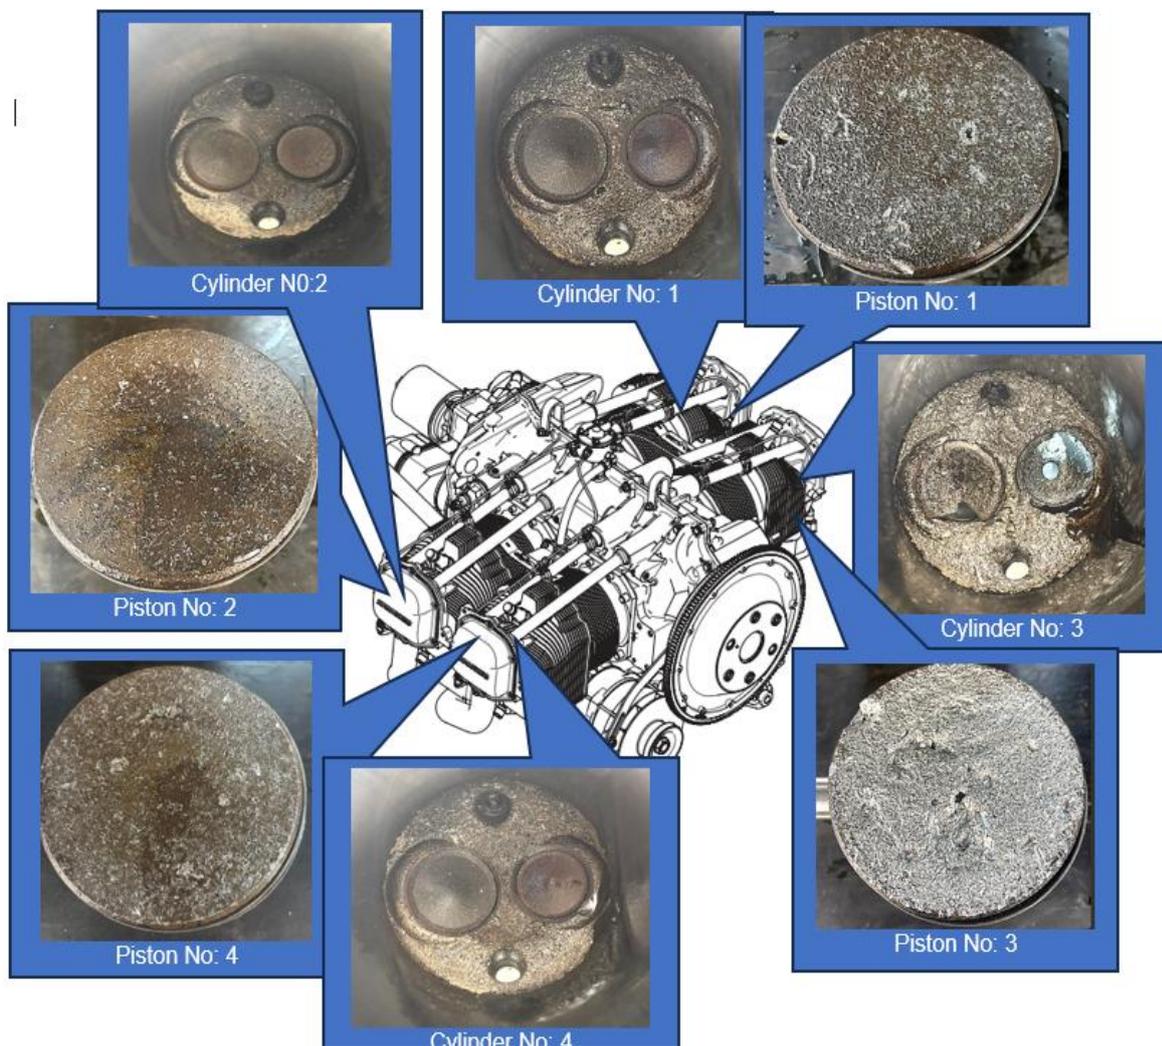
- All four cylinders were removed from the engine casing. The Number 3 cylinder and the associated piston showed signs of damage caused by the failed exhaust valve. The exhaust valve was damaged on the stem behind the valve head which caused damage to both the cylinder and piston. The exhaust valve spring (upper rotator) key with part number MS13997-3 failed and caused the valve to get stuck and, subsequently, the malfunctioning of the valve operation. This, therefore, led to it being damaged by the piston movement, further exacerbating damage.
- The number 1, 2 and 4 cylinders also displayed damage caused by debris (fragments) from the Number 3 (No.3) cylinder and piston.
- Debris from the engine component was found in the oil sump which caused blockage in the oil strainer.

Figure 4: The damaged engine cylinders and their associated pistons.

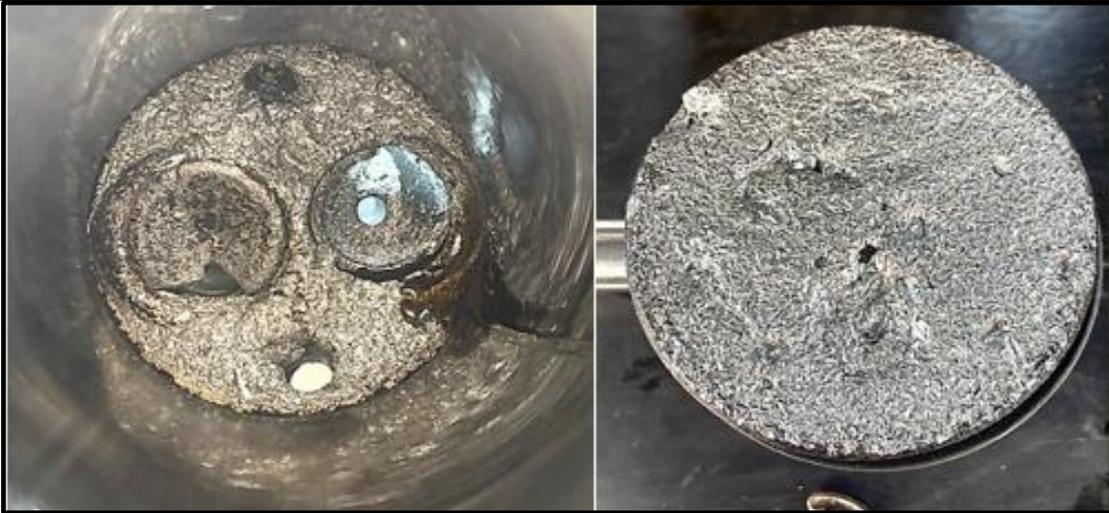
Figure 5: The damaged No.3 piston, exhaust valve area and piston crown.

- 7. The valve key on the No.3 cylinder failed during flight, 29 hours after the engine overhaul was conducted. This caused the exhaust valve to drop into the cylinder and was struck by the piston. The impact broke the valve and this led to serious internal engine damage which resulted in complete engine failure. The pilot conducted a successful forced landing.

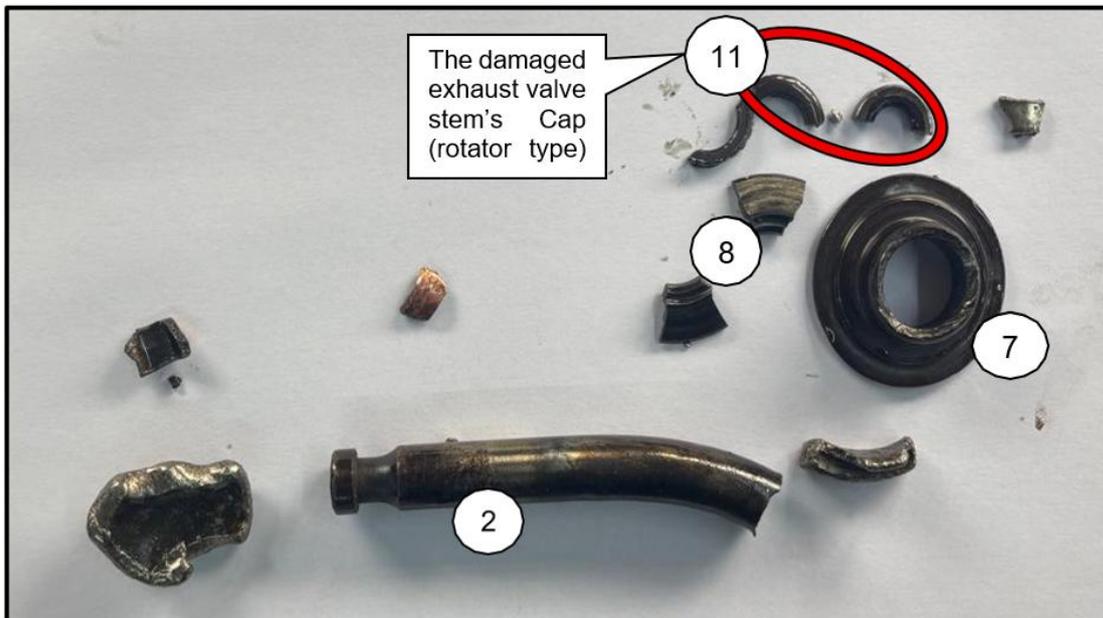
Figure 6: The failed No.3 cylinder exhaust valve.

Figure 6 shows the failed components: the damaged exhaust valve rotatory type cap (11), the damaged exhaust valve stem (rotator type) (2), and the failed upper valve spring seat (8).

After reporting the failure to the supplier, the AMO received communication that they will receive a new set of components as they (supplier) believed there was a manufacturing defect that had led to the No.3 cylinder exhaust valve stem failure.

The valve key failed which caused the exhaust valve to drop into the cylinder where it was repeatedly struck by the piston. This caused the valve to break and, subsequently, caused extensive internal engine damage.
