**LIMITED OCCURRENCE INVESTIGATION REPORT – FINAL**

<b>Reference Number</b>		CA18/3/2/1483					
<b>Classification</b>	Serious Incident	<b>Date</b>	7 June 2025			<b>Time</b>	1645Z
<b>Type of Operation</b>	Private (Part 94)						
<b>Location</b>							
Place of Departure	Plettenberg Bay (FAPG), Western Cape		Place of Intended Landing	Plettenberg Bay (FAPG), Western Cape			
Place of Occurrence	Runway 30 at Plettenberg Bay (FAPG), Western Cape Province						
GPS Co-ordinates	Latitude	34°05'17.37"S	Longitude	023°19'43.02"E	Elevation	465 ft	
<b>Aircraft Information</b>							
Registration	ZU-FIH						
Make; Model; S/N	Kitplanes for Africa; Bushbaby Explorer (Serial Number: 128-09-07)						
Damage to Aircraft	Substantial		Total Aircraft Hours	773.27			
<b>Pilot-in-command</b>							
Licence Type	National Pilot Licence (NPL) Aeroplane		Gender	Male		Age	69
Licence Valid	Yes	Total Hours	719.82		Total Hours on Type	54.40	
Total Hours 30 days	11.2		Total Flying on Type Past 90 days			32.8

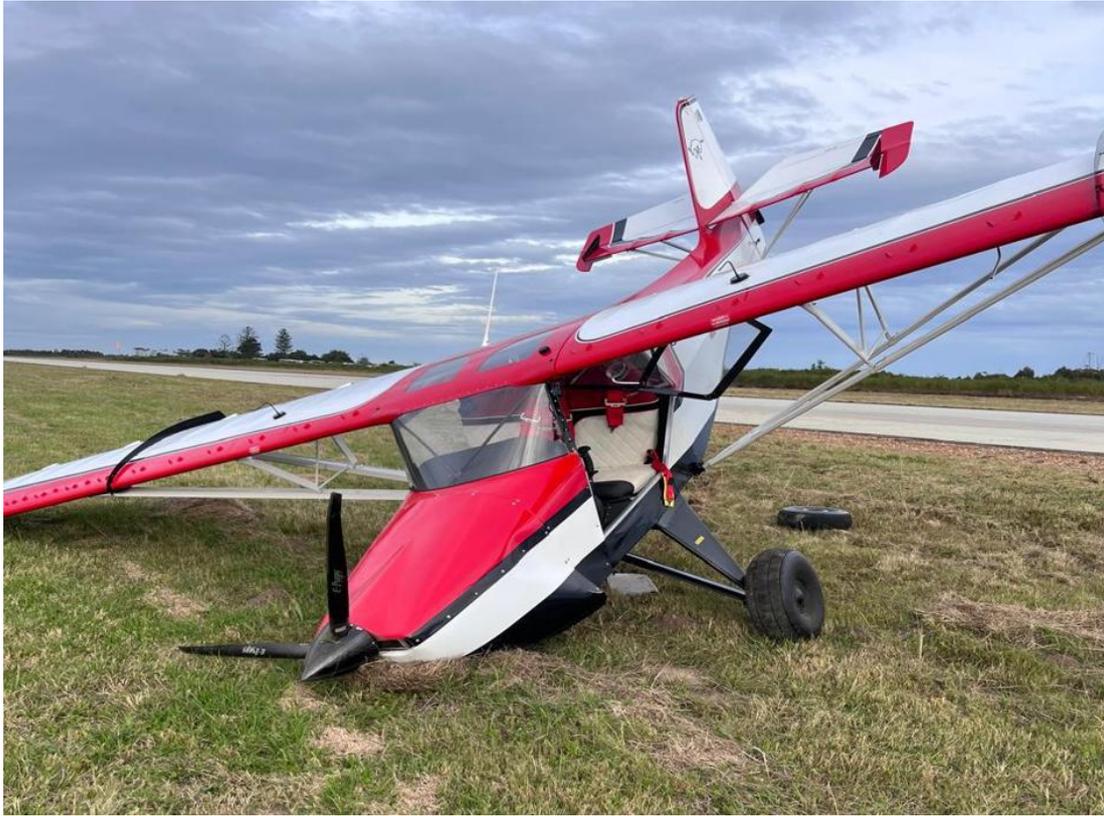
<b>People On-board</b>	1+0	<b>Injuries</b>	0	<b>Fatalities</b>	0	<b>Other (on ground)</b>	0
<b>What Happened</b>							
<p>On Saturday, 7 June 2025, a pilot on-board a Kitplanes For Africa (KFA) Bushbaby Explorer aircraft, registered ZU-FIH, departed from Plettenberg Bay Aerodrome (FAPG) in Western Cape province to conduct a private scenic flight in the area, with the intention to land back at the same aerodrome. The flight was conducted under visual meteorological conditions (VMC) by day in accordance with the provisions of Part 94 of the Civil Aviation Regulations (CAR) 2011 as amended.</p> <p>According to the pilot, he conducted a pre-flight inspection of the aircraft with no abnormalities noted. Good weather conditions with calm winds and clear visibility prevailed at the time of the flight. The pilot stated that the take-off and the scenic flight were uneventful, and the aircraft returned to FAPG for a full-stop landing. The pilot positioned the aircraft for landing on Runway 30 (RWY 30). The aircraft was stable on final approach; however, the pilot heard a loud sound during landing as the main wheels contacted the runway. This was followed by the aircraft veering off to the right of the runway centreline.</p> <p>The pilot attempted to correct the direction of the aircraft by applying full rudder and differential braking to the left, however, the aircraft departed the paved surface and rolled onto the grass on the right side of the runway, approximately 60 to 70 metres (m) from the initial touchdown point. During the runway excursion, the right main wheel detached from the undercarriage assembly. The aircraft came to rest in a nose-down attitude. No person was injured; the pilot disembarked from the aircraft unaided.</p>

**Figure 1:** The resting position of the aircraft post-serious incident. (Source: Pilot)

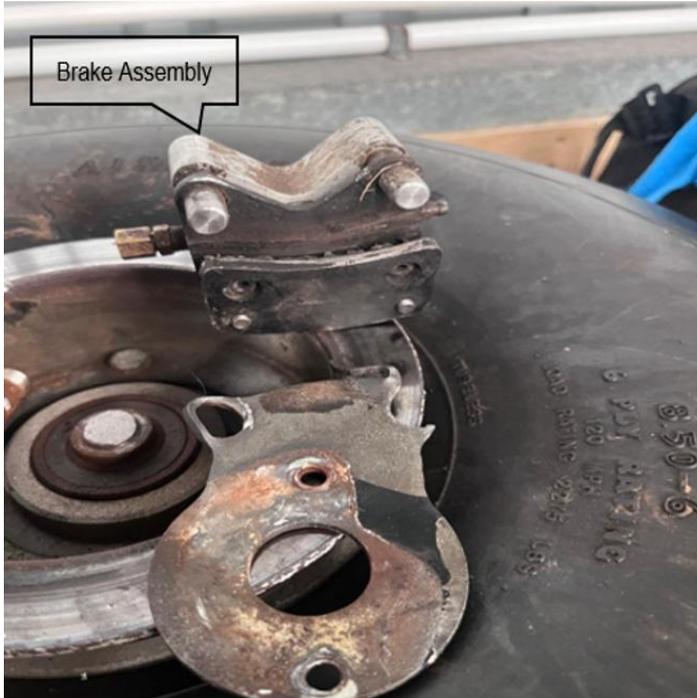
**Figure 2:** The broken brake assembly. (Source: Pilot)

The inspection after the serious incident revealed that the right axle had fractured at the point where it connected to the undercarriage leg. The fractured section of the axle then lodged in the brake calliper assembly, which resulted in the pilot losing directional control of the aircraft.

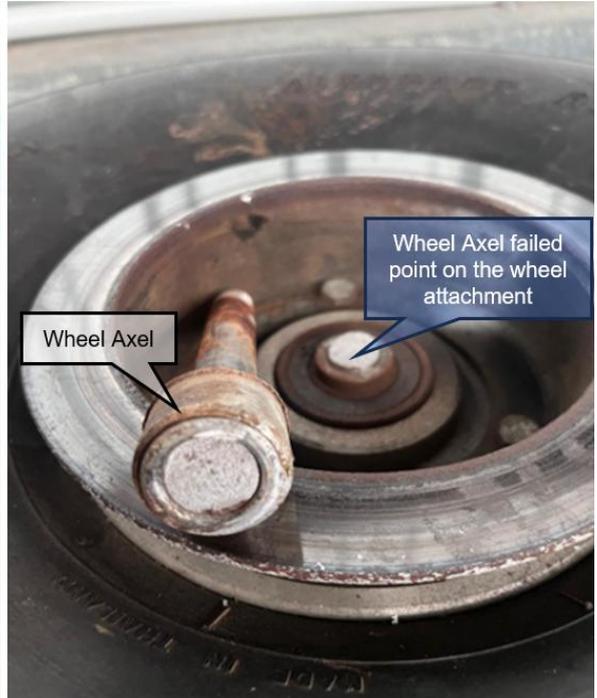
**Figure 3:** The broken wheel axle. (Source: Pilot)

2.3. The right main landing gear wheel axle broke off during the landing roll and the aircraft veered off to the right. Post-serious incident examination determined that the failure of the axle was due to metal fatigue which resulted from a pre-existing crack.

Metal fatigue.

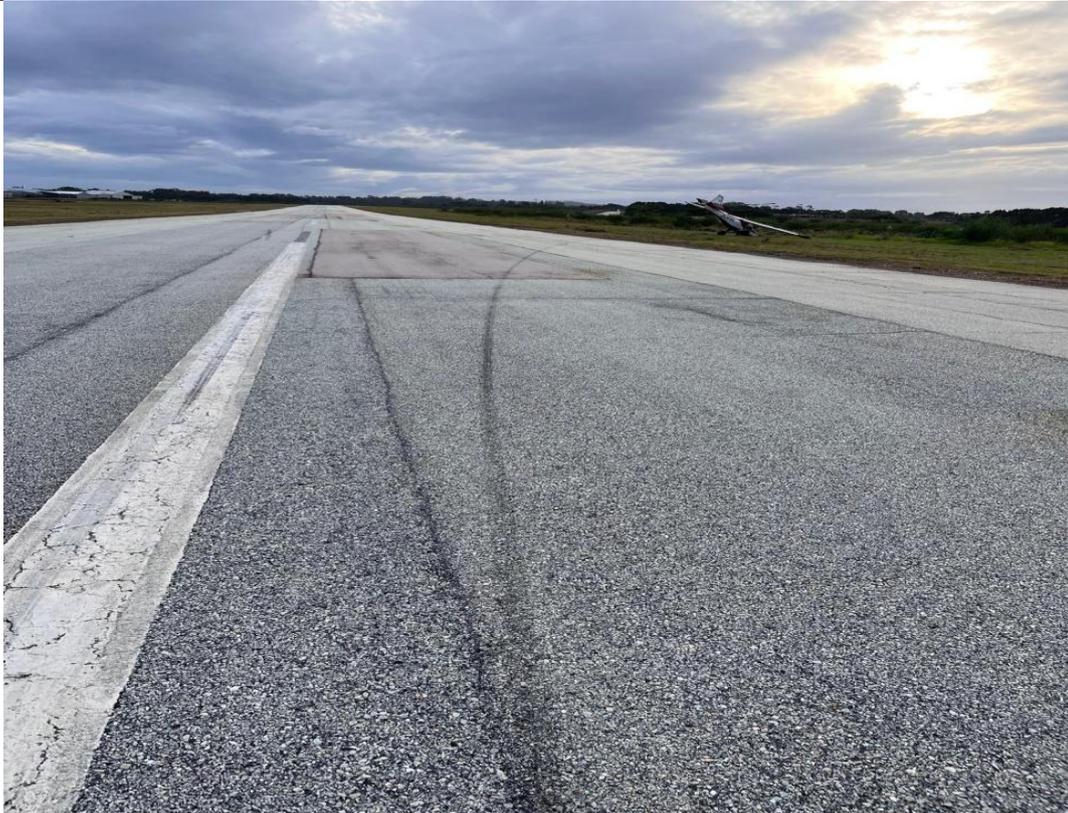
**Figure 4:** Skid marks on Runway 30 at FAPG.

Skid marks on Runway 30 indicated an asymmetric drag and wheel detachment during rollout.

4.2 Braking input from the pilot, combined with the right axle failure resulted in asymmetric drag, evidenced by skid marks on Runway 30.
