LIMITED OCCURRENCE INVESTIGATION REPORT – FINAL

Reference Number	CA18/3/2/1484						
Classification	Serious Incident		Date	11 June 2025		Time	1045Z
Type of Operation	Private (Part 91)						
Location							
Place of Departure	Wonderboom Aerodrome (FAWB), Gauteng Province		Place of Intended Landing	AL 3 Farm Airfield near Dendron, Limpopo Province			
Place of Occurrence	On Runway 04 at AL 3 Farm near Dendron, Limpopo Province						
GPS Co-ordinates	Latitude	23° 25' 36.0" S	Longitude	029° 17' 57.0" E	Elevation	3 545 ft	
Aircraft Information							
Registration	ZS-KLP						
Make; Model; S/N	Beech Aircraft; BE58TC (Serial Number: TK-129)						
Damage to Aircraft	Substantial		Total Aircraft Hours	3 844.5			
Pilot-in-command							
Licence Type	Private Pilot Licence (PPL)		Gender	Male		Age	72
Licence Valid	Yes	Total Hours	13 406.5		Total Hours on Type	301.5	
Total Hours 30 Days	7.2		Total Flying on Type Past 90 Days	10.3			
People On-board	1 + 0	Injuries	0	Fatalities	0	Other (on ground)	0

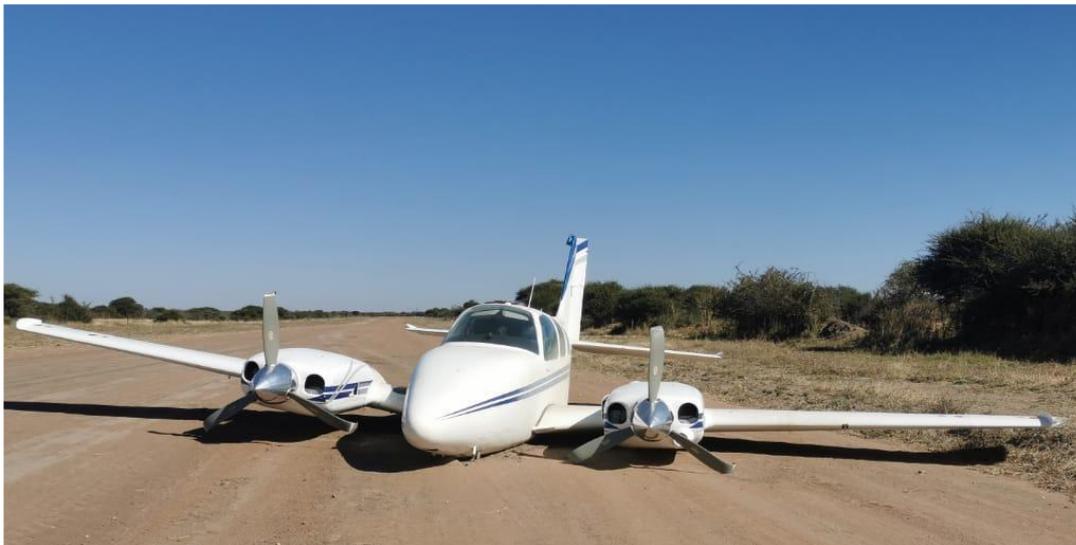
What Happened							
<p>On Wednesday, 11 June 2025, a pilot on-board a BE58TC aircraft with registration ZS-KLP was on a private flight from Wonderboom Aerodrome (FAWB) in Gauteng province to AL 3 Farm Airfield near Dendron in Limpopo province when the serious incident occurred. The flight was conducted under visual meteorological conditions (VMC) by day and under the provisions of Part 91 of the Civil Aviation Regulations (CAR) 2011 as amended.</p> <p>According to the pilot, he performed a pre-flight inspection of the aircraft at FAWB with no anomalies noted. Thereafter, he started the engine and took off at approximately 1005Z. The flight proceeded uneventfully during which the pilot contacted the Makhado Air Force Base Air Traffic Control (ATC) personnel. The pilot flew over the AL 3 Farm Airfield and joined in accordance with the unmanned joining procedures; the wind conditions favoured Runway (RWY) 04. Whilst on base leg, the pilot noticed a herd of impalas close to the runway. On final approach to land on Runway 04, he was fixated on the herd movement and forgot to extend the landing gear as prescribed in the Before Landing Checklist. This resulted in a wheels-up landing. The aircraft skidded on the runway and came to rest approximately 200 metres (m) from the initial point of touchdown. The pilot was not injured. The aircraft sustained damage to the propellers, flaps and front part of the belly.</p>

Figure 2: The aircraft at the serious incident site. (Source: Pilot)

3.	<u>Meteorological Information</u>
3.1	The weather conditions were not a contributory factor to this serious incident.
4.	<u>Conclusion</u>
4.1	The pilot omitted to complete the before landing checklist as prescribed in the Pilot's Operating Handbook (POH). This omission led to the failure to extend and check the landing gear before touchdown, hence, the subsequent wheels-up landing.
