LIMITED OCCURRENCE INVESTIGATION REPORT – FINAL
--

Reference Number		CA18/3/2/1485									
Classification		Serious Incident		Date		15 June 2025	Time		1100Z		
Type of Operation		Private (Part 94)									
Location											
Place of Departure		Kuruman Airfield (FAKU), Northern Cape Province			Place of Intended Landing			Airspan Airfield, Kroondal, North West Province			
Place of Occurrence		Runway 03 at Airspan Airfield, North West Province									
GPS Co-ordinates		Latitude		25°45'43" S		Longitude		027°19' 23" E	Elevation		3951ft
Aircraft Information											
Registration		ZU-FCR									
Make; Model; S/N		KP 2U-Rapid (Serial Number: 2118123L)									
Damage to Aircraft		Substantial			Total Aircraft Hours		704				
Pilot-in-command											
Licence Type		National Pilot Licence (NPL)			Gender		Male		Age	55	
Licence Valid		Yes		Total Hours		1 725.7		Total Hours on Type		200	
Total Hours 30 Days		100.9			Total Flying on Type Past 90 Days			56.8			
People On-board		1+0	Injuries		0	Fatalities		0	Other (on ground)		0

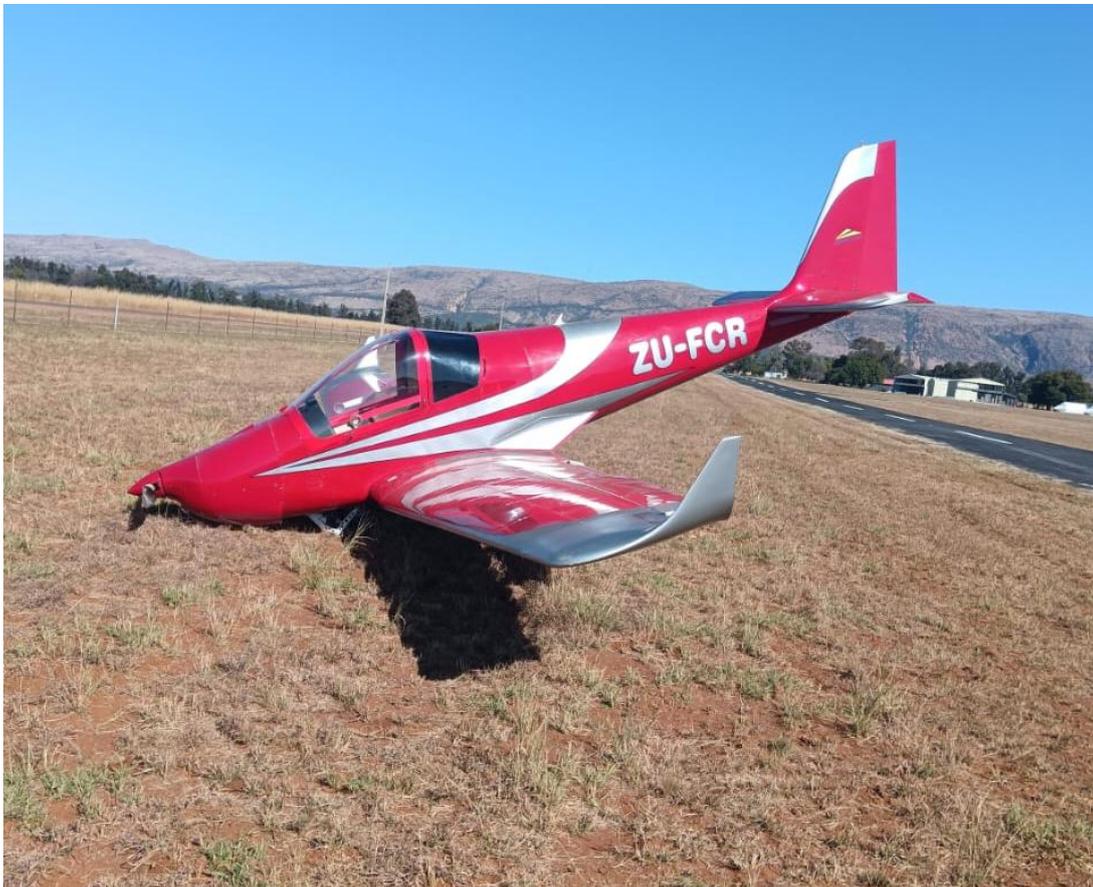
Figure 2: The aircraft after it had come to a stop. (Source: Pilot)

5. The Certificate of Registration (C of R) was issued to the present owner on 19 September 2023.
6. After touchdown, the aircraft bounced and landed hard with the nose gear; subsequently, it broke off and the propeller struck the runway. The pilot lost directional control and the aircraft skidded for 10m before it veered off to the right and exited the runway after.

Probable Cause(s)
The aircraft landed hard, and the nose gear broke off; subsequently, the pilot lost directional control of the aircraft.
Contributing Factor(s)
None.
Safety Action(s)
None.
Safety Message
Pilots are encouraged to initiate go-arounds when conditions are not conducive for safe landings.
About this Report
<p><i>The decision to conduct a limited investigation is based on factors including whether the cause is known and the evidence supporting the cause is clear, the level of safety benefit likely to be obtained from an investigation and that will determine the scope of an investigation. For this occurrence, a limited investigation has been conducted, and the Accident and Incident Investigations Division (AIID) has relied on the information submitted by the affected person/s and organisation/s to compile this limited report. The report has been compiled using information supplied in the initial notification, as well as from follow-up desktop enquiries to bring awareness of potential safety issues to the industry in respect of this occurrence, as well as possible safety action/s that the industry might want to consider in preventing a recurrence of a similar occurrence.</i></p> <p><i>All times given in this report are Co-ordinated Universal Time (UTC) and will be denoted by (Z). South African Standard Time is UTC plus 2 hours.</i></p>

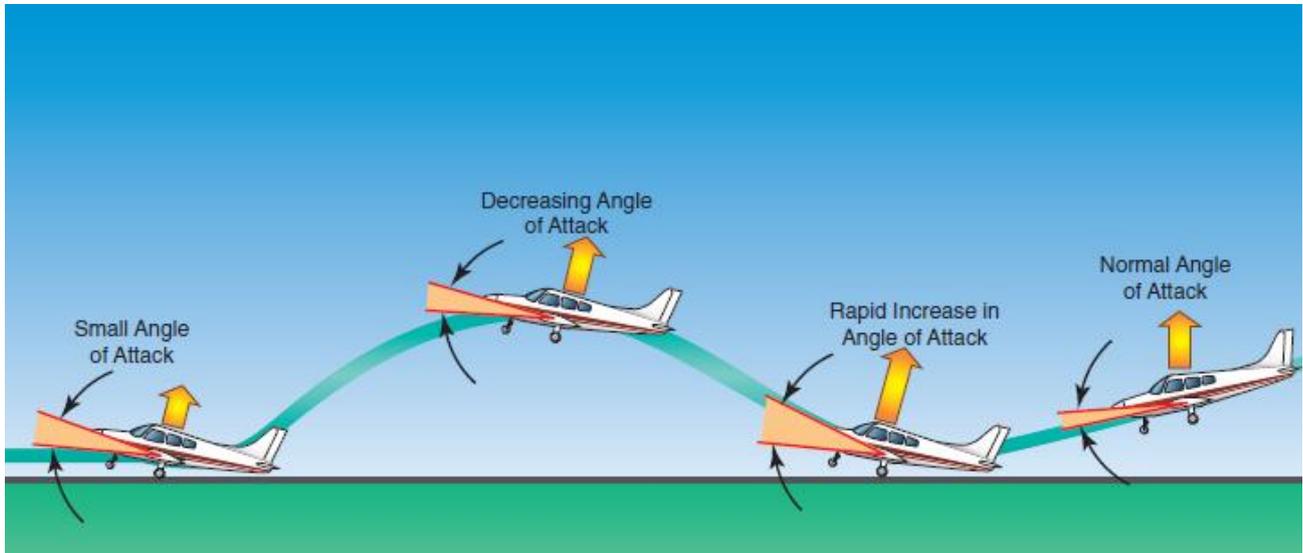
When the aeroplane contacts the ground with a sharp impact as the result of an improper attitude or an excessive rate of sink, it tends to bounce back into the air.

Illustration 1: A depiction of a bounce. (Source: FAA-aeroplane Flying Handbook)

When a bounce is severe, the safest procedure is to 'execute a go-around immediately'. No attempt to salvage the landing should be made. Full power should be applied while simultaneously maintaining directional control and lowering the nose to a safe climb attitude.
